UNIVERSITY OF TRANSPORTATION AND COMMUNICATIONS  
*SECTION OF URBAN TRANSPORT WORKS*

# THE BONDING STEEL PLATES AND CARBON FIBER REINFORCED POLYMER PLATES TECHNOLOGY FOR REPAIRING CONCRETE BRIDGES IN VIET NAM

Pro.Dr. Nguyen Viet Trung

## **EXISTING CONCRETE BRIDGES REPAIRED BY BONDING STEEL PLATES AND CARBON FIBER REINFORCED POLYMER PLATES IN VIET NAM AFTER 14 YEARS OF SERVICE**

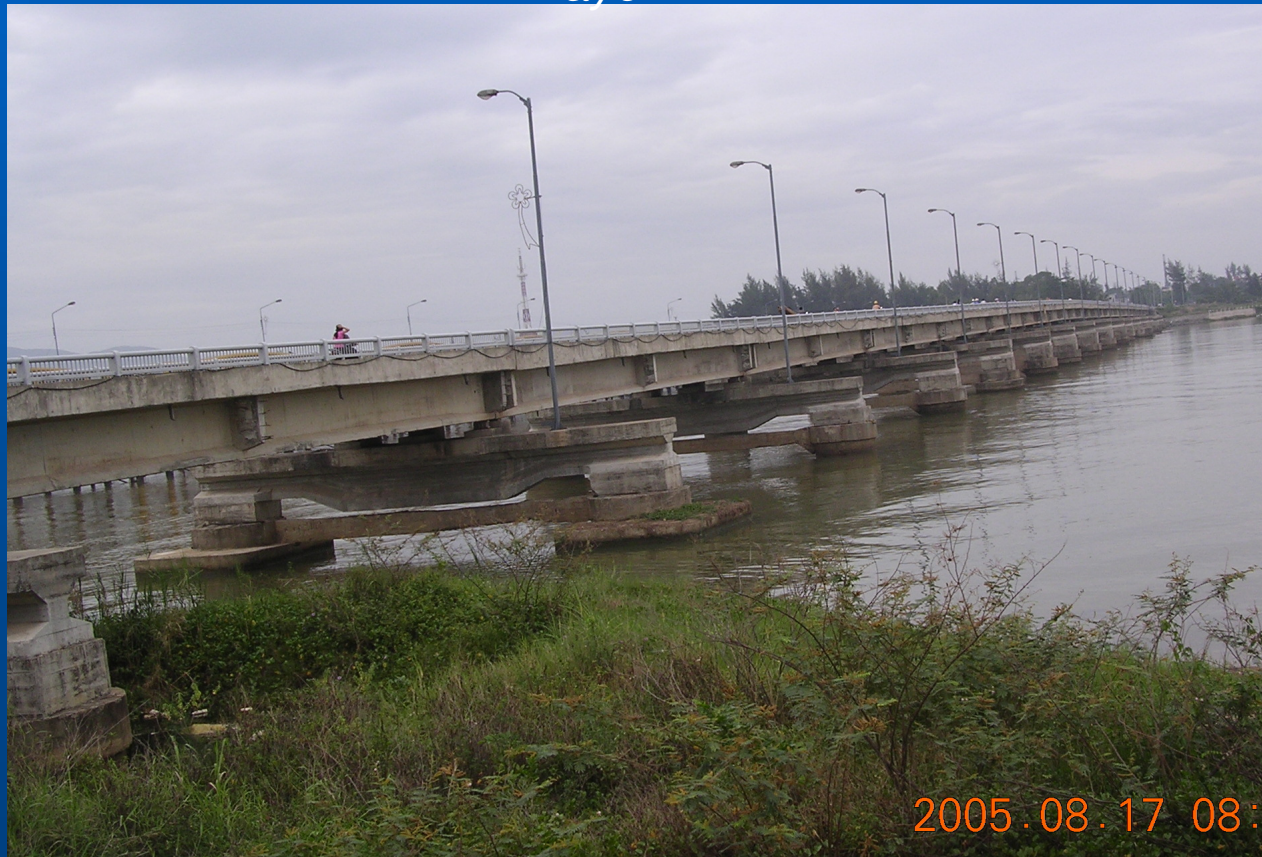
*Picture 1: Existing of Tran – Thi Ly Bridge*

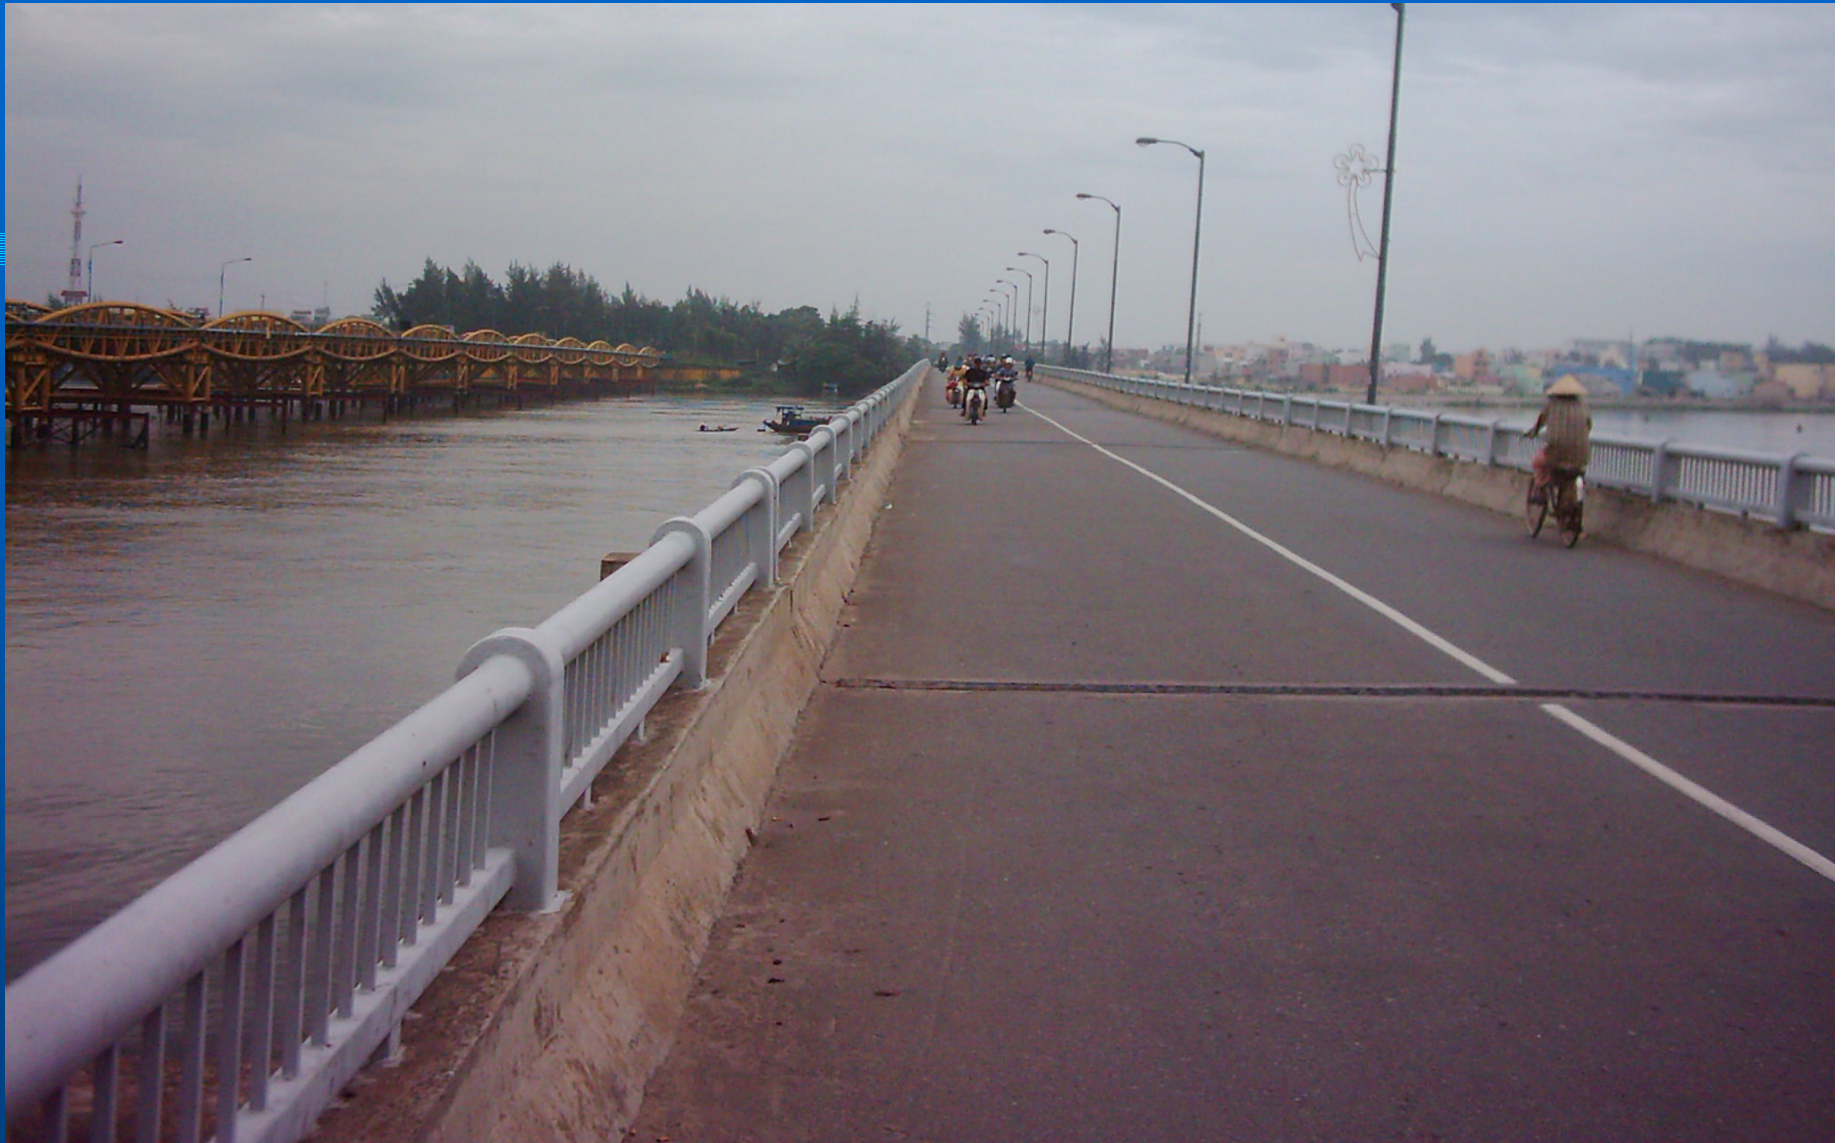
*Picture 2: Surface bridge structure.*

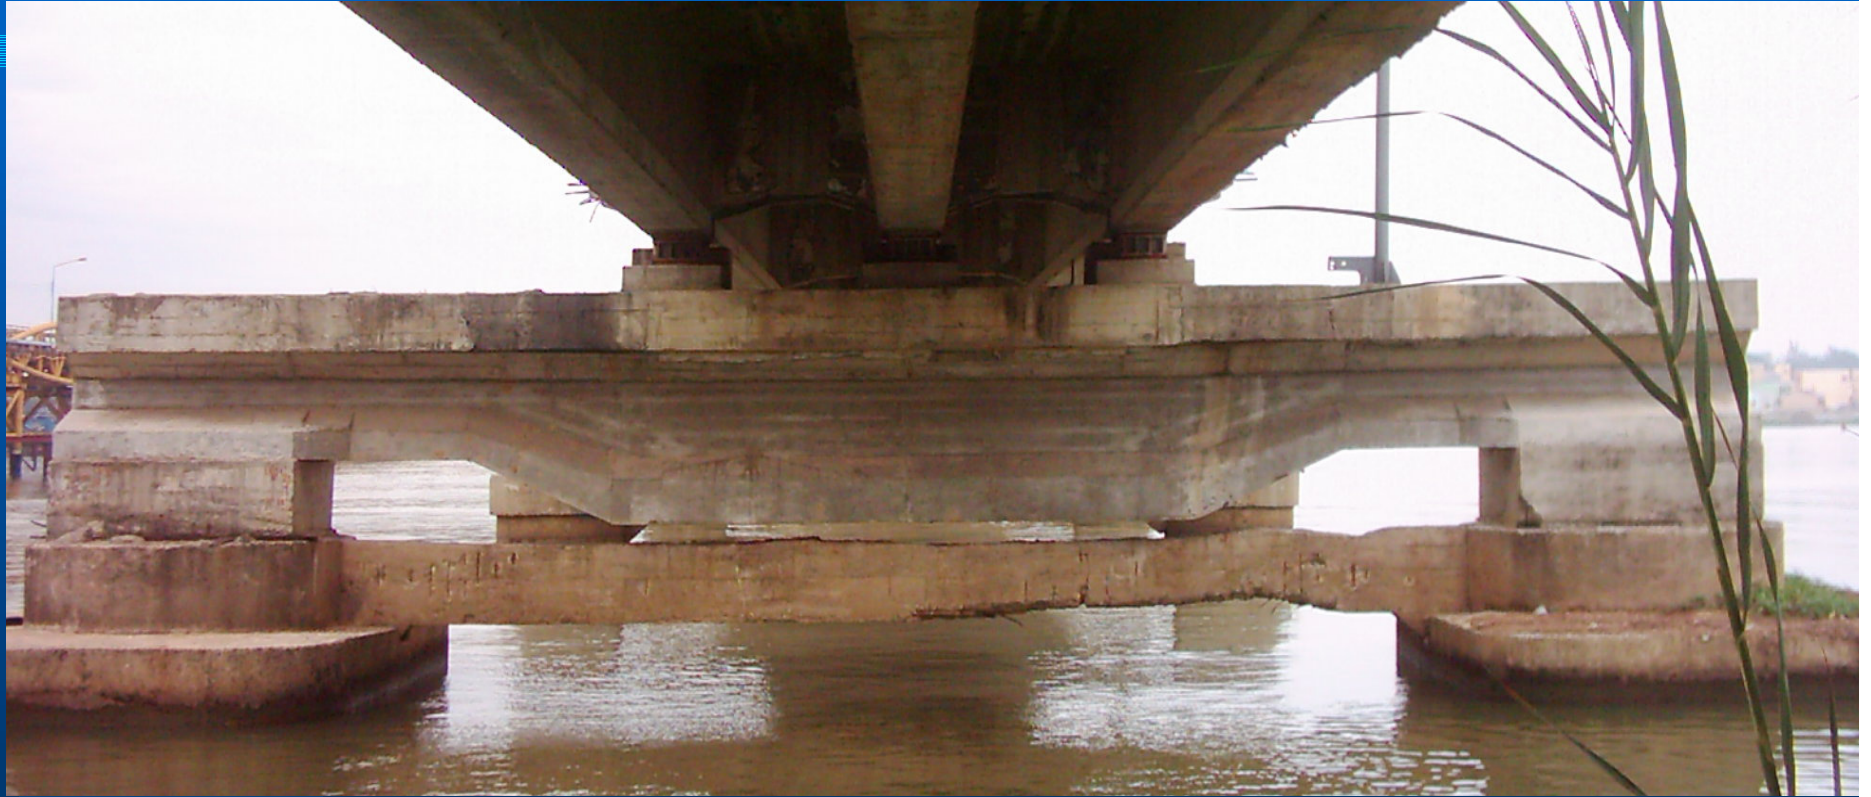
*Picture 3: Head beam have been repaired by polymer mortar and additional bonding steel plates*

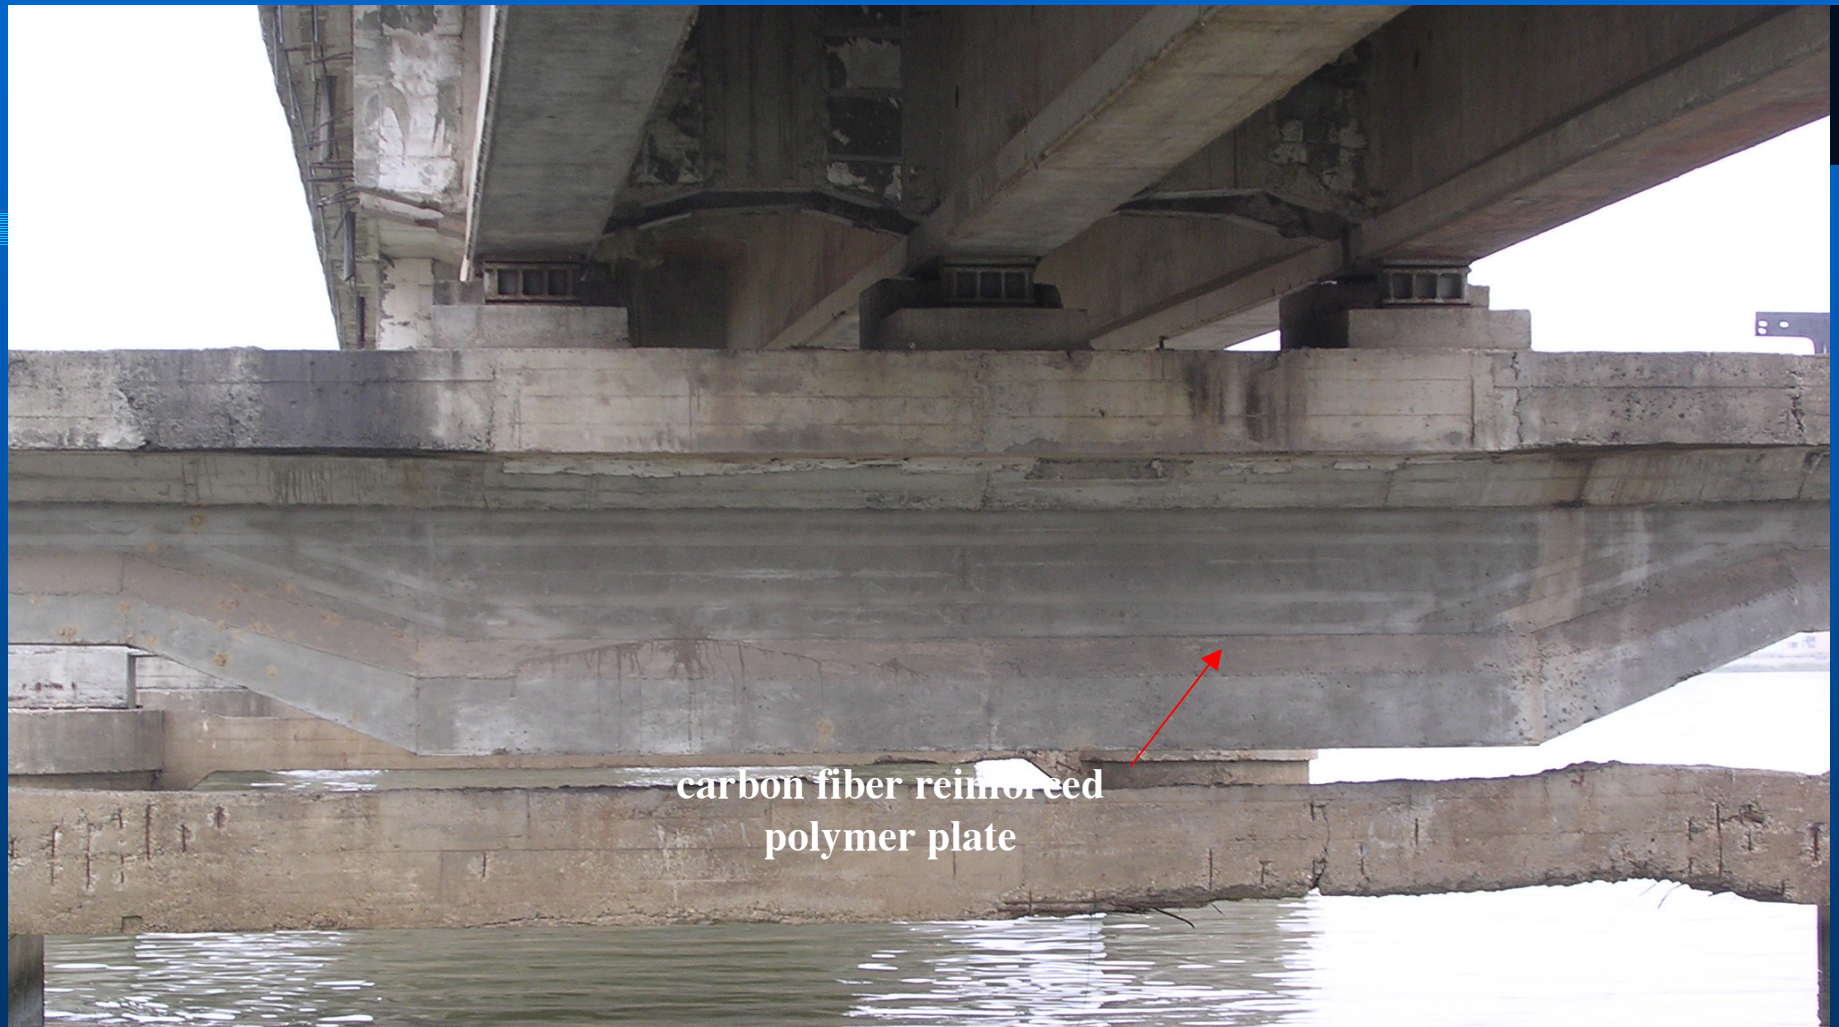
***Picture 4: Head beam of Tran - Thi - Ly Bridge in 8/2005***

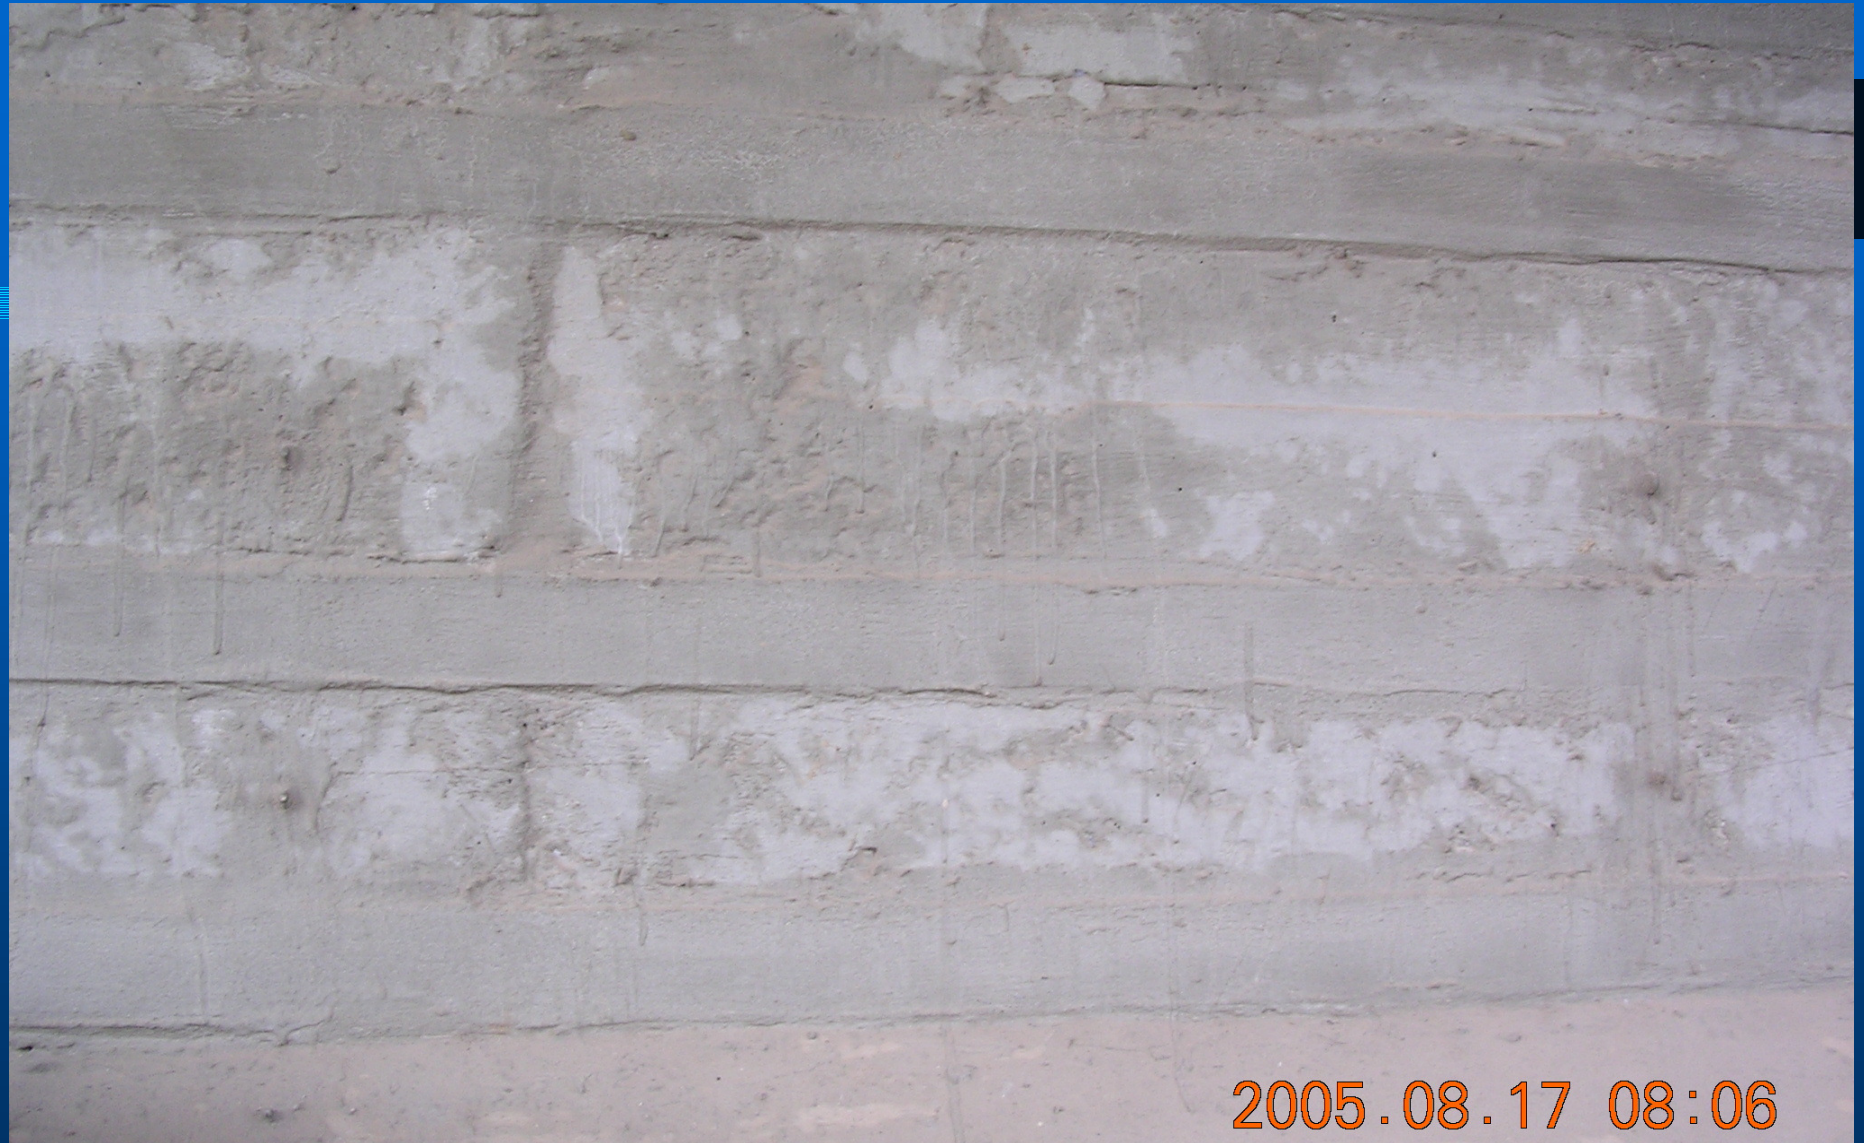
***Picture 5: Location of protected FRP plates***

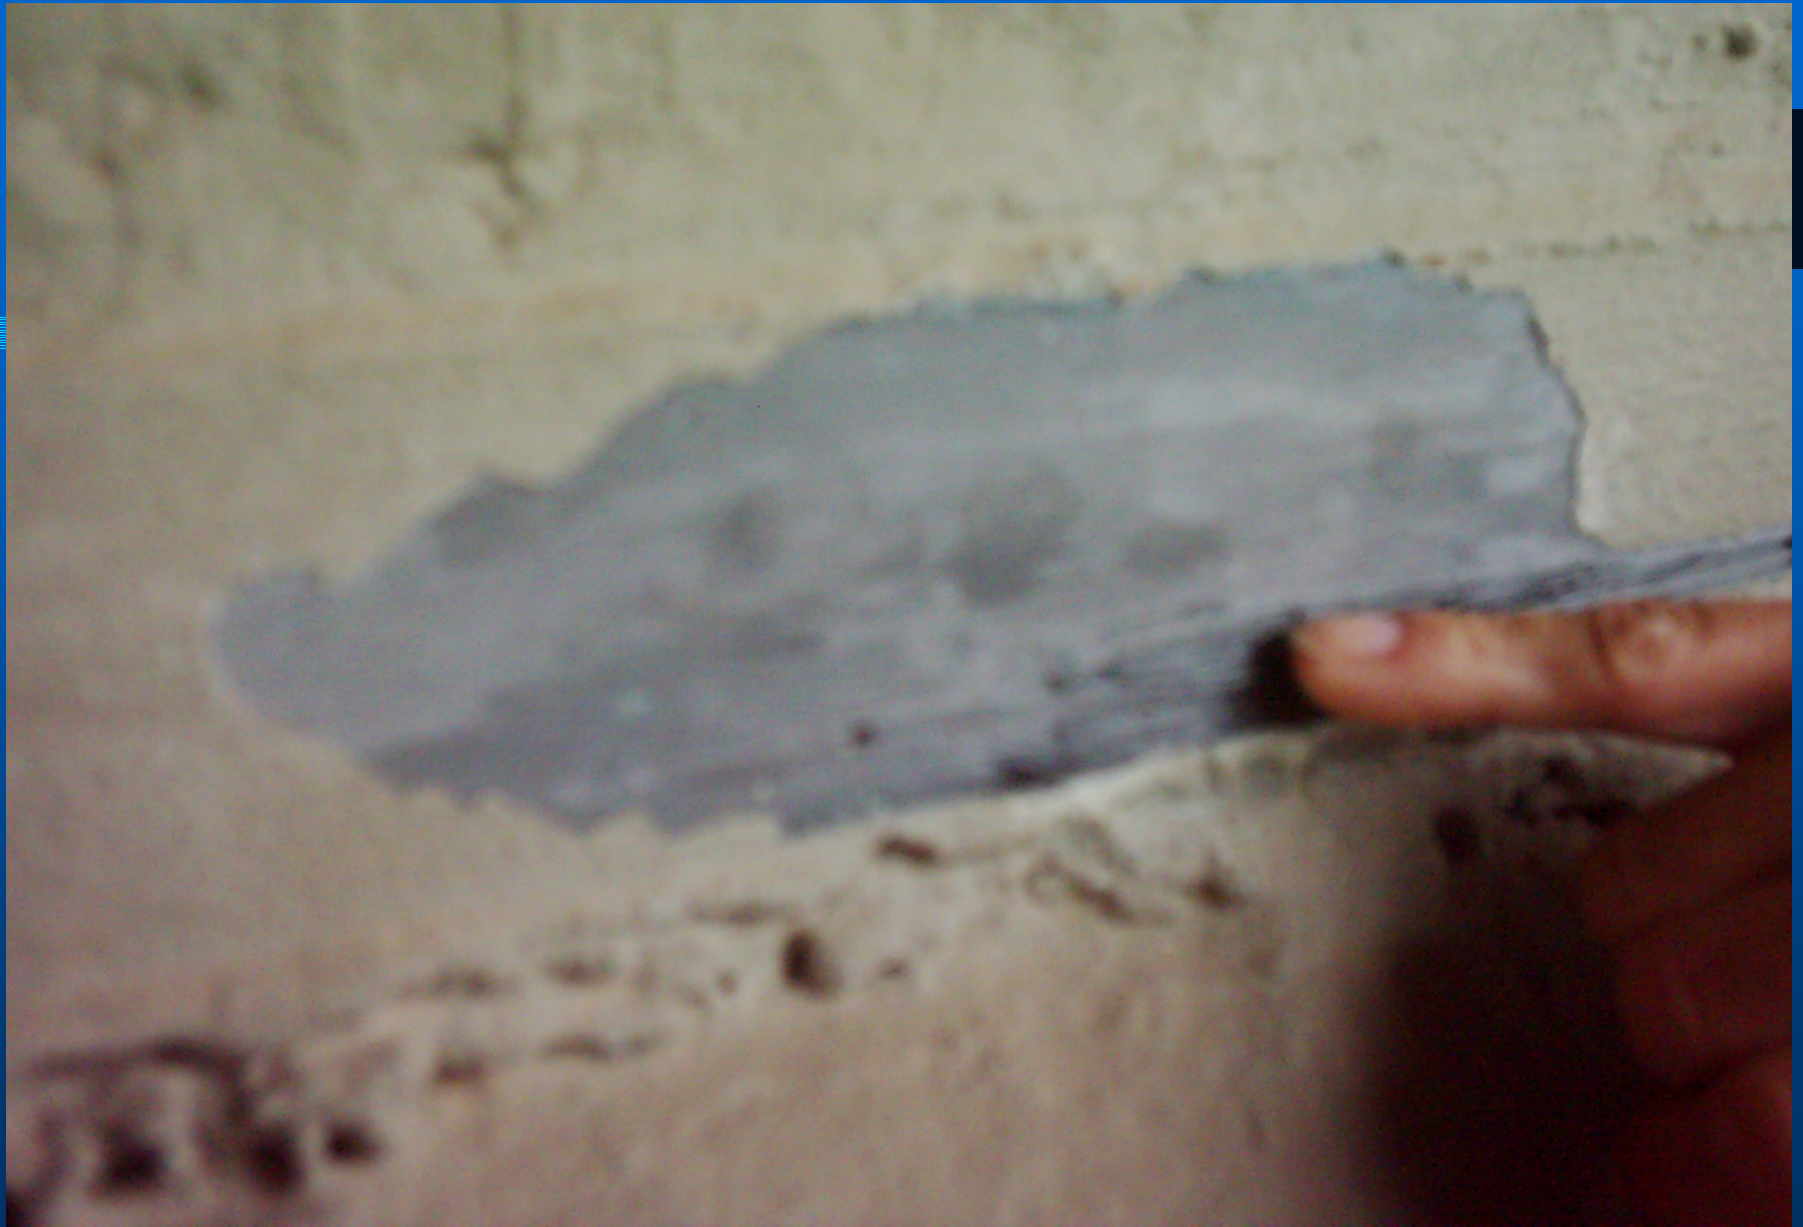
*Existing live load of bridge are car, bicycle and pedestrian load. After servicing, the bridge appeared some corrupts, example protection layer.*

***Picture 6: Some damages of protecting cover of FRP plates***

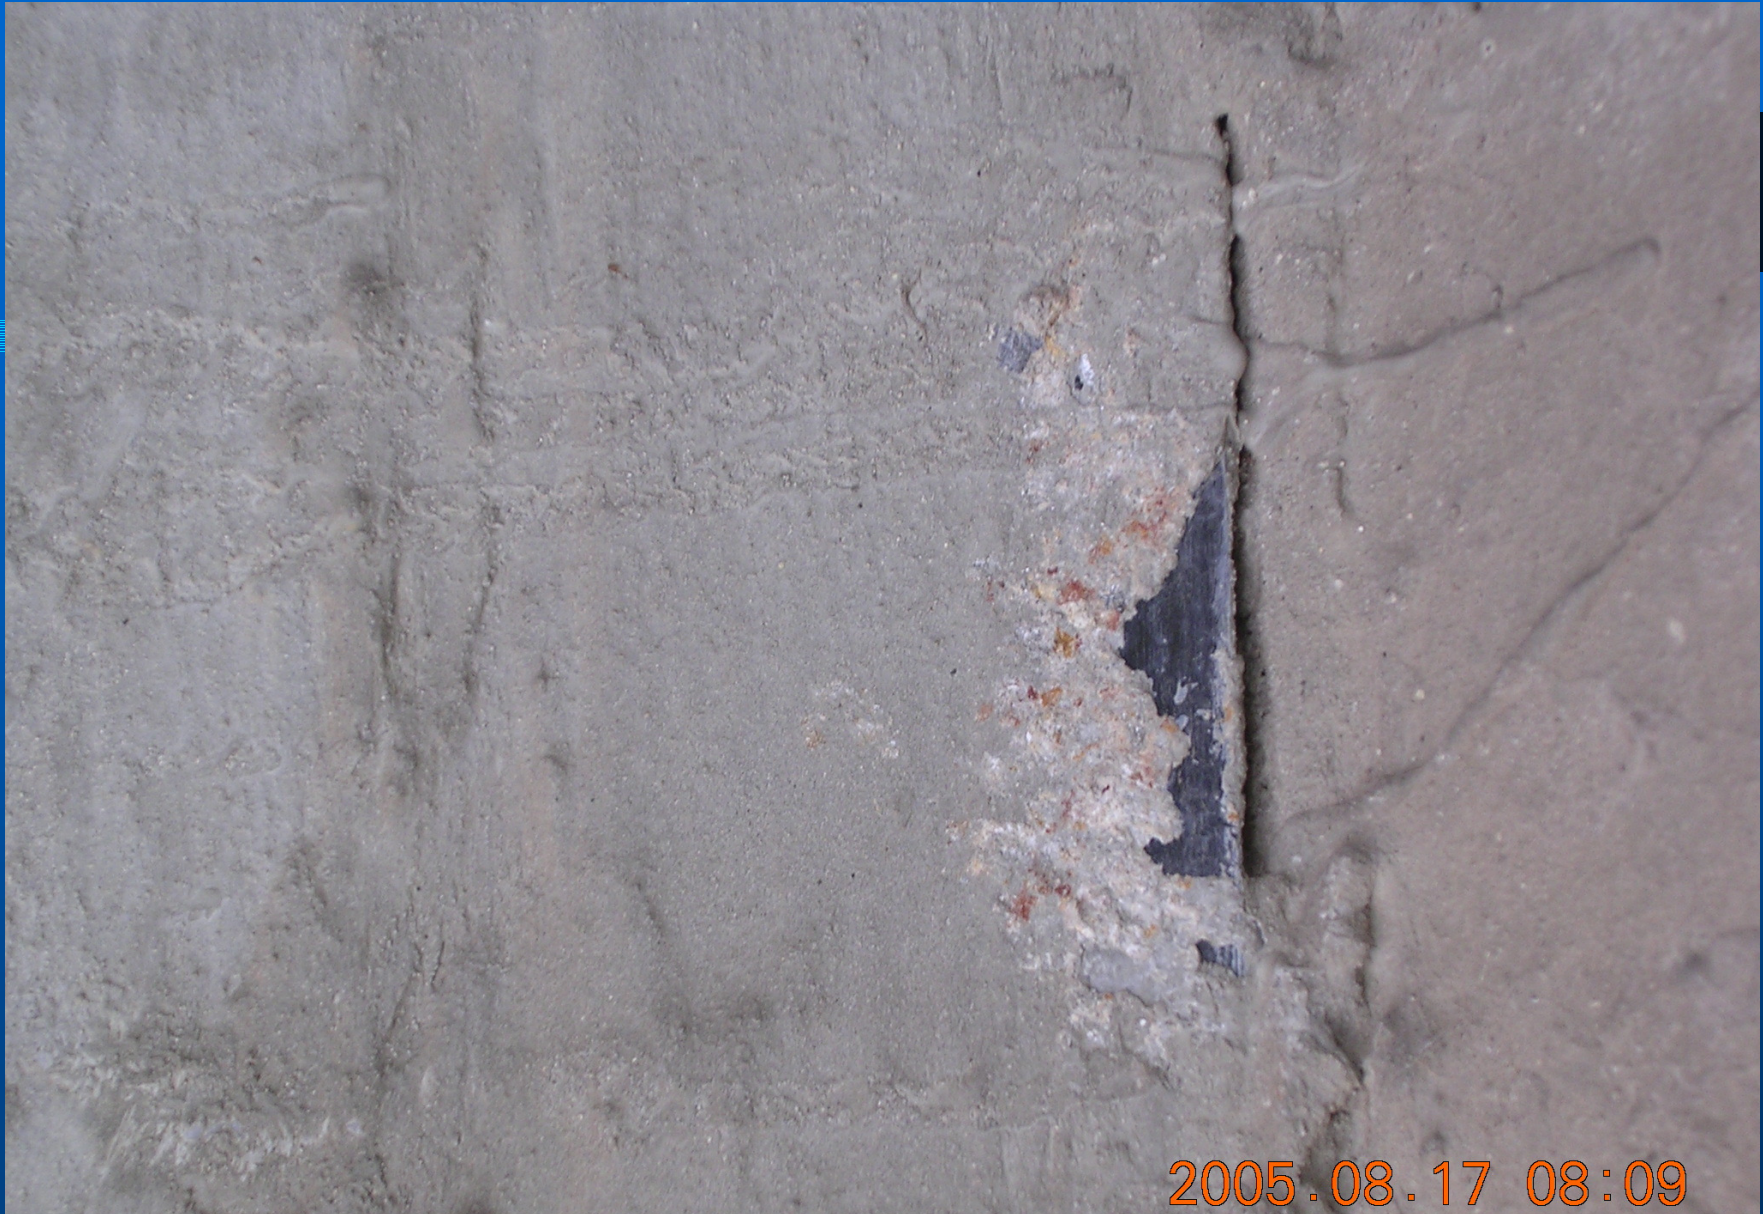
***Picture7 : Some damages of protecting cover of FRP plates***

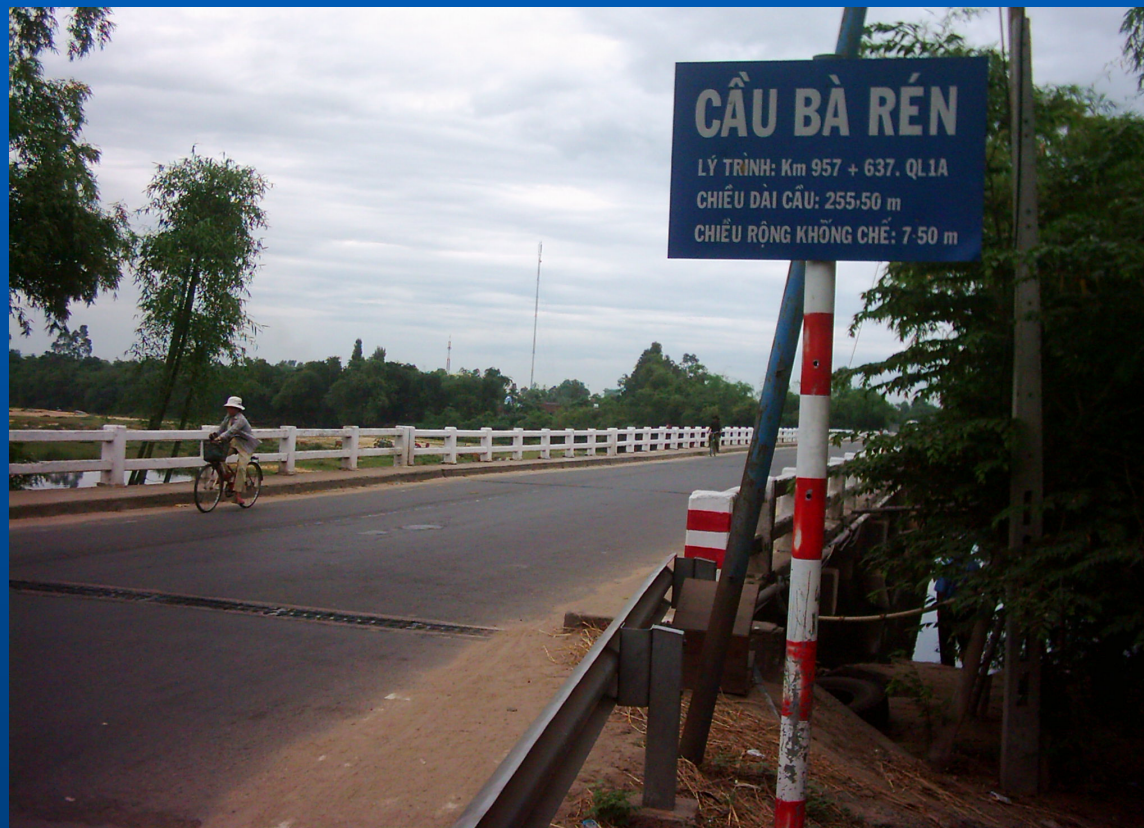
*Picture 8: Existing of Ba - Ren bridge in Km 957 + 637*

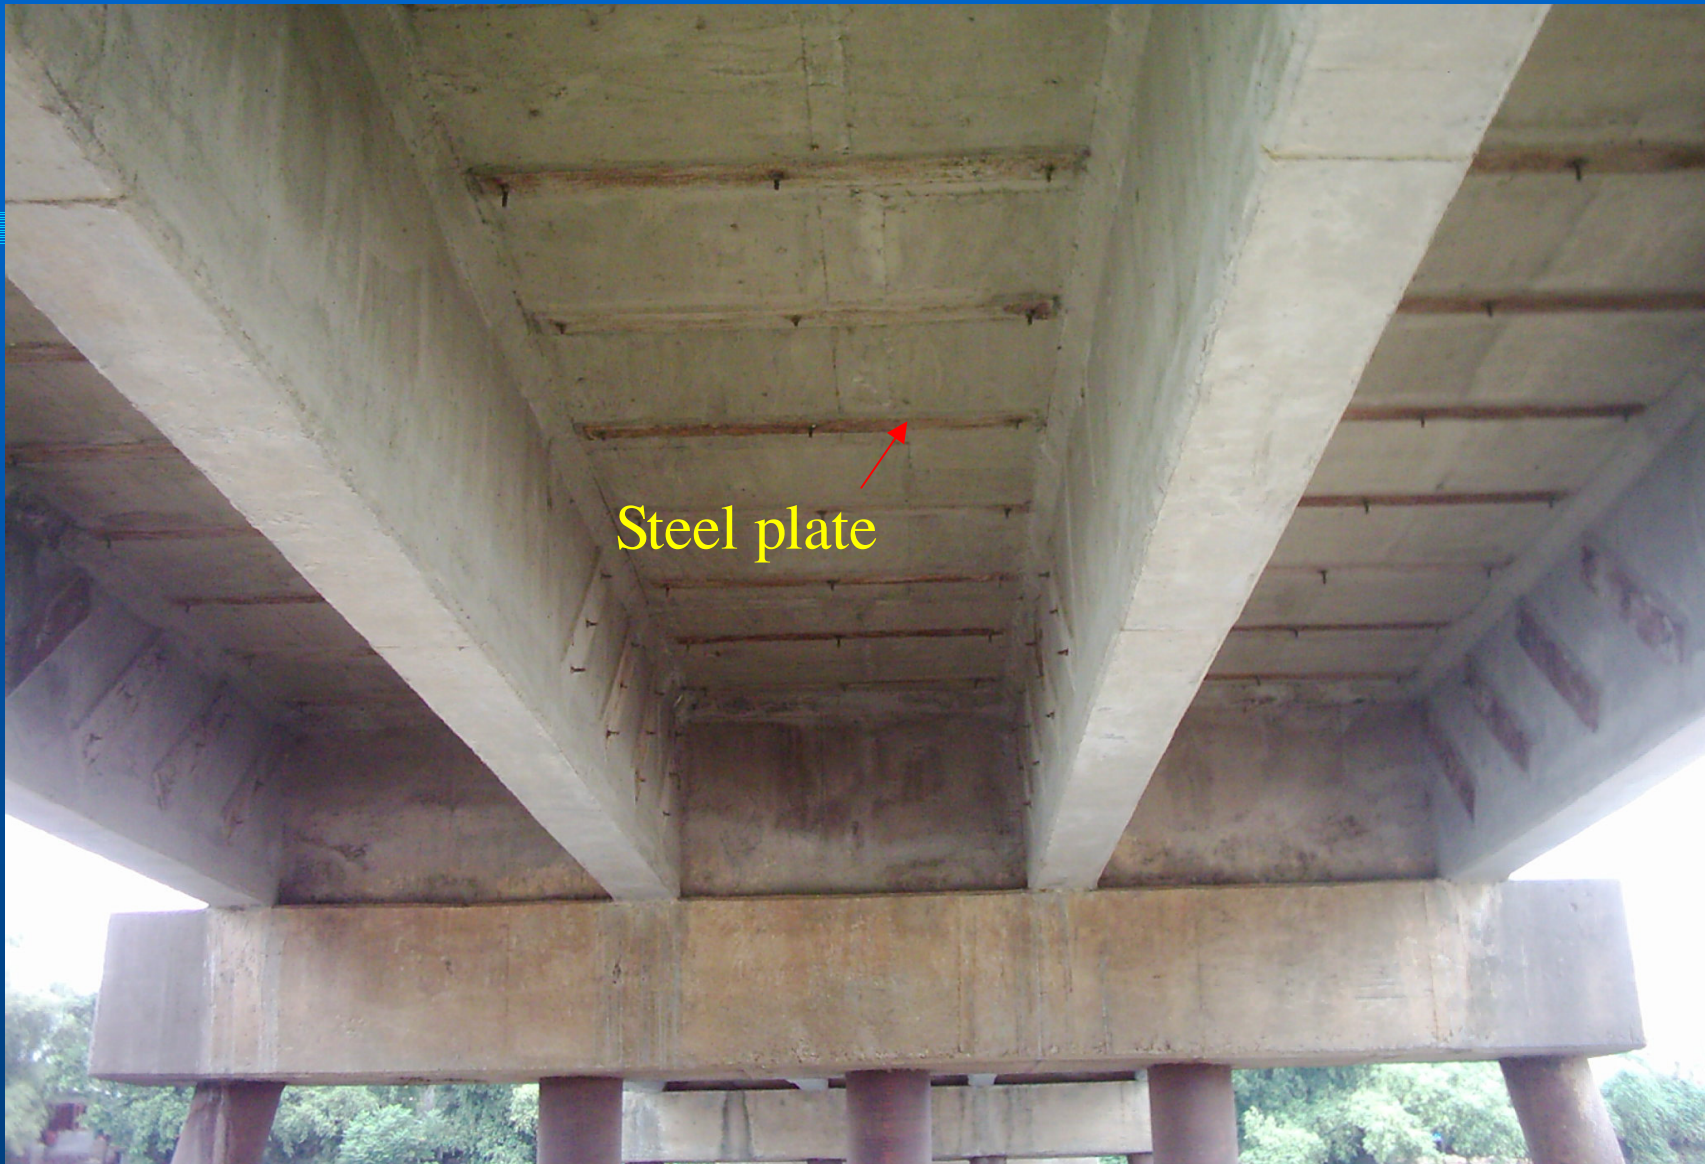
**Picture9: Span structure of Ba – Ren bridge (8/2005)**

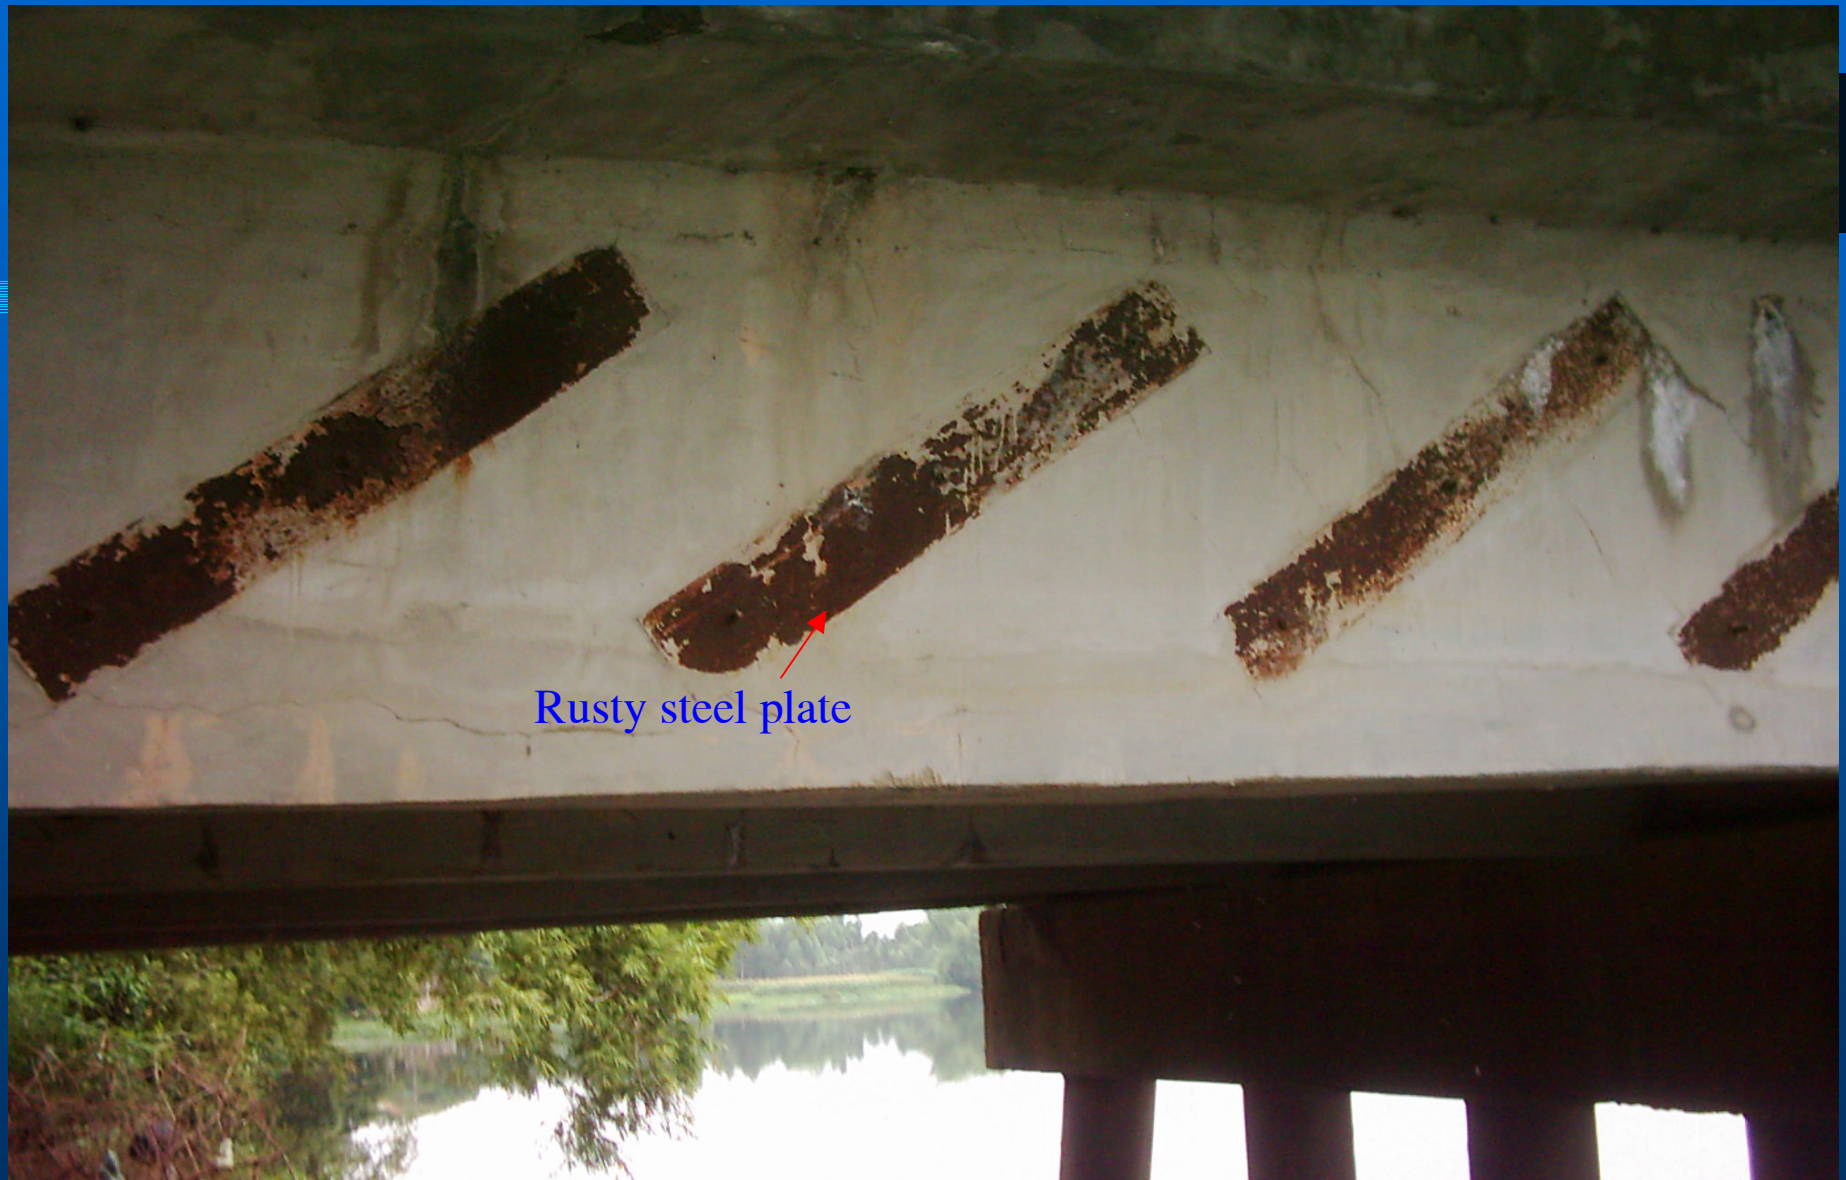
*Until now, after 12 years servicing, the bridge is good with service load HL93. The crack are not developing. However, there are some rusts in wet places. The reason of this rust is: we did not keep the surface of steel plate clean*

***Picture 10: The rust in steel inclined plate in wet place***

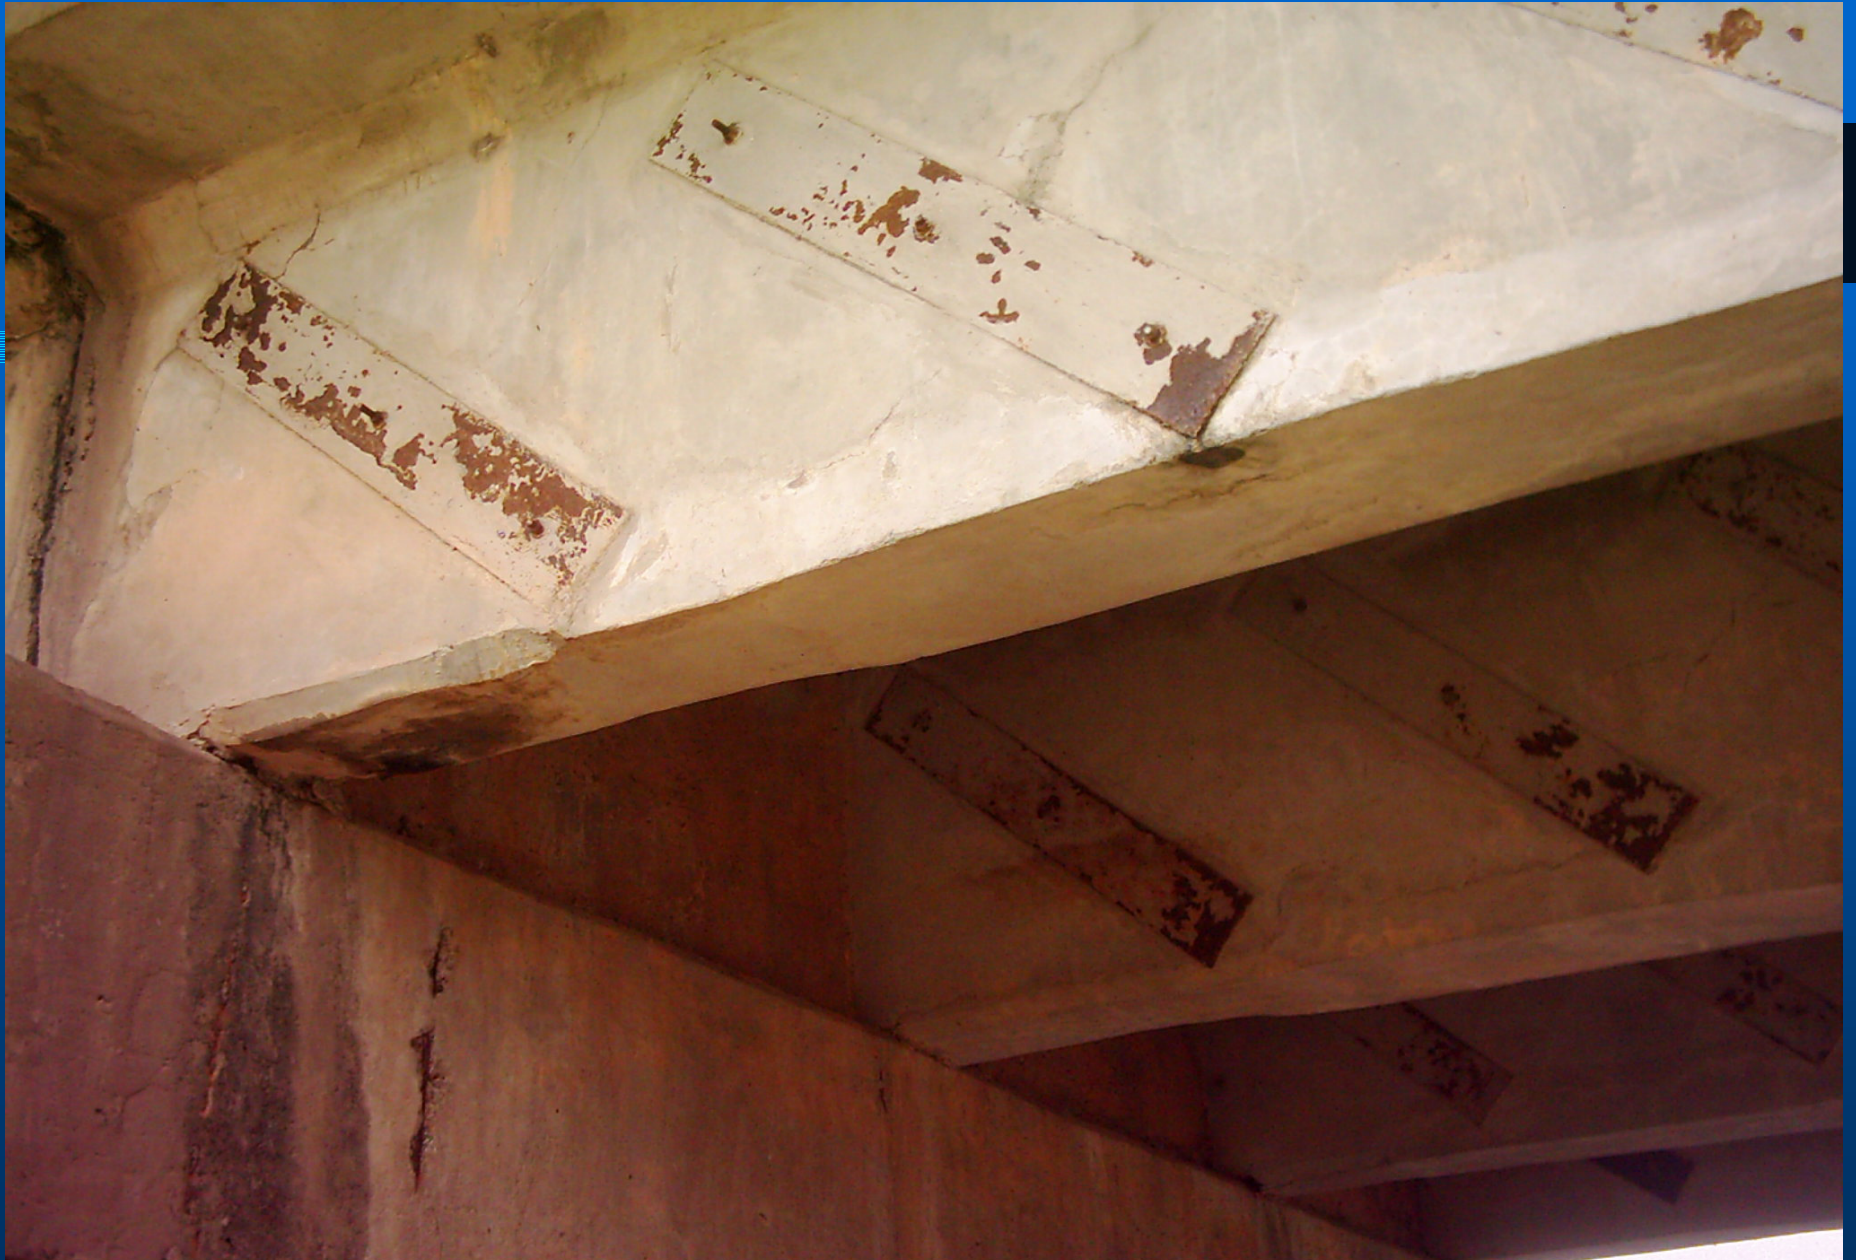
***Picture 11: The rust in steel plate in wet place***

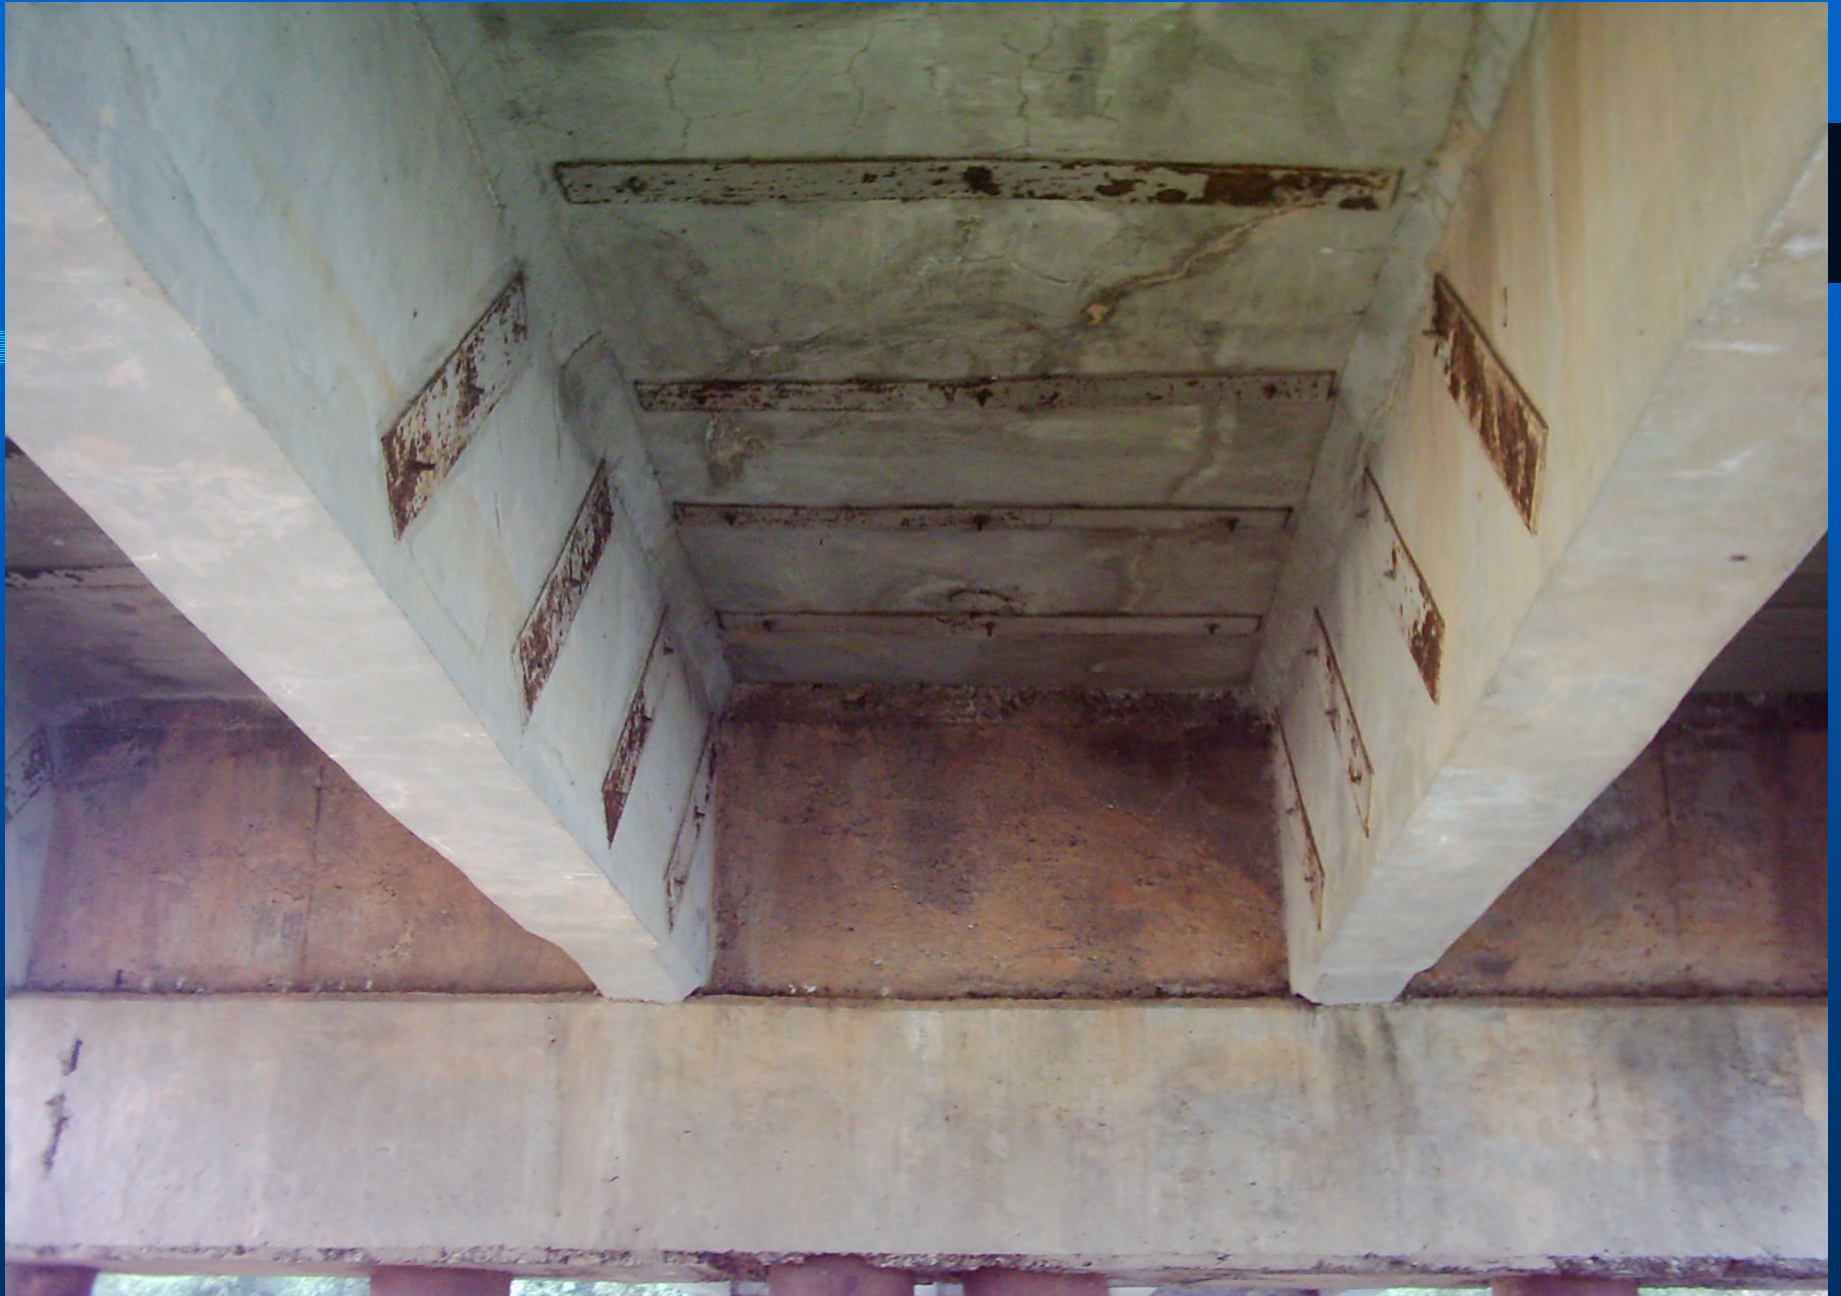
***Picture 12: The rust in steel inclined plate in wet place***
