UNIVERSITY OF TRANSPORTATION AND COMMUNICATIONS  
*SECTION OF URBAN TRANSPORT WORKS*

# THE BONDING STEEL PLATES AND CARBON FIBER REINFORCED POLYMER PLATES TECHNOLOGY FOR REPAIRING CONCRETE BRIDGES IN VIET NAM

Pro.Dr. Nguyen Viet Trung

## **EXISTING CONCRETE BRIDGES REPAIRED BY BONDING STEEL PLATES AND CARBON FIBER REINFORCED POLYMER PLATES IN VIET NAM AFTER 14 YEARS OF SERVICE**

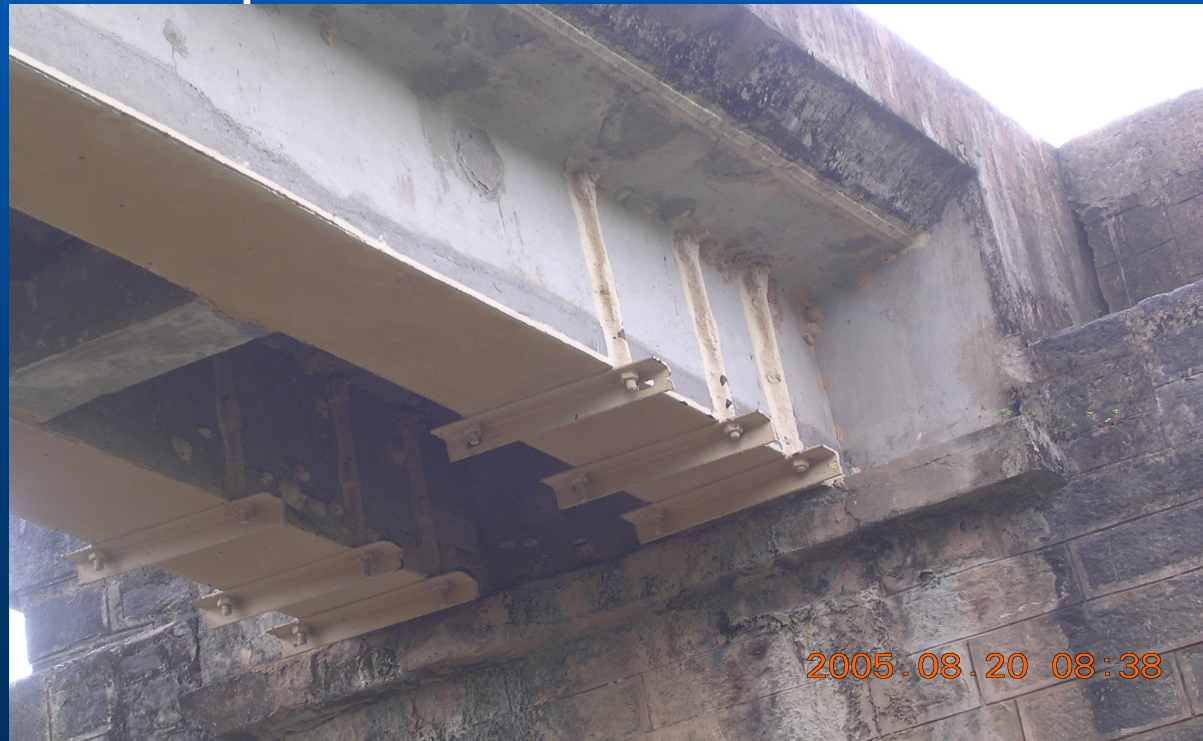
- After a long time servicing, this bridge is good with service load of railway. We have some comment such as:
- - The bonding steel plate process is
- - The width of cracks is not developing.
- - The steel plates is good. There is only some rust on the surface of steel plates

*Picture 13: Railway bridge in Km 410+580 in August 2005*

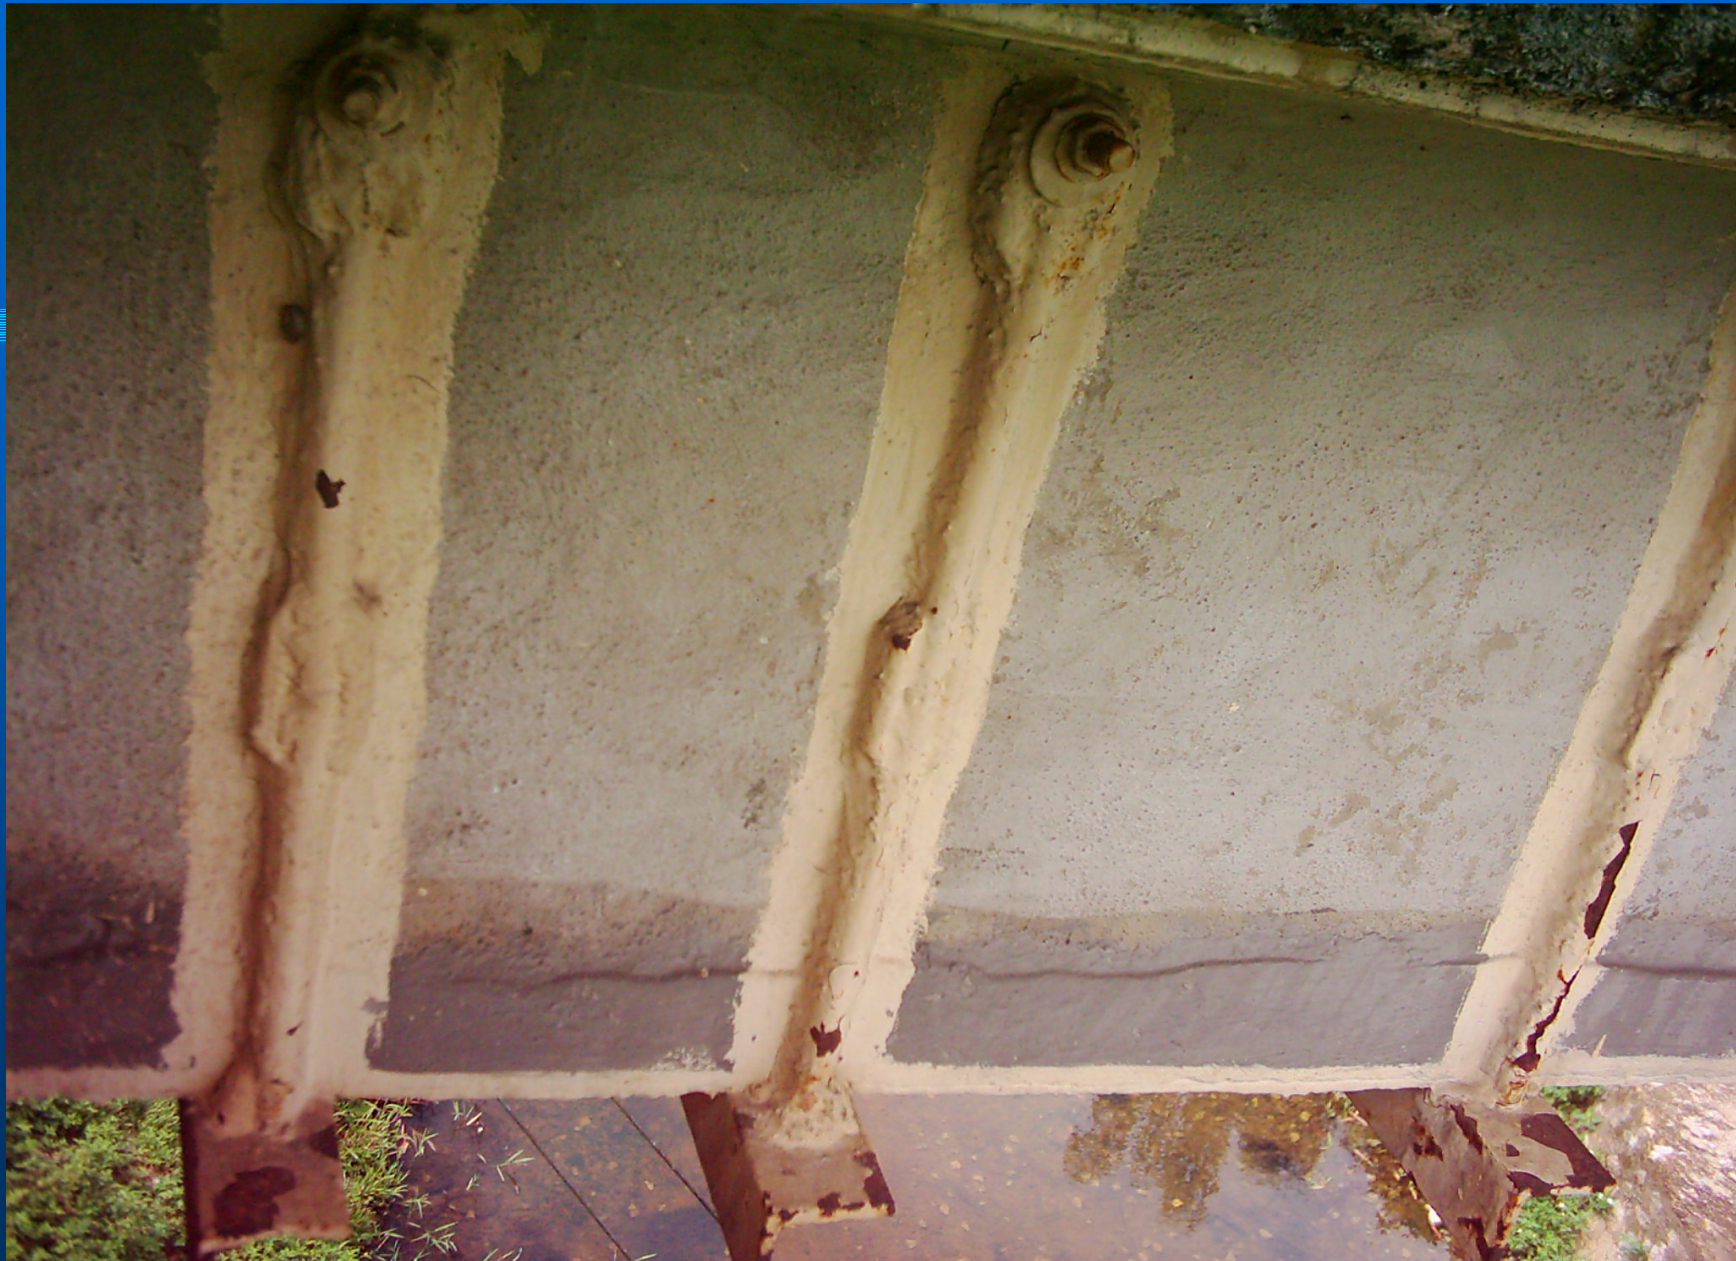
***Picture 14: Some rusts in cangue.***

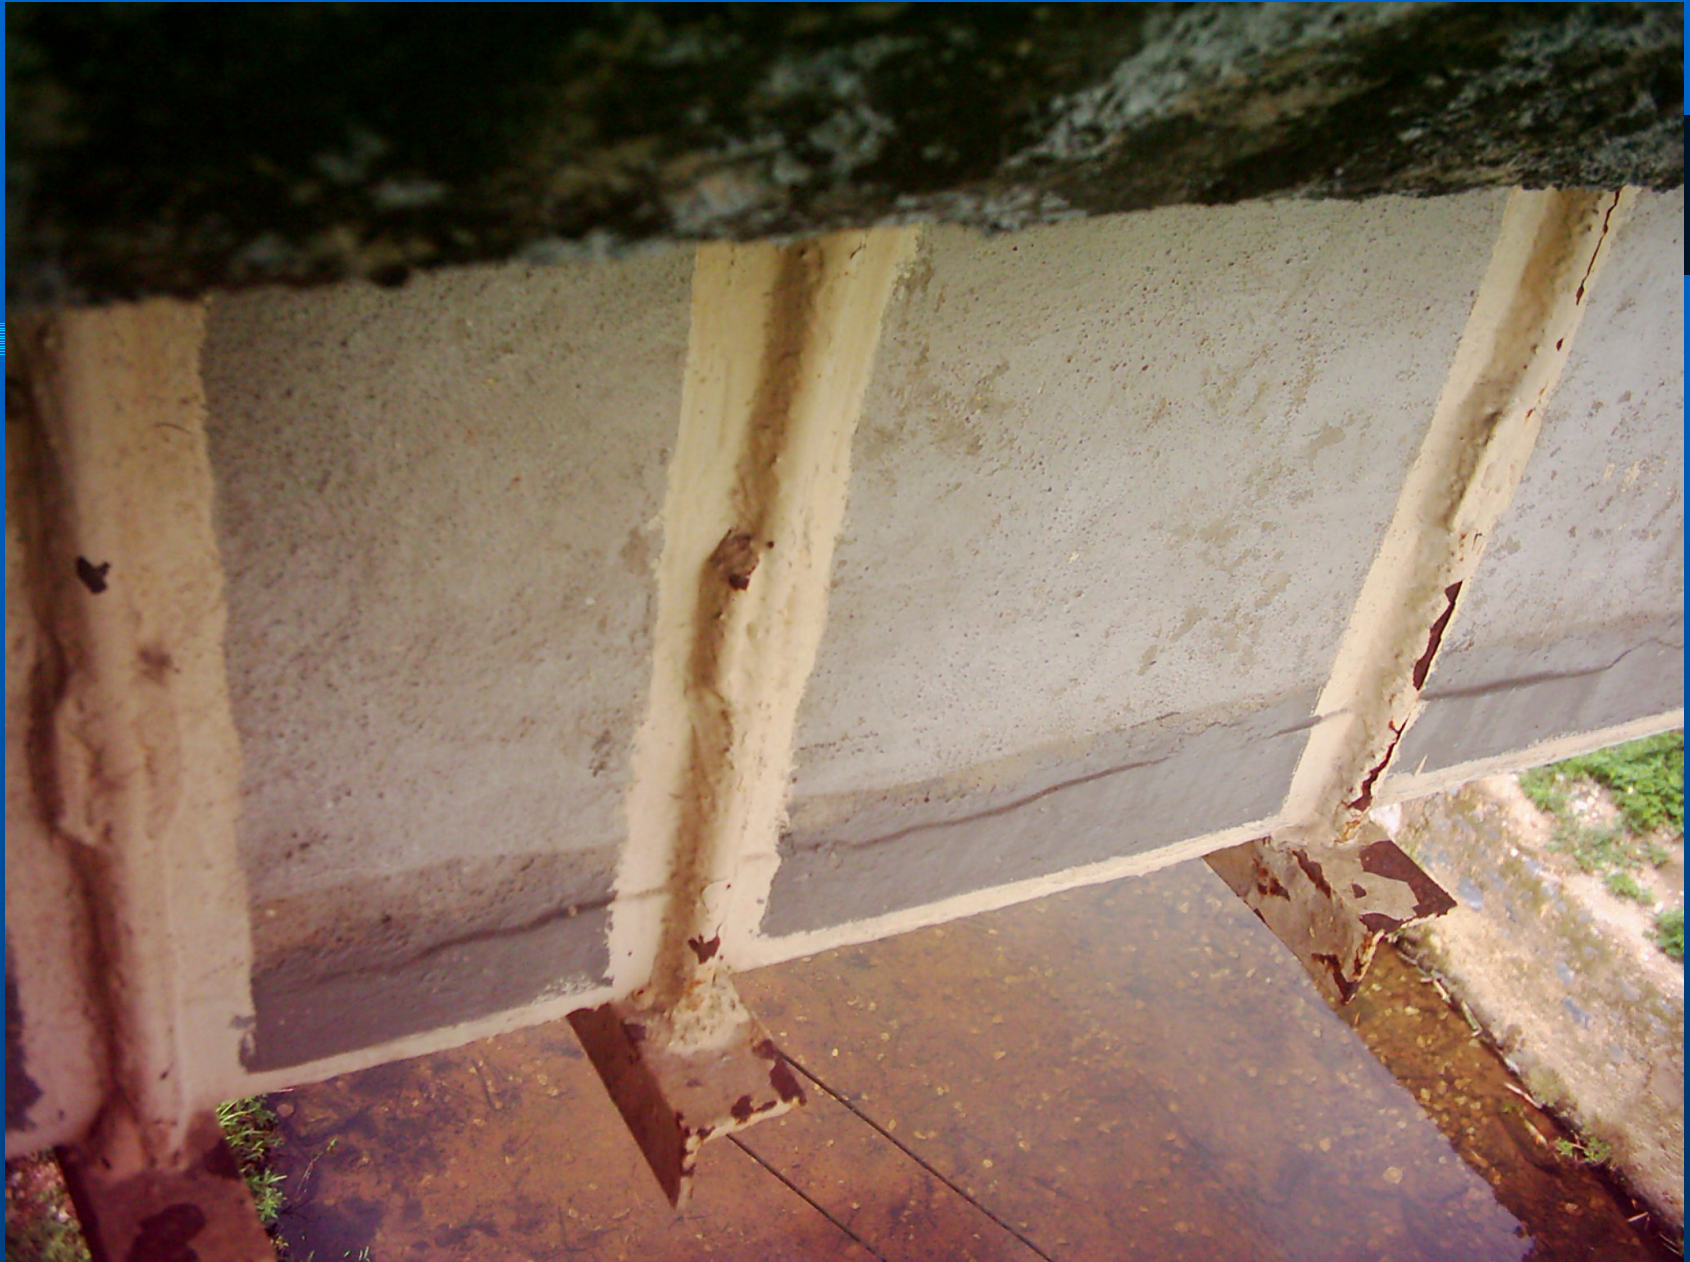
*Picture 15: Some rusts in cangue.*

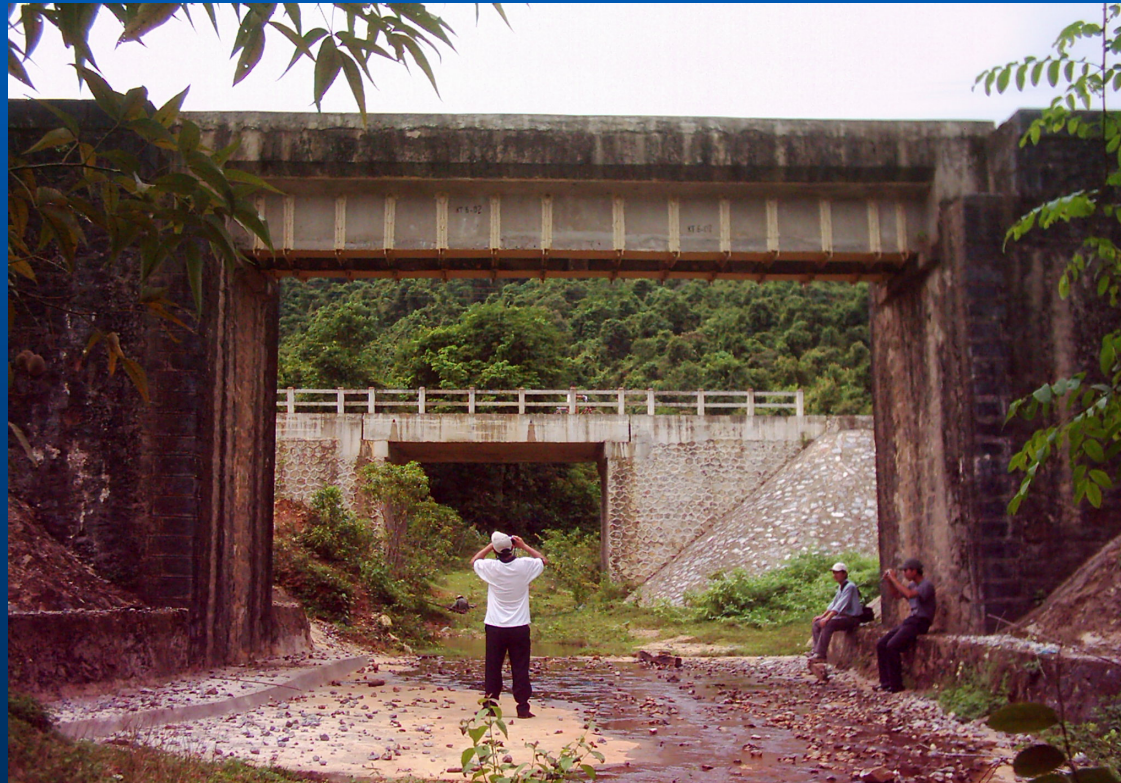
- After a long time servicing, this bridge is good with service load of railway. We have some comment such as:
- - The bonding steel plate process is
- - The width of cracks is not developing.
- - The steel plates is good. The is only some rust on the surface of steel plates

**Picture 16: Existing of railway bridge Km 411+800 in August 2005**

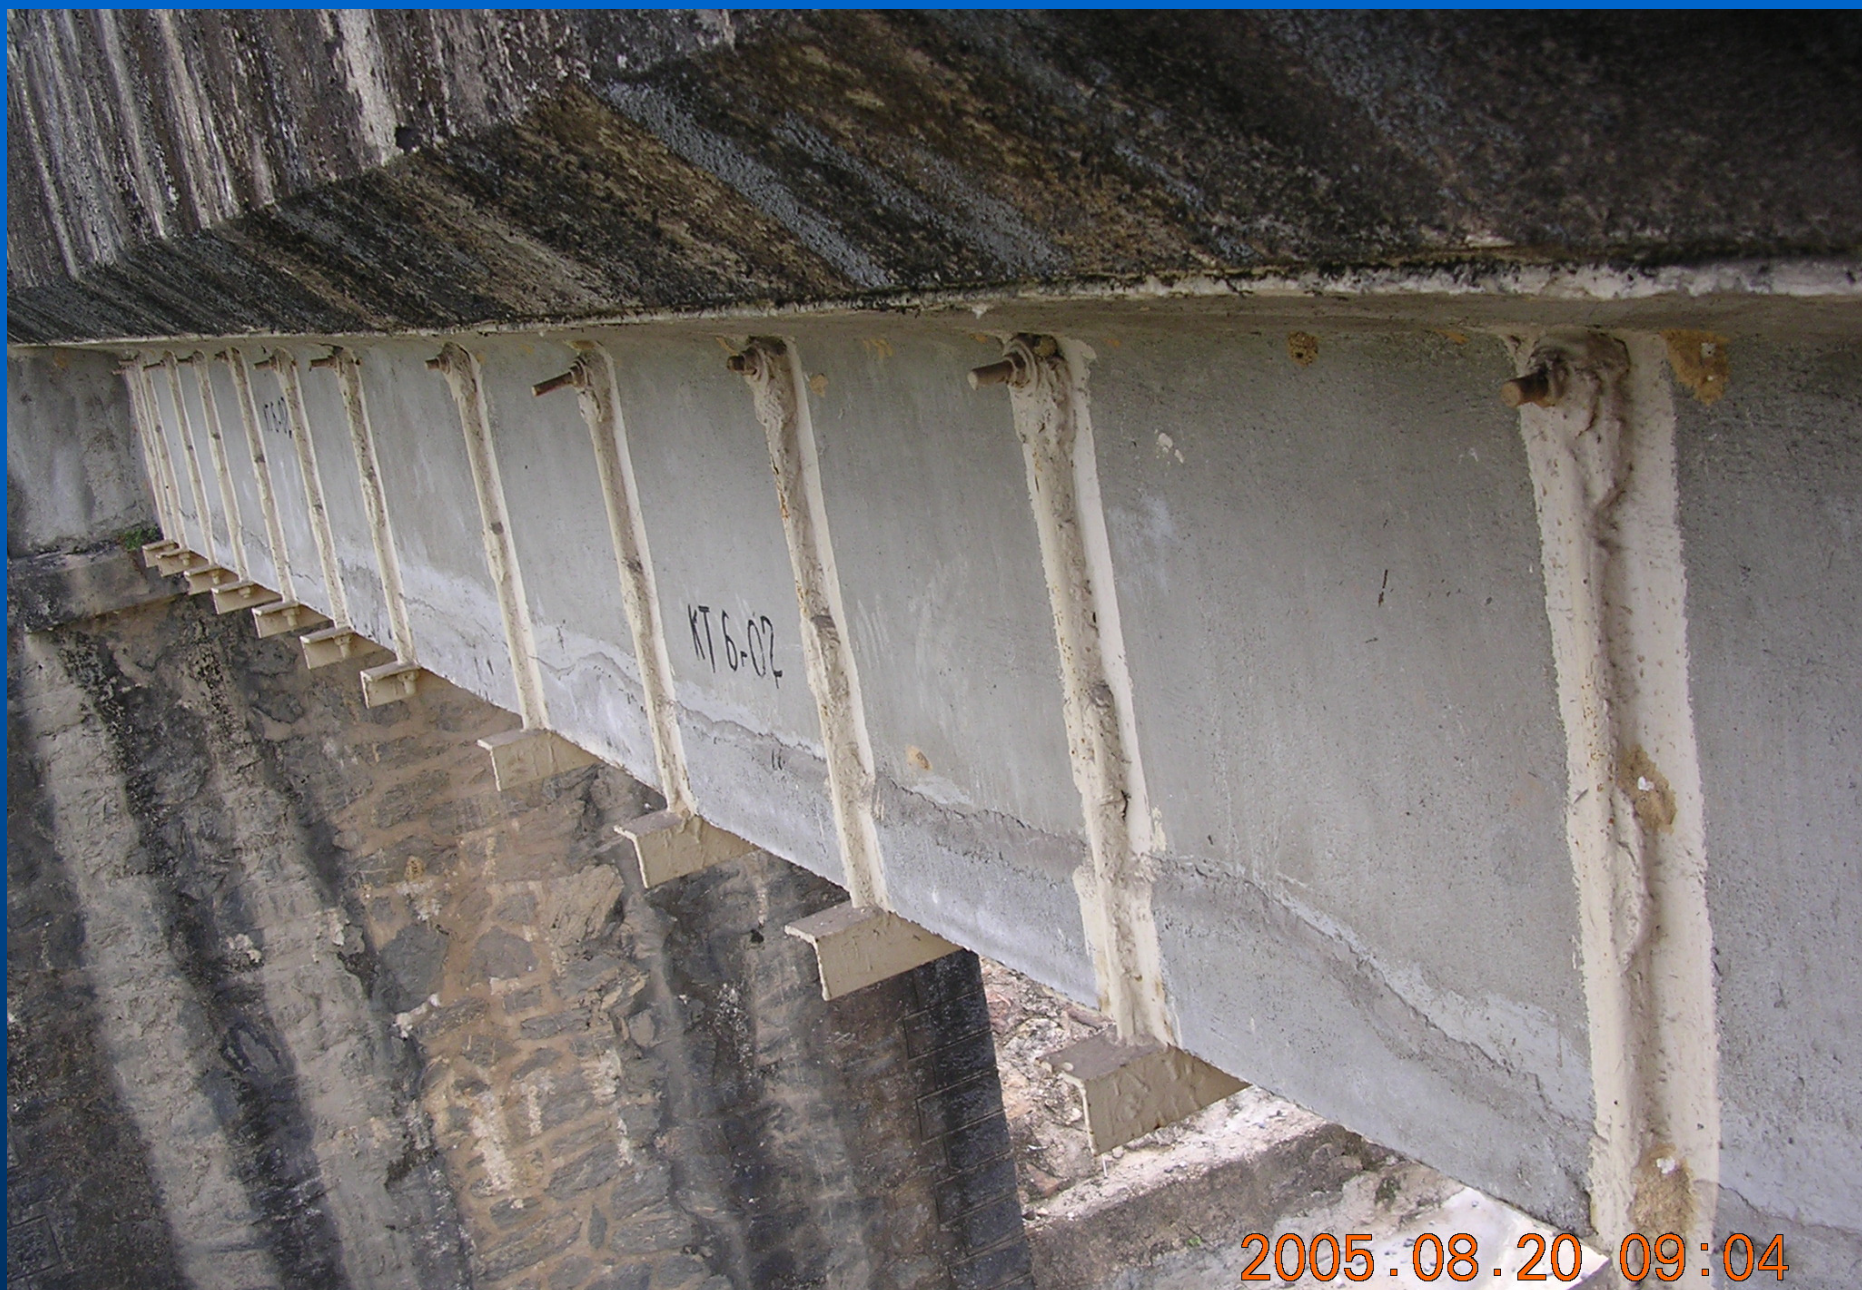
*Picture 17: The cangue*

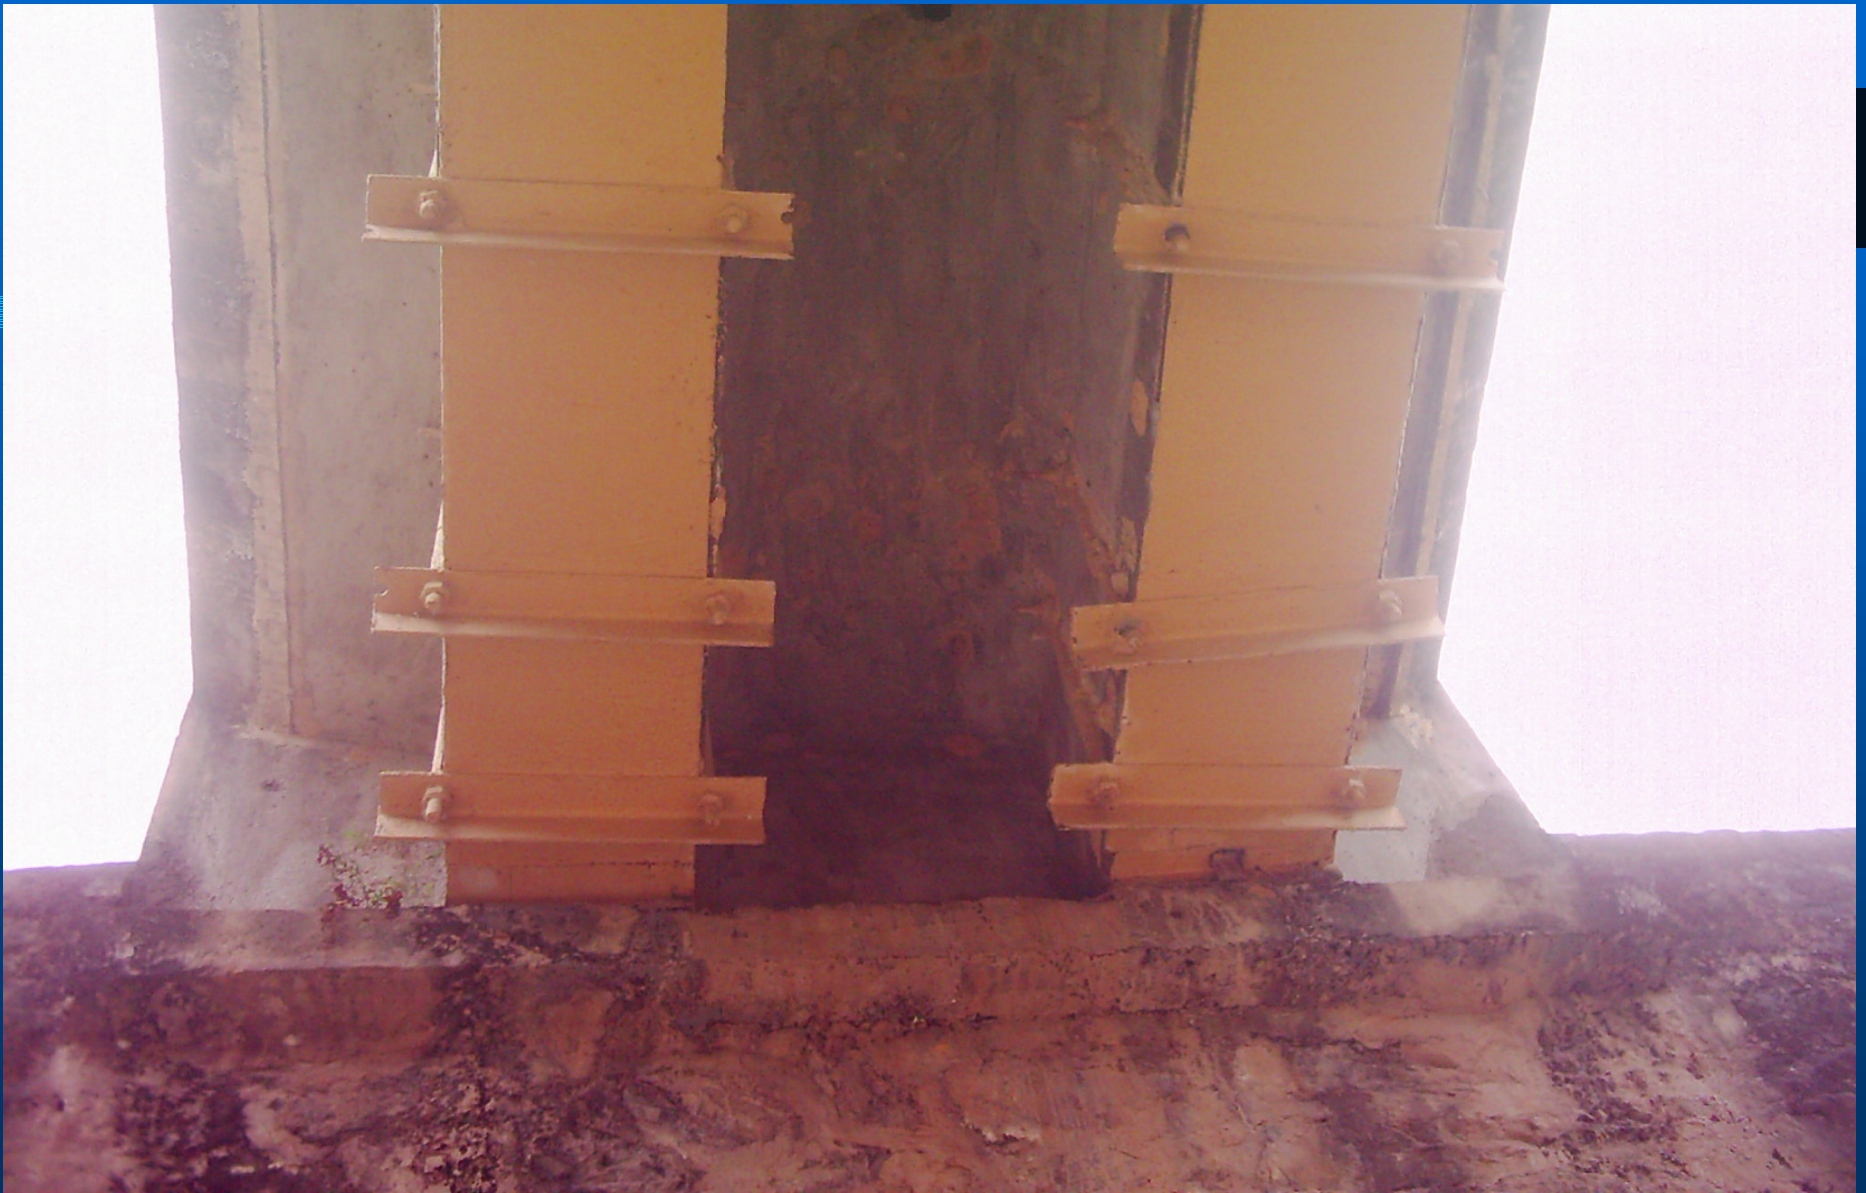
*Picture 18: The steel plates*

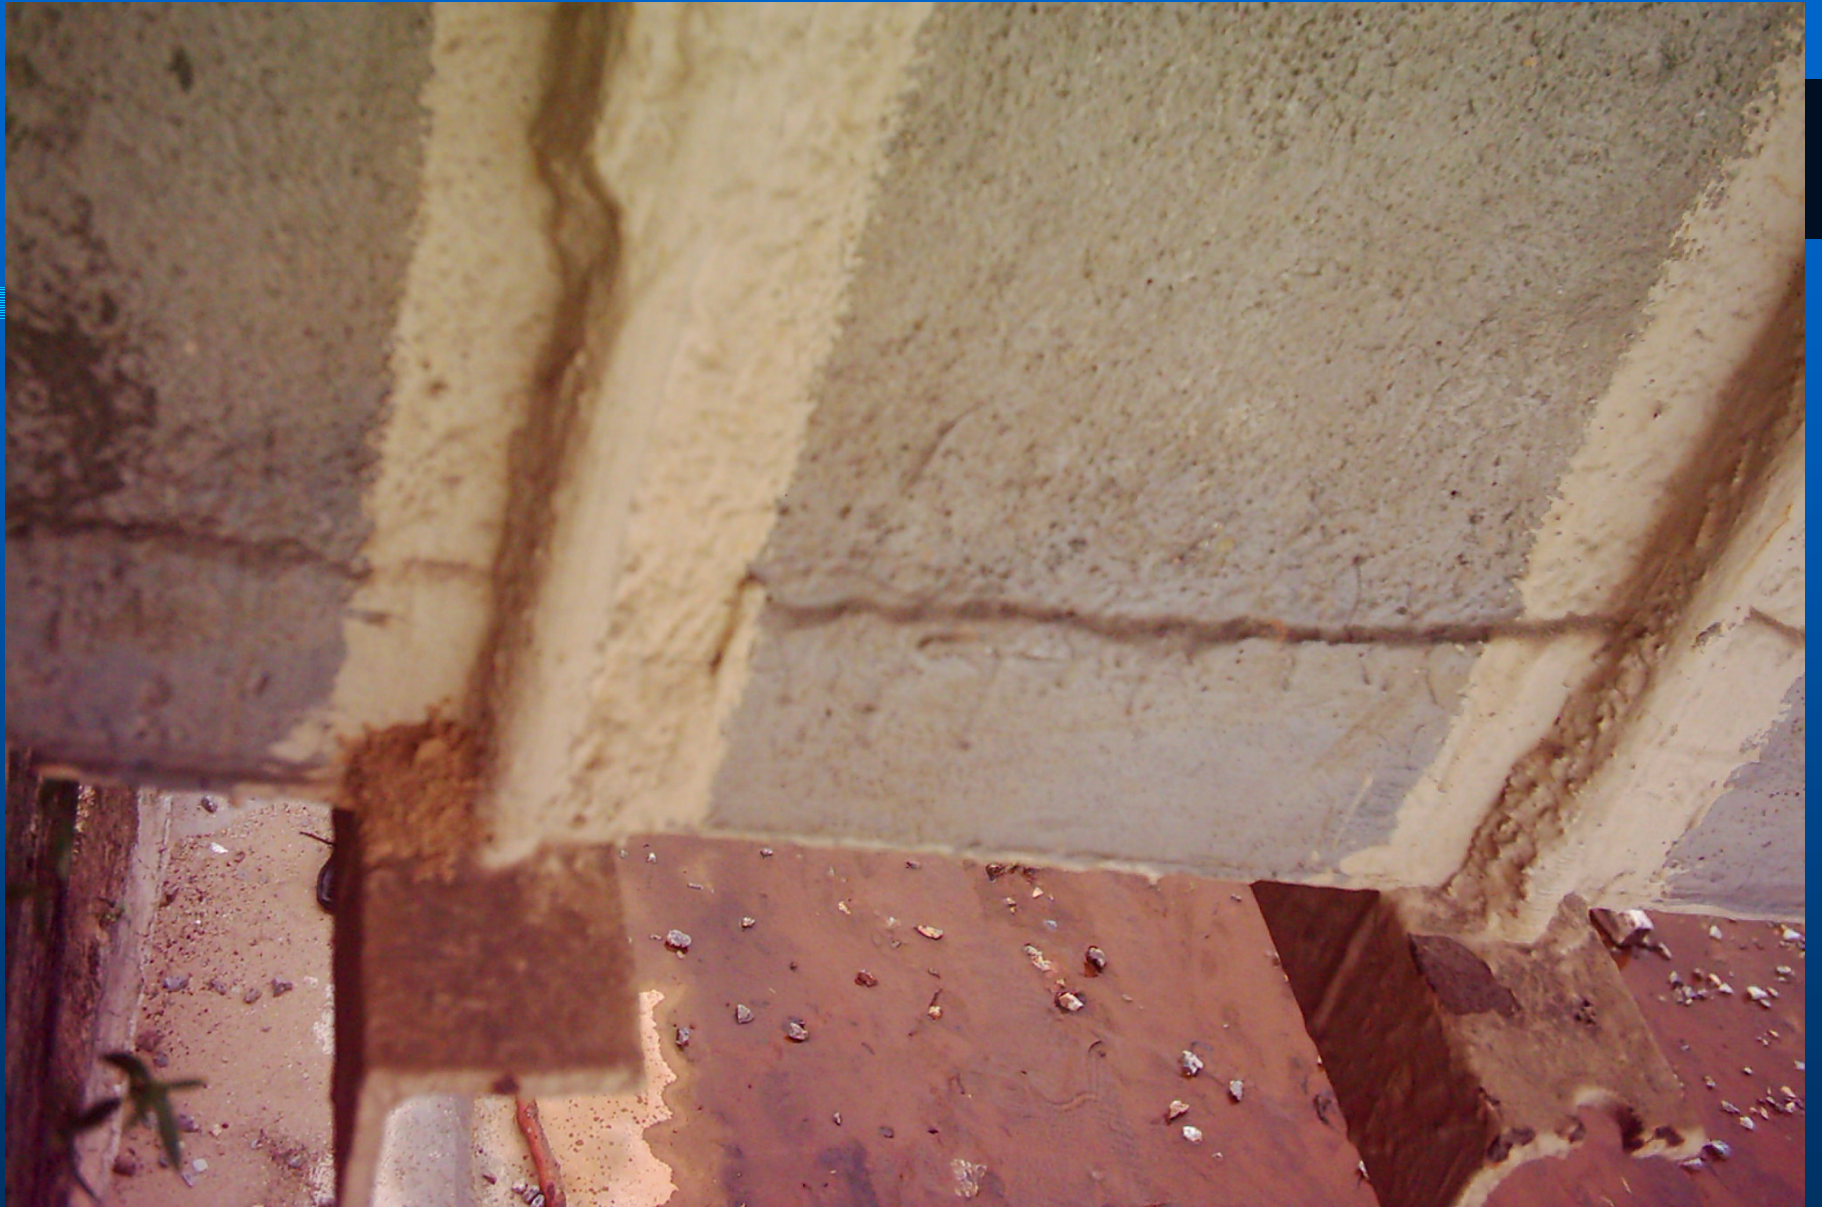
*Picture 19: The cangue*

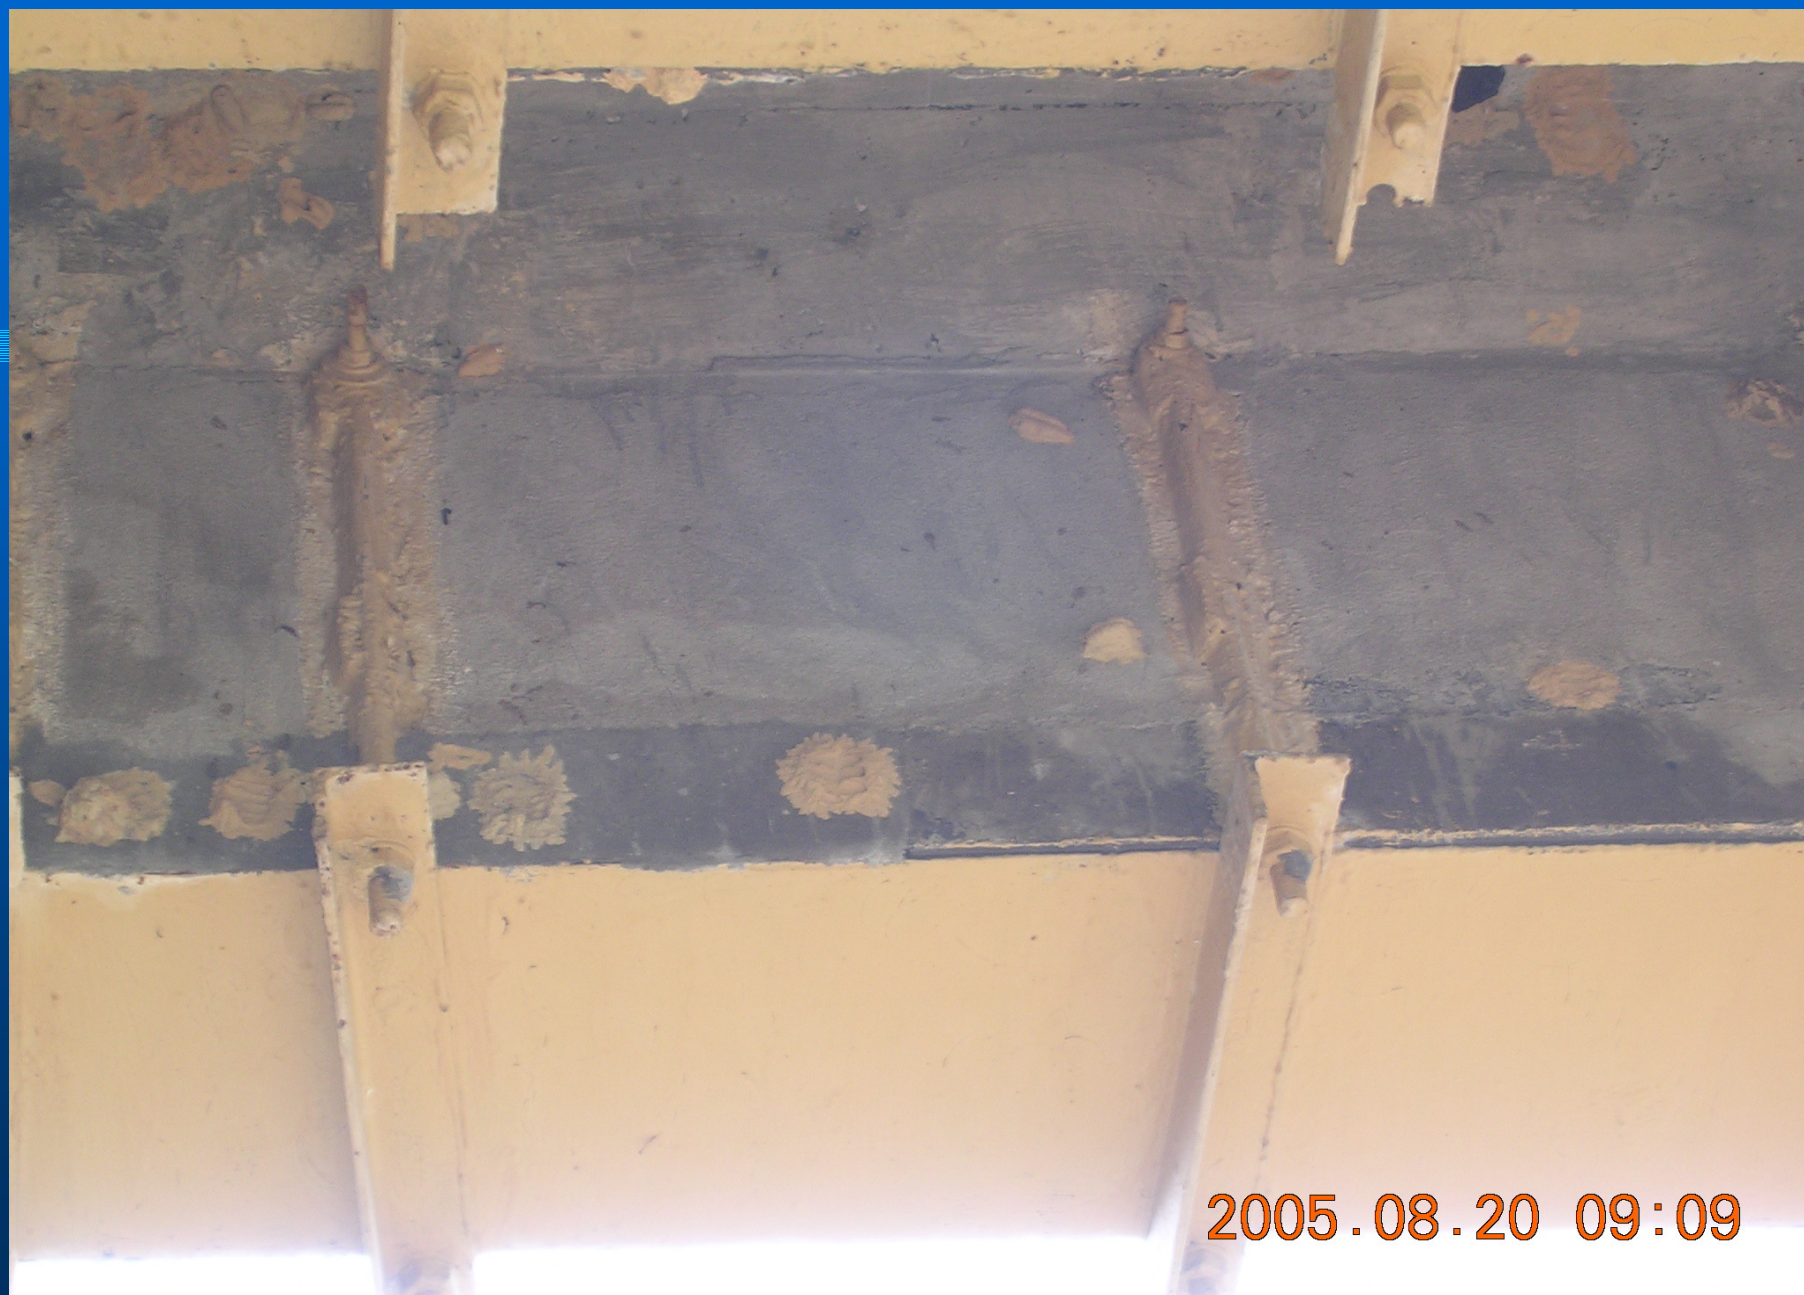
*Picture 20: The steel plates at the bottom of beam*

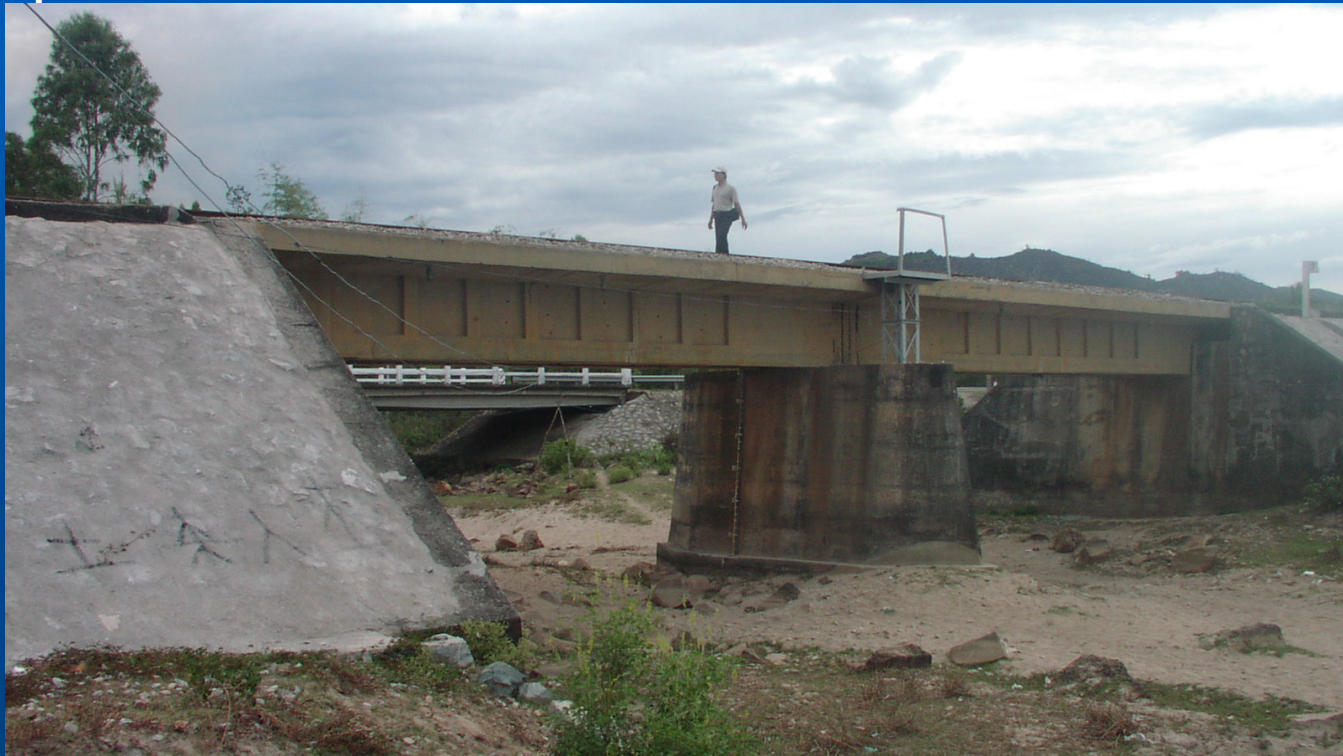
- After a long time servicing, this bridge is good with service load of railway. We have some comment such as:
- - The bonding steel plate process is
- - The width of cracks is not developing.
- - The steel plates is good. The is only some rust on the surface of steel plates

*Picture 21: The railway bridge in Km 983+900 in August 2005*

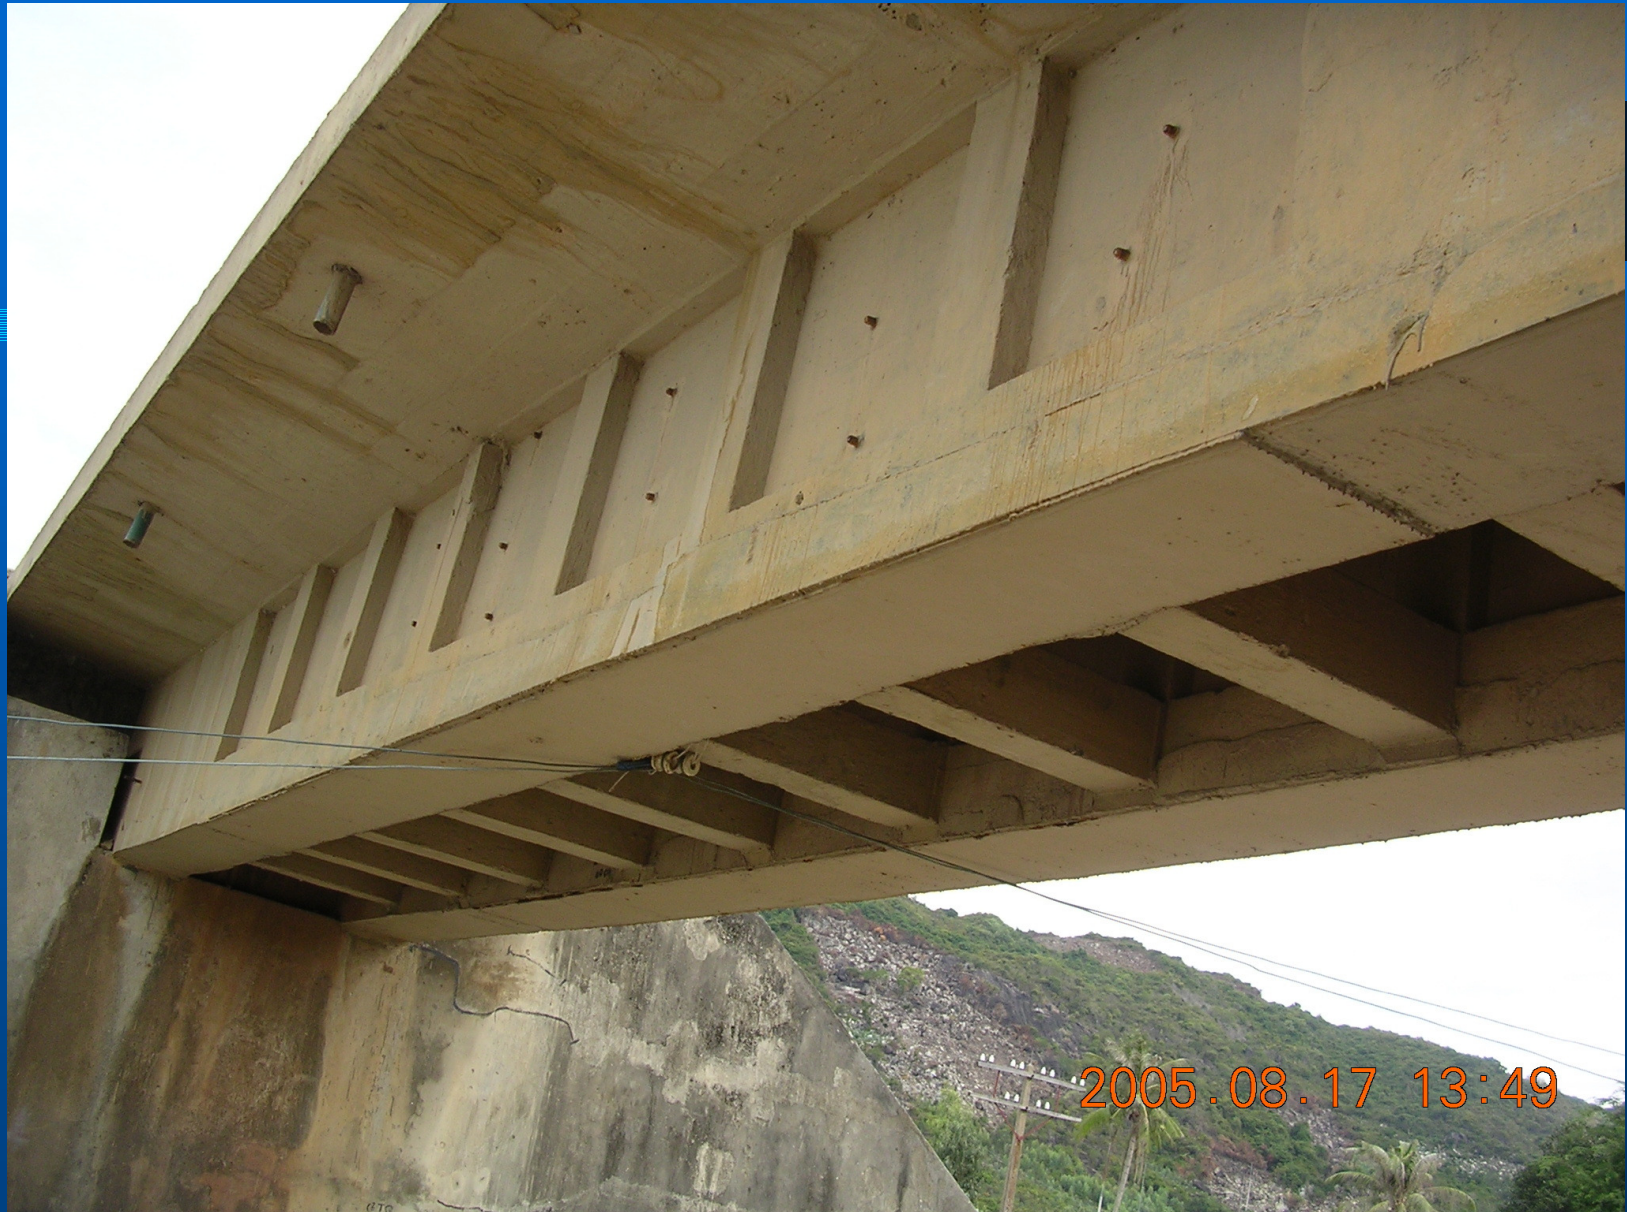
*Picture 22: Steel plates*

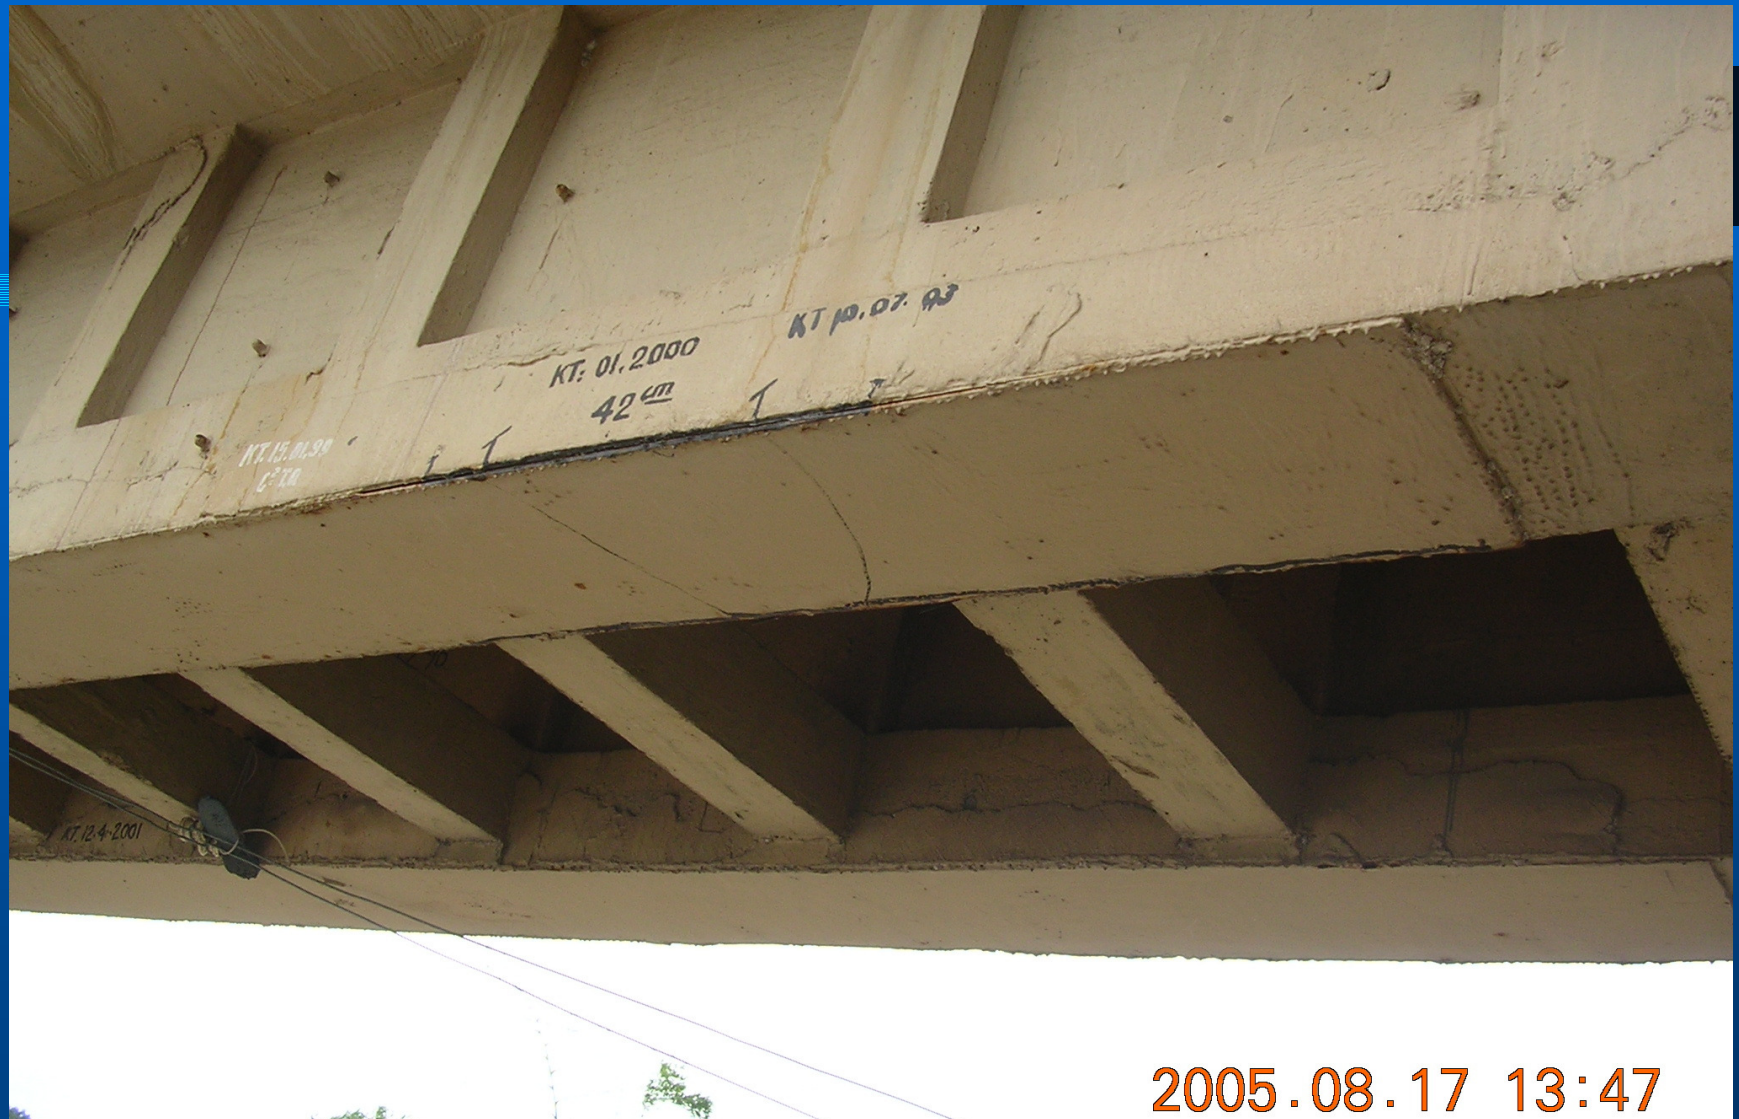
**Picture 23: Steel plates at the bottom of beam**

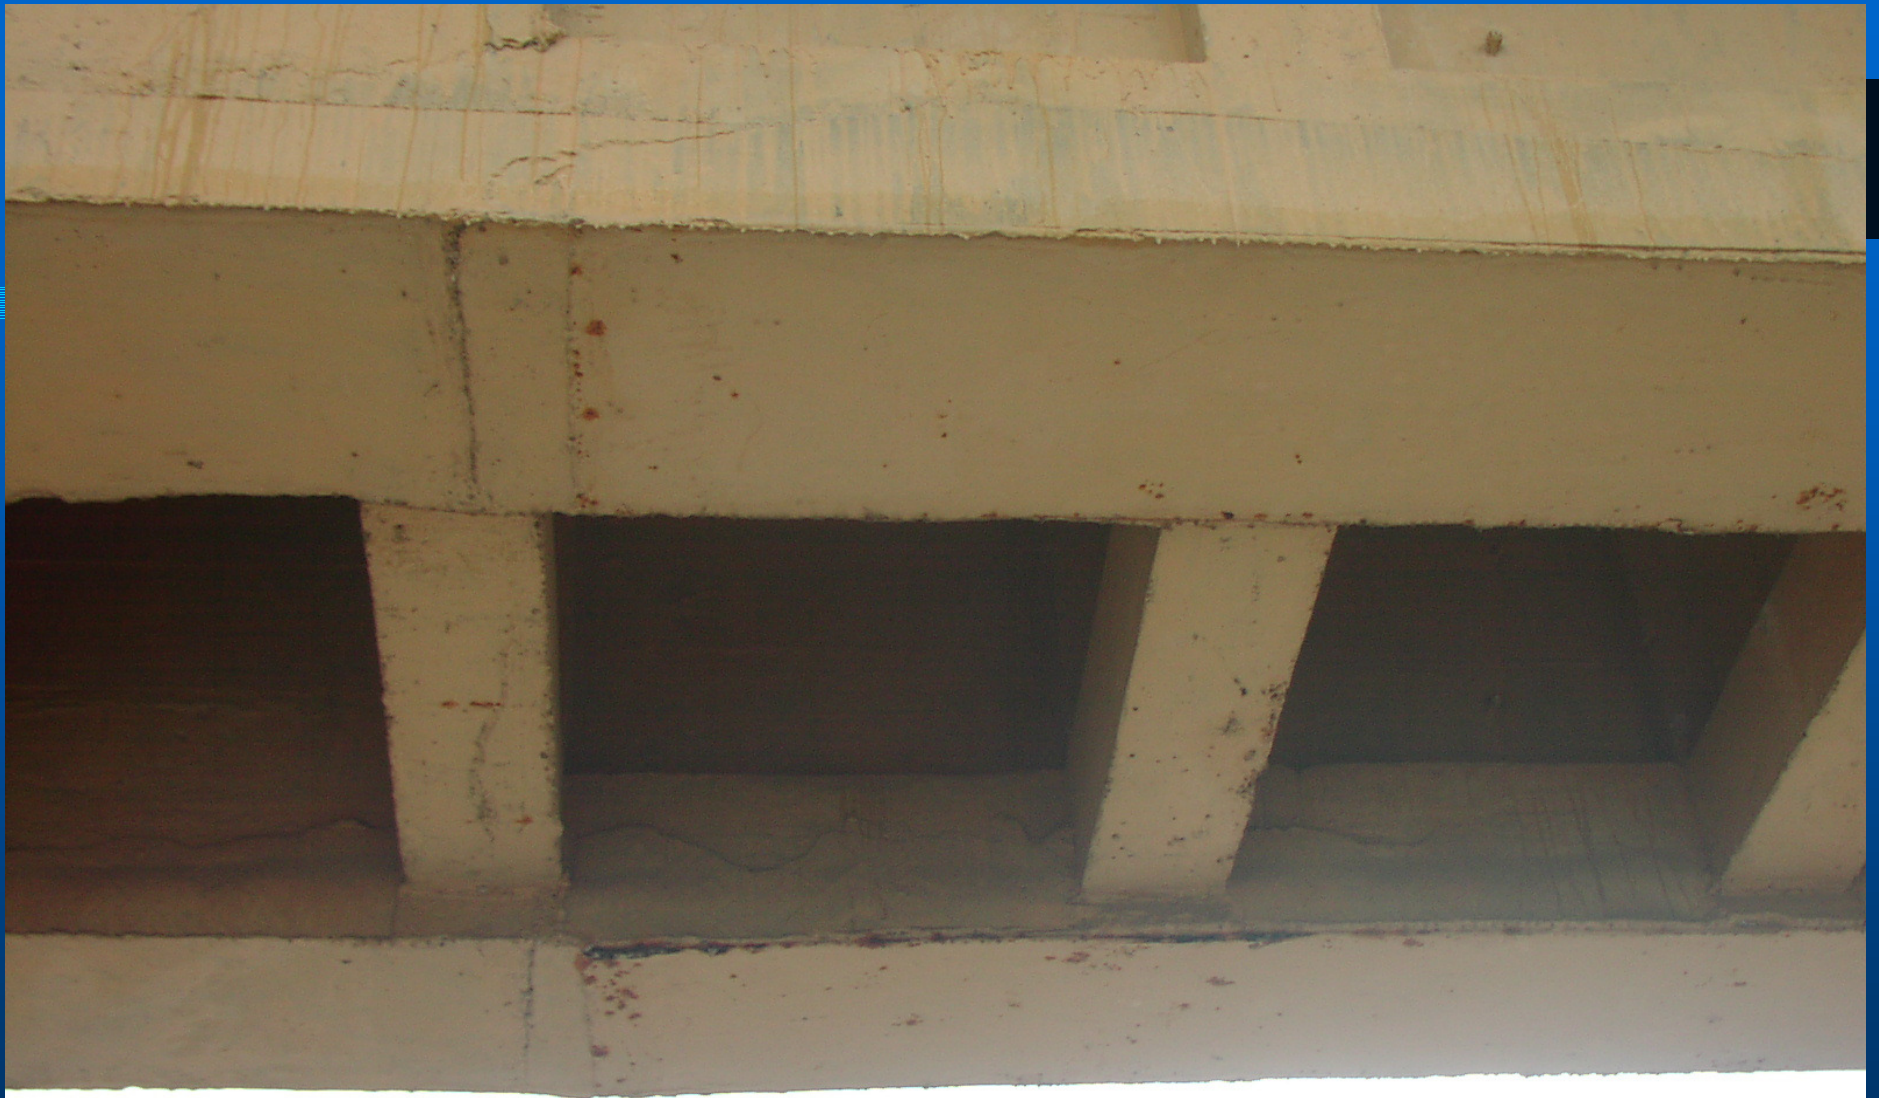
*Picture 24: There are some rust at steel plate*
