UNIVERSITY OF TRANSPORTATION AND COMMUNICATIONS  
*SECTION OF URBAN TRANSPORT WORKS*

# THE BONDING STEEL PLATES AND CARBON FIBER REINFORCED POLYMER PLATES TECHNOLOGY FOR REPAIRING CONCRETE BRIDGES IN VIET NAM

Pro.Dr. Nguyen Viet Trung

## **EXISTING CONCRETE BRIDGES REPAIRED BY BONDING STEEL PLATES AND CARBON FIBER REINFORCED POLYMER PLATES IN VIET NAM AFTER 14 YEARS OF SERVICE**

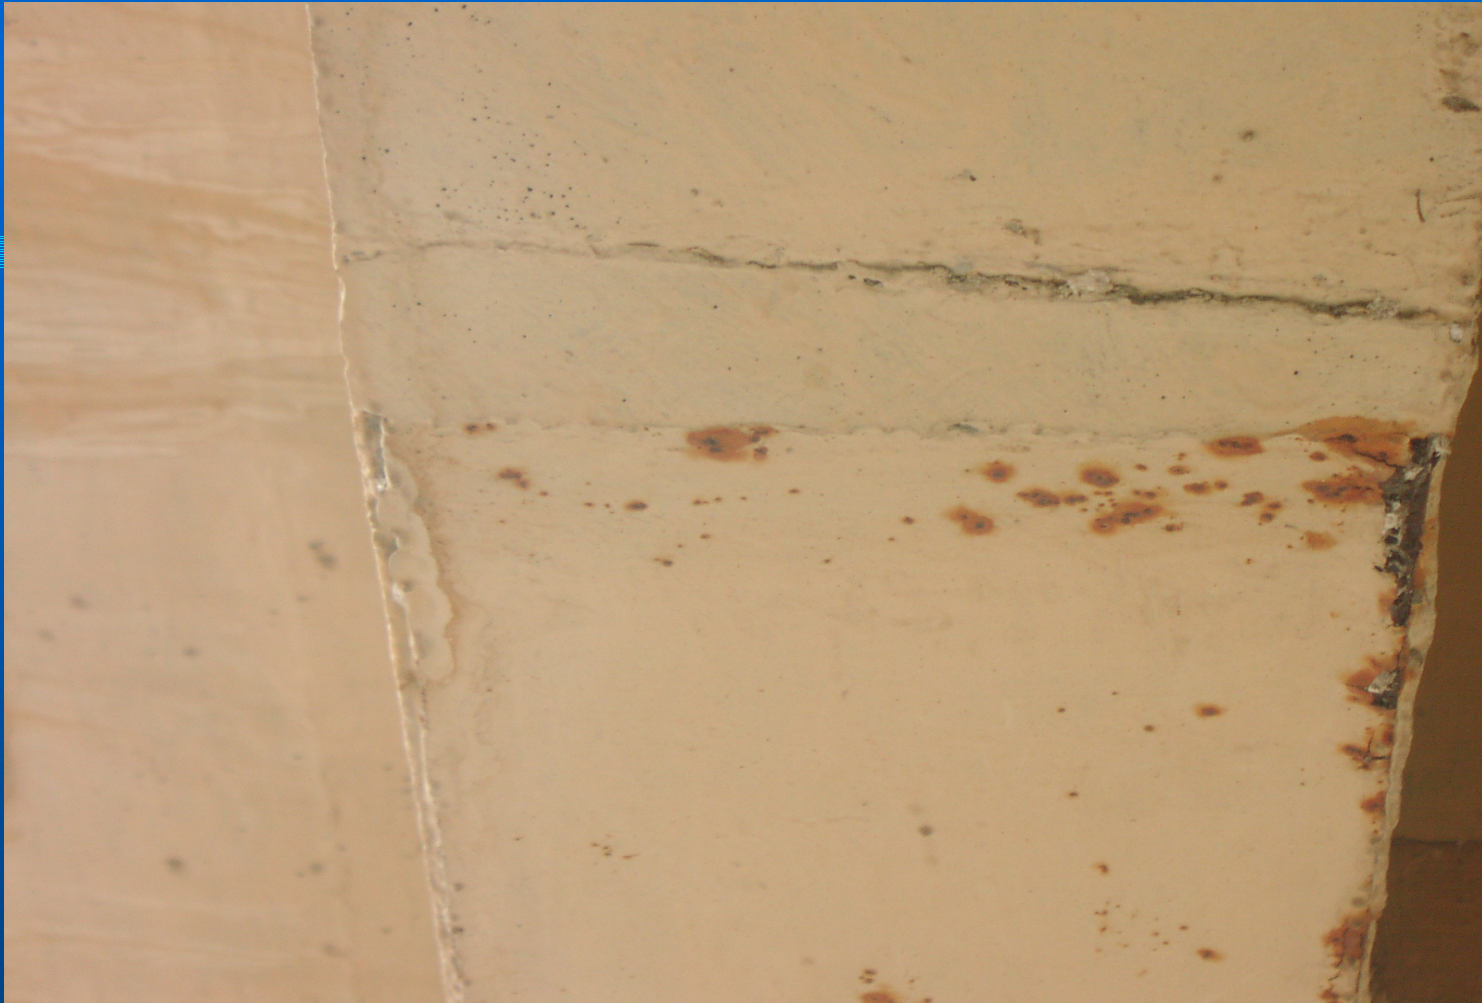
*Picture 25: The rust of steel plate*

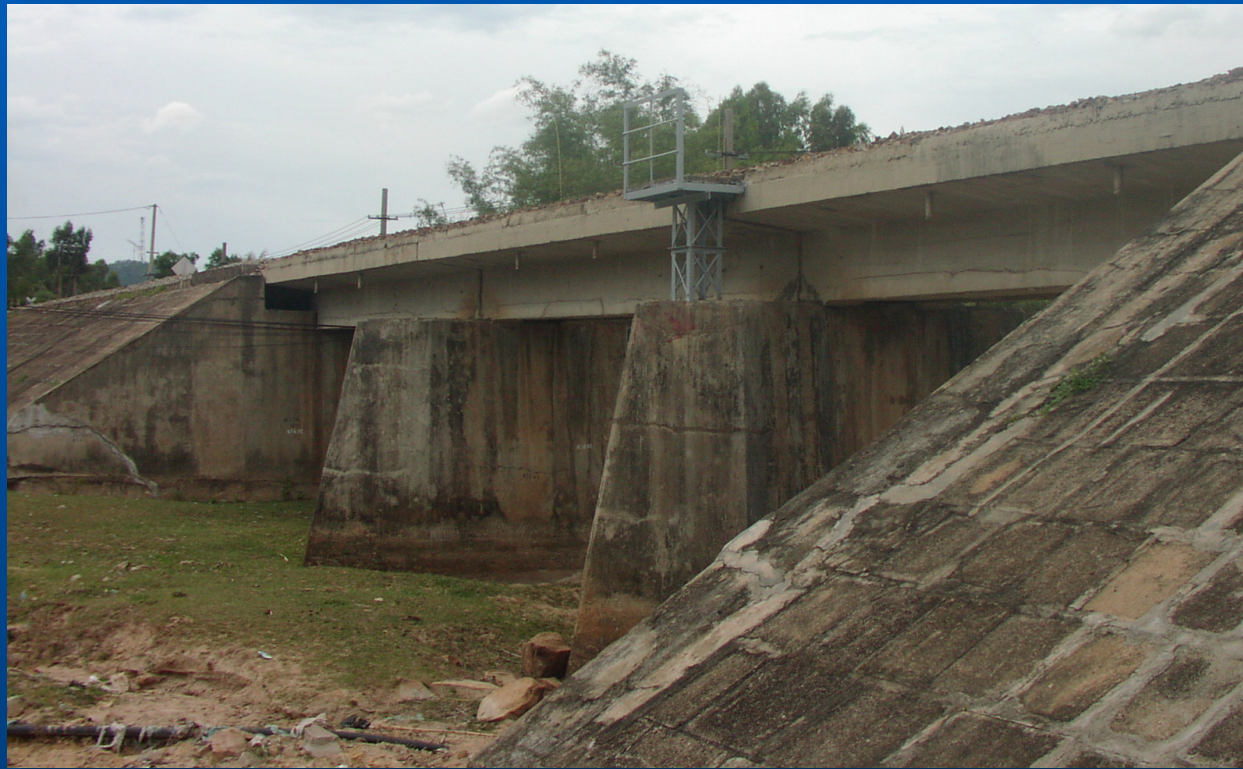
- After a long time servicing, this bridge is good with service load of railway. We have some comment such as:
- - The bonding steel plate process is
- - The width of cracks is not developing.
- - The steel plates is good. The is only some rust on the surface of steel plates

*Picture 27: Existing of railway bridge Km 995+693 in August 2005*

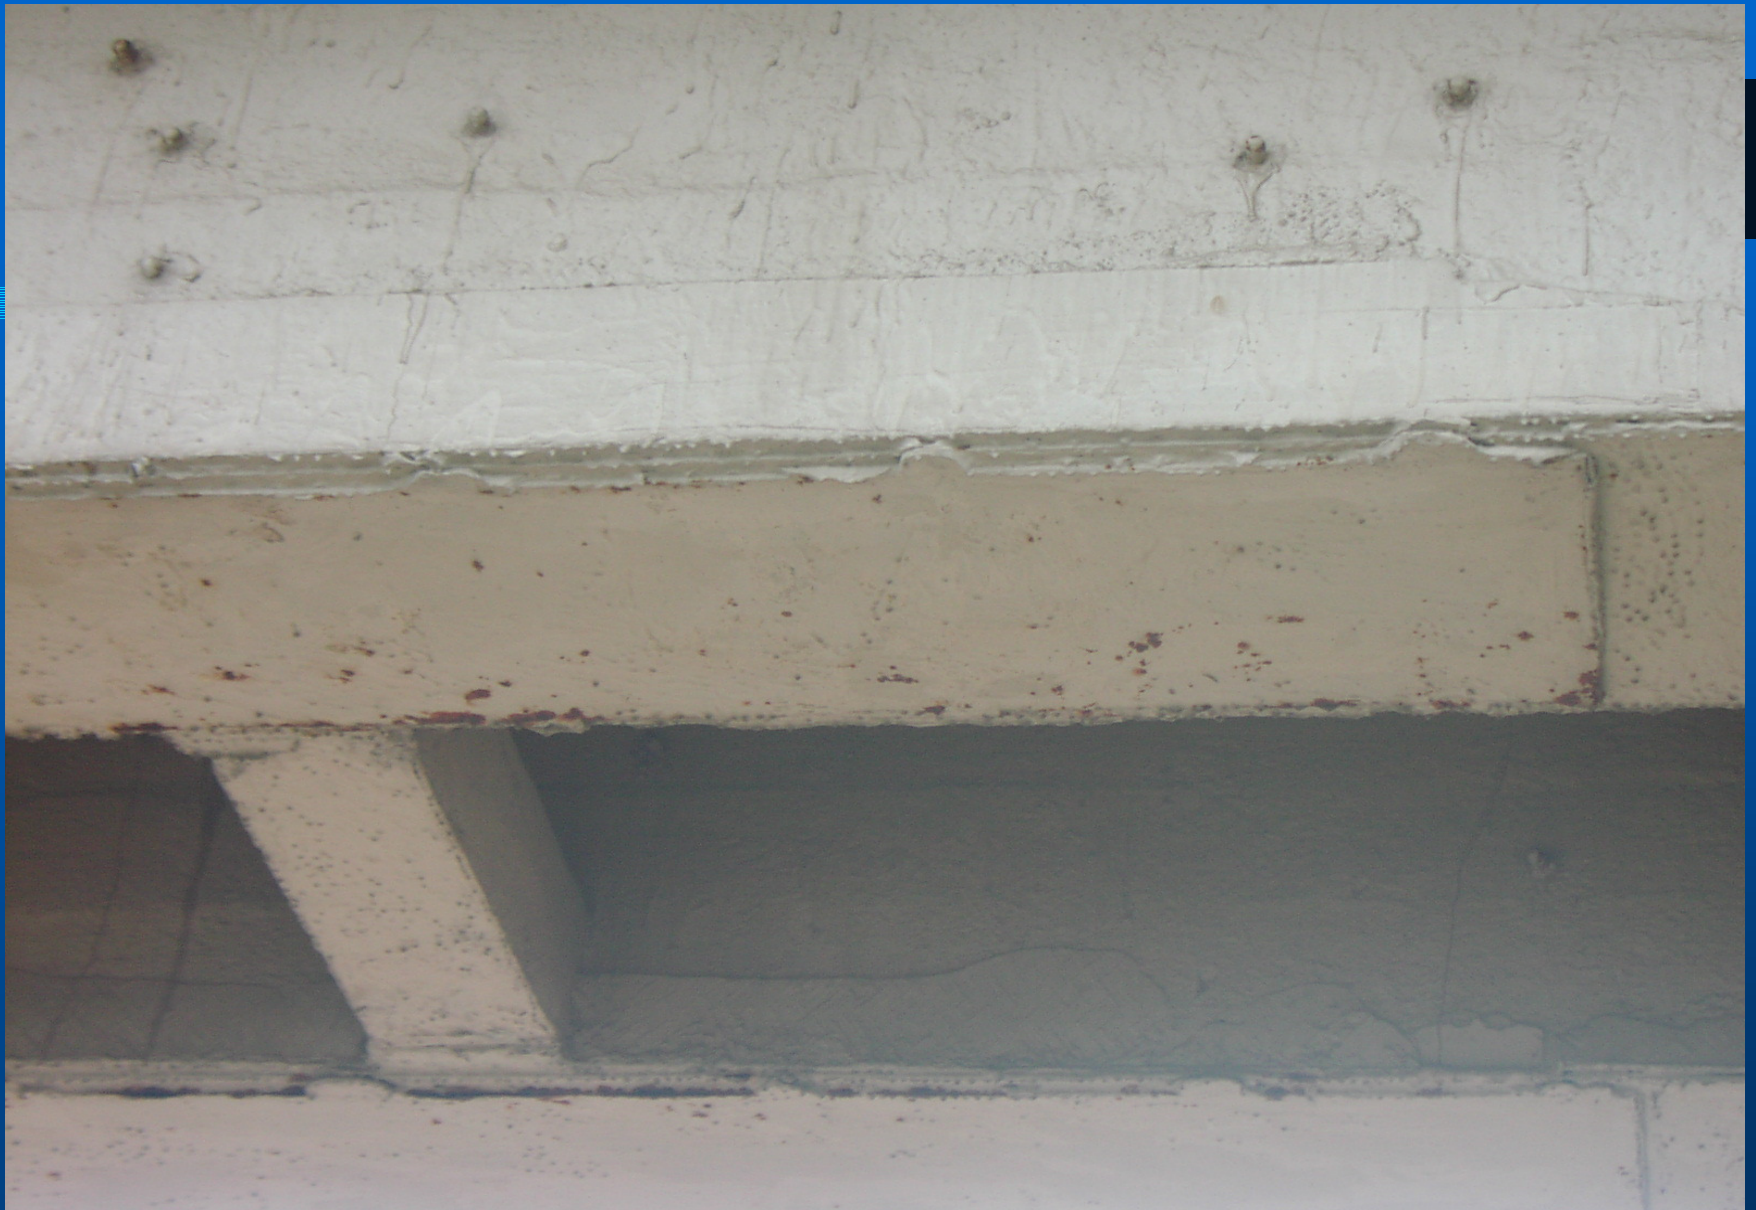
***Picture 28: The steel plates after 10 years servicing***

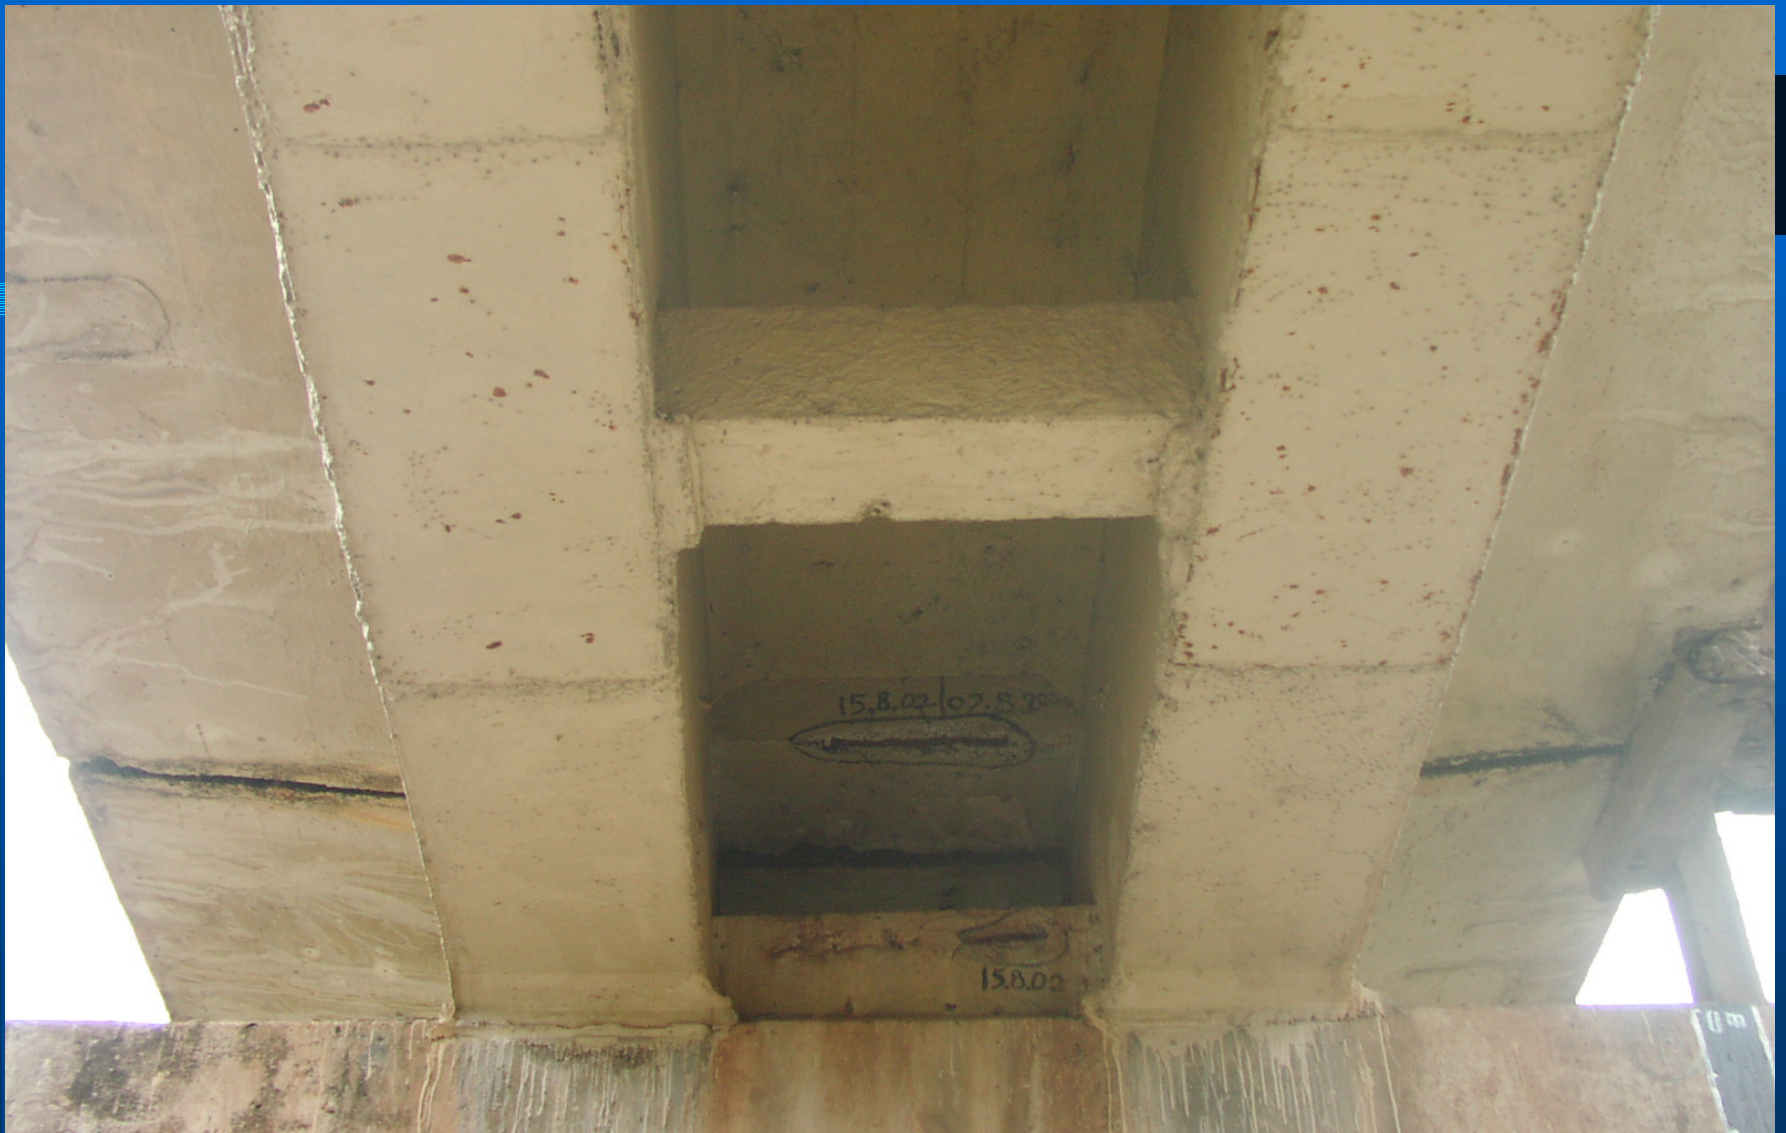
*Picture 29: The steel plates*

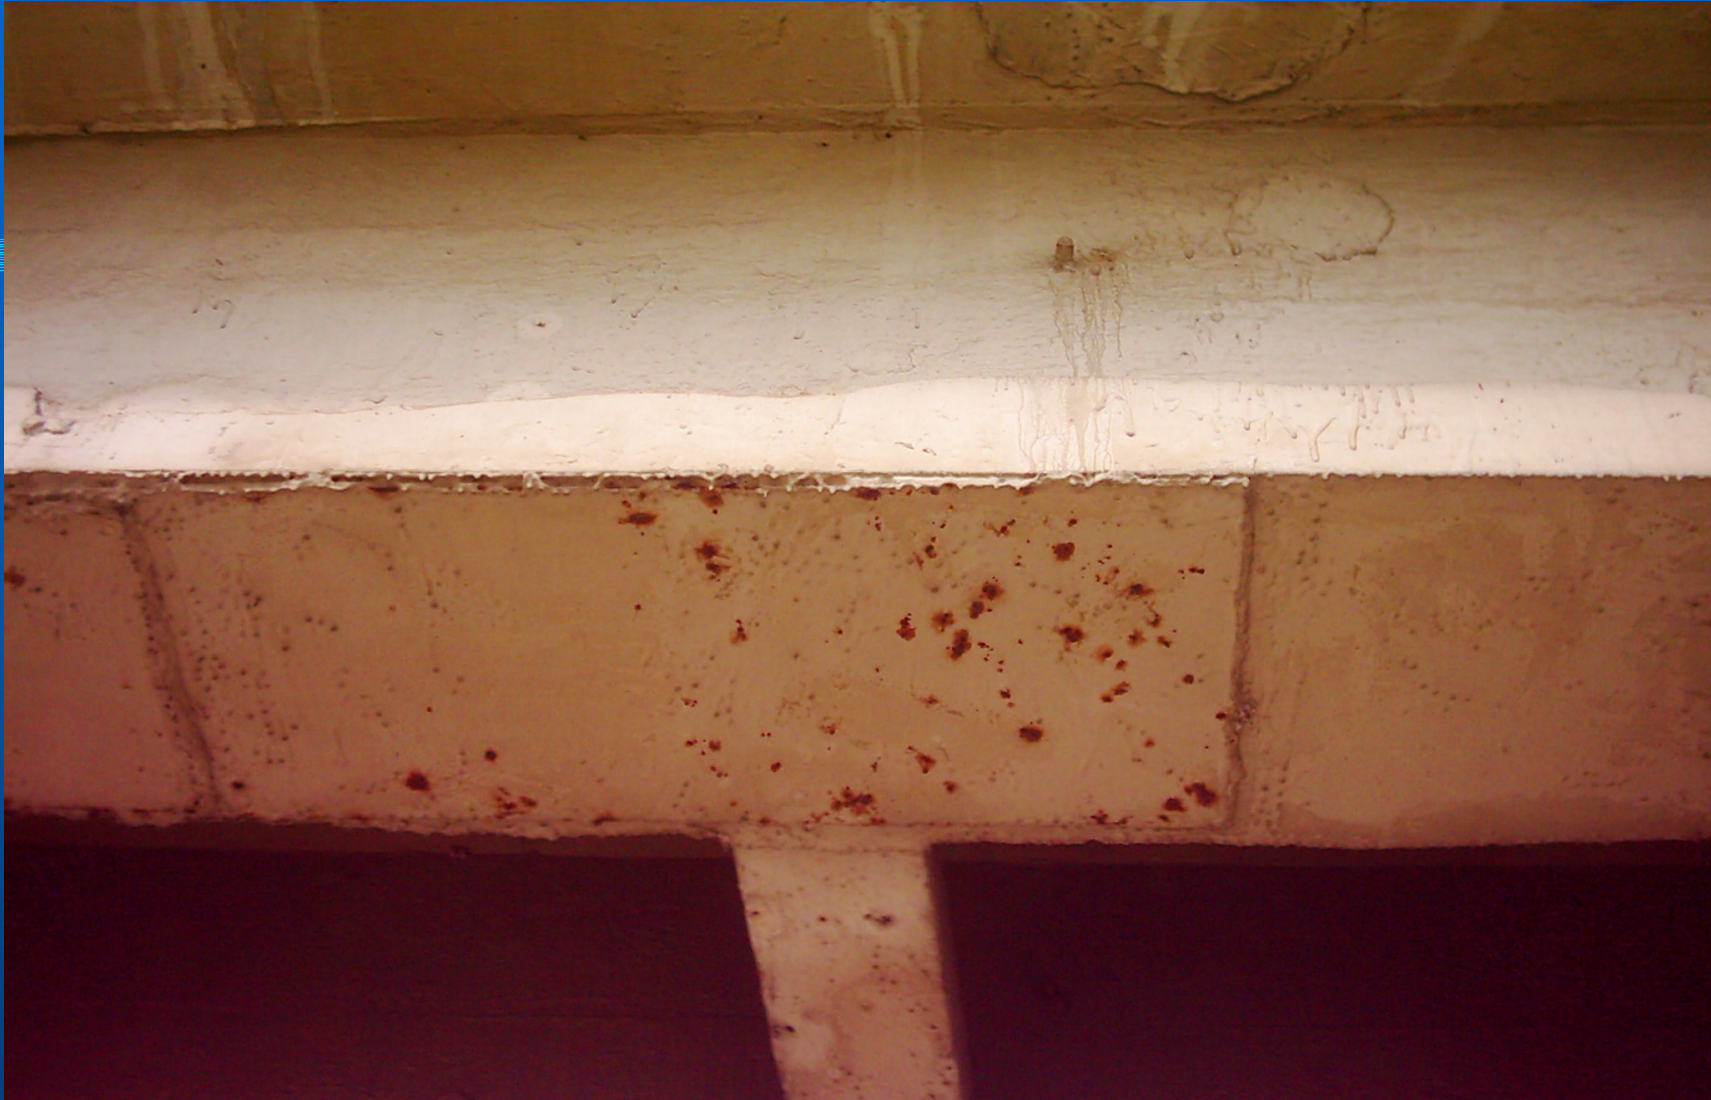
*Picture 30: Some rusts at steel plate*
