Kyoto Univ. and UTC Joint Summer Training Course of
Road Infrastructure Asset Management

Bridge Management (3)
Deterministic Deterioration Prediction

Osaka Univ.
Assoc. Prof. Dr. Kiyoyuki KAITO
kaito@ga.eng.osaka-u.ac.jp

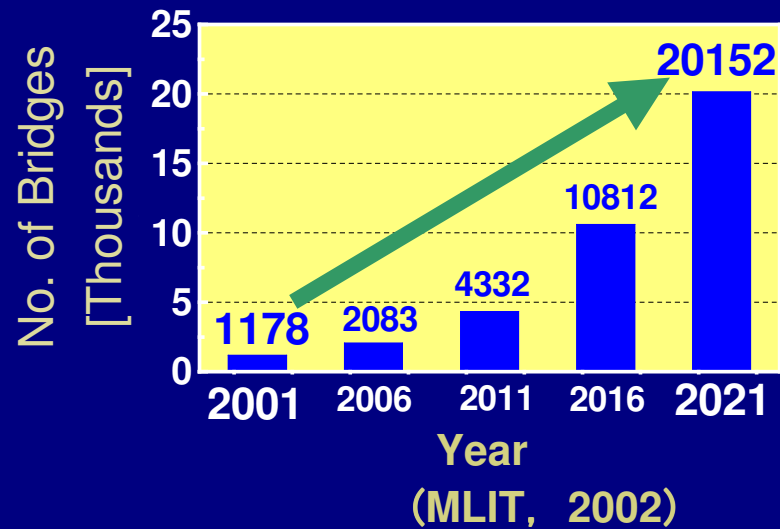
**Changes in No. of Bridges over 50 Years
(National Road & Highway)**

**No. of Bridges over 50 Years
increases to 17 times in 2020
due to concentrative
construction in the high
economic growth period in
1960's to 70's**

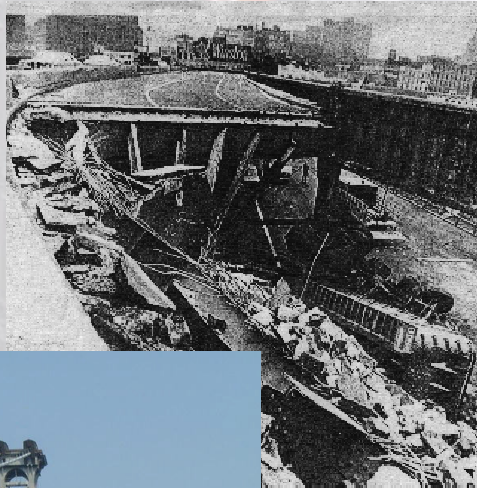
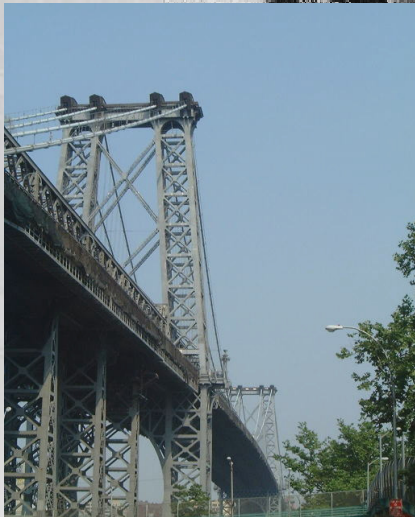
West Side Highway

Williamsburg Bridge

- **Average Age: about 75 years Aging**
- **Severe Condition in Winters Corrosion**
- **Capital City of the World Fatigue Crack**
- **Bitter Experience in the Past
Collapse of West Side Highway,
Closure of Williamsburg Br.**
- **Existence of Some Landmarks: Brooklyn
Br., George Washington Br.**

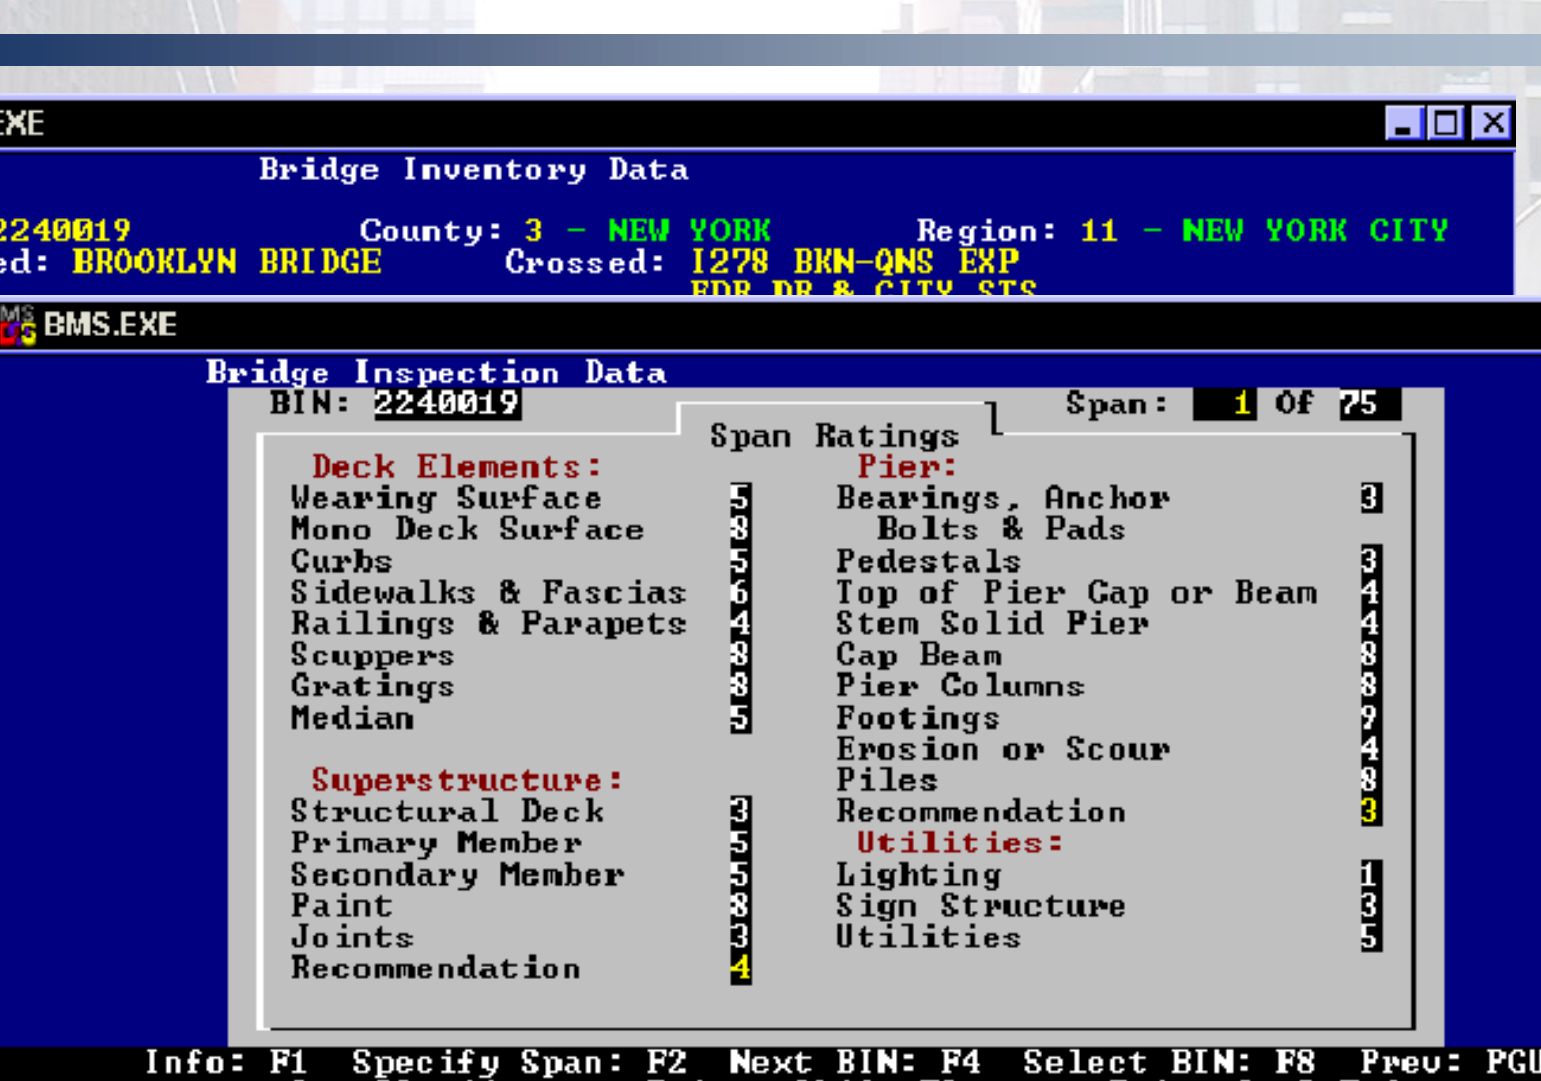
Database

The screenshot displays two windows from the BMS.EXE application. The top window, titled 'Bridge Inventory Data', shows information for BIN: 2240019, County: 3 - NEW YORK, Region: 11 - NEW YORK CITY, Carried: BROOKLYN BRIDGE, and Crossed: 1278 BKN-QNS EXP. The bottom window, titled 'Bridge Inspection Data', shows the same BIN and provides a detailed inspection for Span 1 of 75. It includes ratings for Deck Elements, Superstructure, Pier, and Utilities. A vertical menu on the left of the bottom window lists various functions like Admin, Serv, Own, Main, Dim, Right, Left, Area, Ver, Over, Loa, Desi, Post, Wat, Bank, and Sub, with 'Next' at the bottom. A status bar at the bottom of the bottom window provides keyboard shortcuts for navigation and printing.

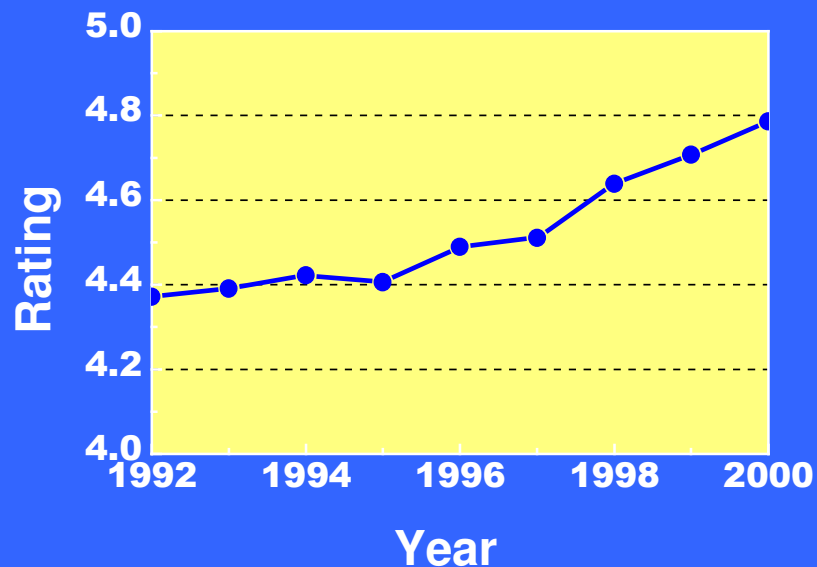
**Averaged Rating of Bridges in NYC
(1992 to 2000)**

- Tends to be increased year by year
- reaches to rating 5 (Good) in 2010

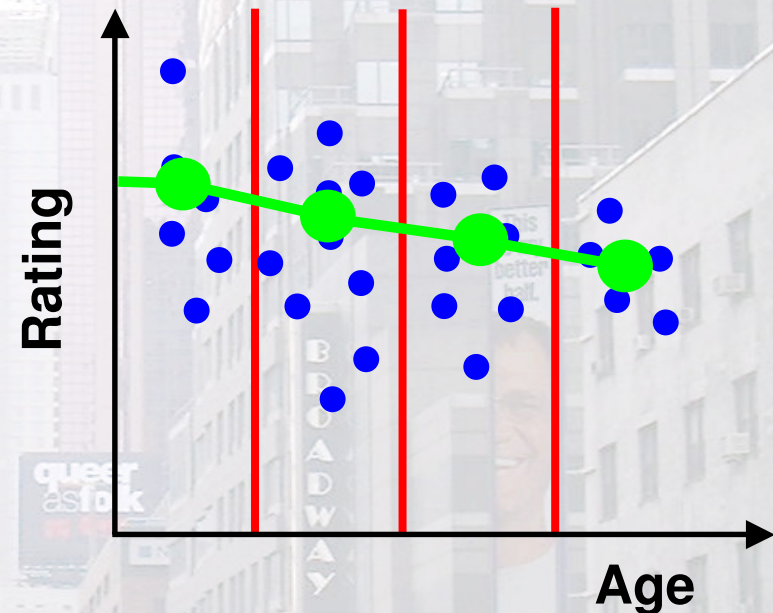
The Simplest Method and Disadvantage

1. Plot all ratings (inspection data) for their ages.
2. Classify them into several segments.
3. Calculate average ratings per each segment and connect them.

Deterioration curve by this method tends to be slower declines than real.

➔ The method does not take into account the effects of any repair/rehabilitation done to the bridge members in the past.

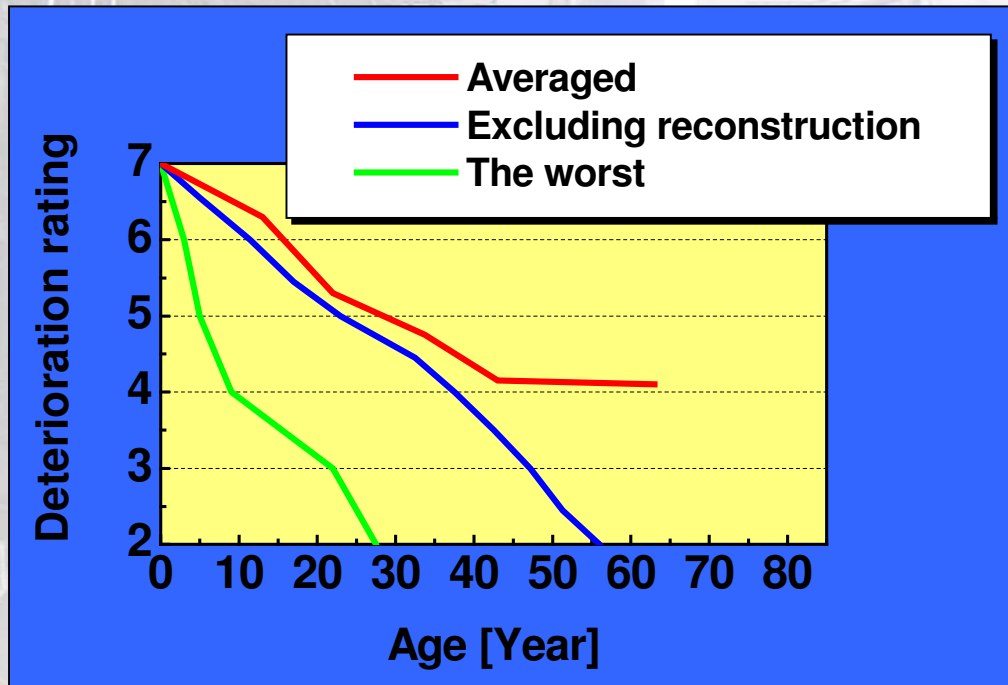
Deterioration curve
under complete information
(Yanev, B. '97)

- Using about 750 ratings in 1994
- Original bridge rating system ('82)
7 to 1 (7: new, 1: failure)

Investigated repair and
rehabilitation history for all
bridges and excluded them.

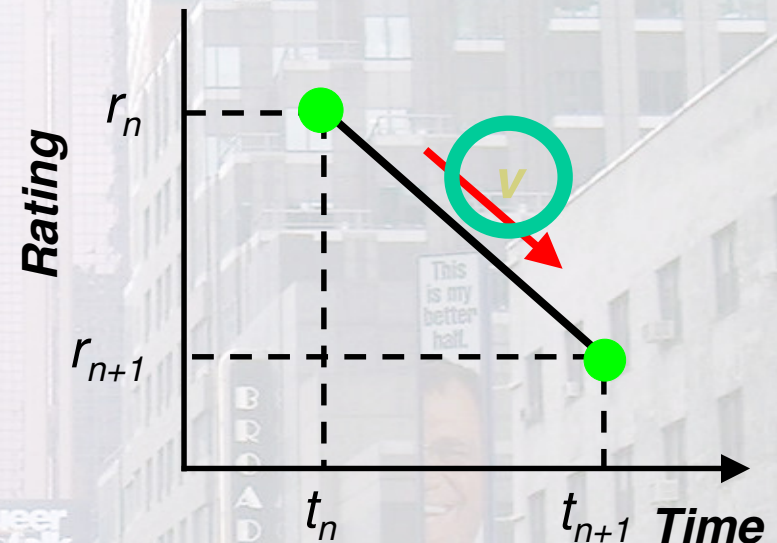
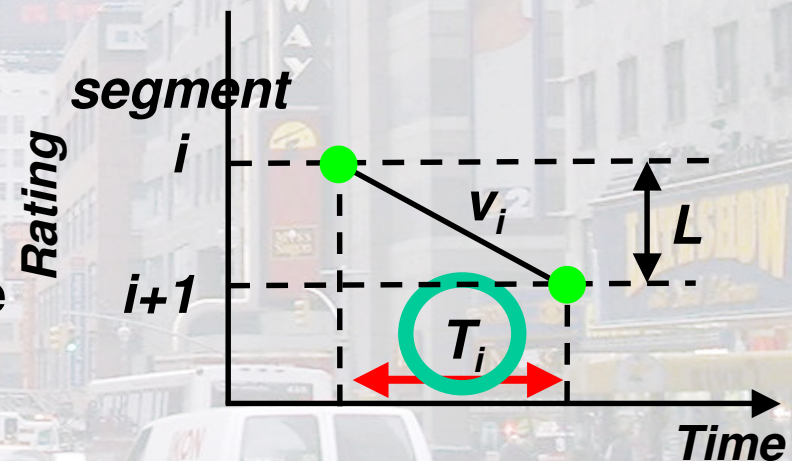
Proposed Method: Step1

1. Calculate deterioration rates between r_{n+1} and r_n .

2. Make several segments for ratings and classify all ratings into the appropriate segments and put rate v in the same segment with the corresponded r_n .

3. Calculate average deterioration rates v_i per each segment, then give deterioration time T_i as the follows.

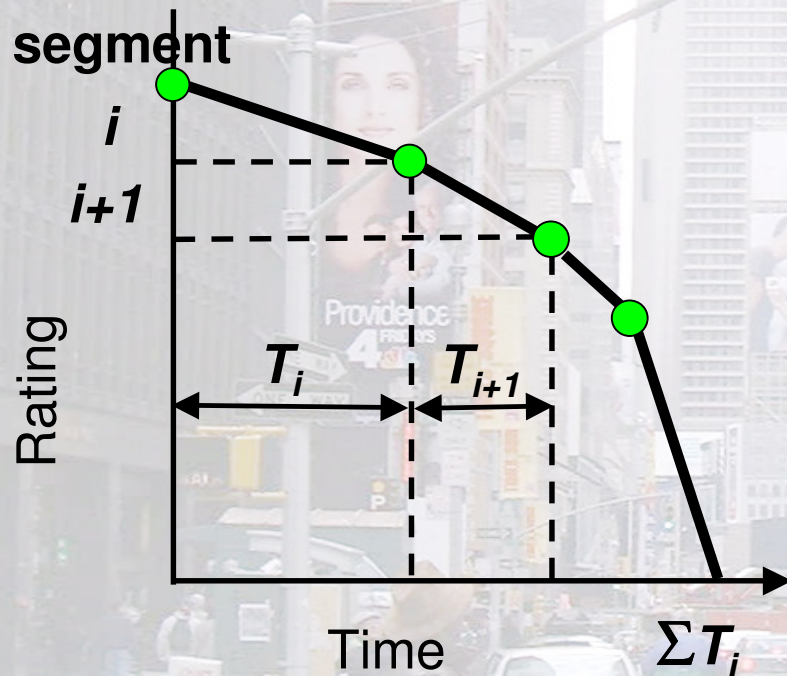
Proposed Method: Step2

4. Accumulate averaged deterioration time for each segment to obtain total deterioration time.

Only deterioration rates (a series of ratings and inspection dates) are required to calculate deterioration curve.

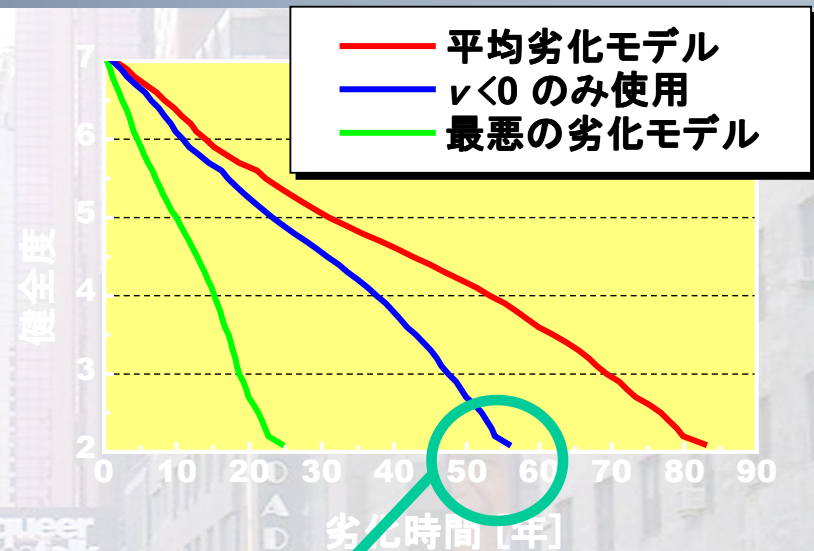
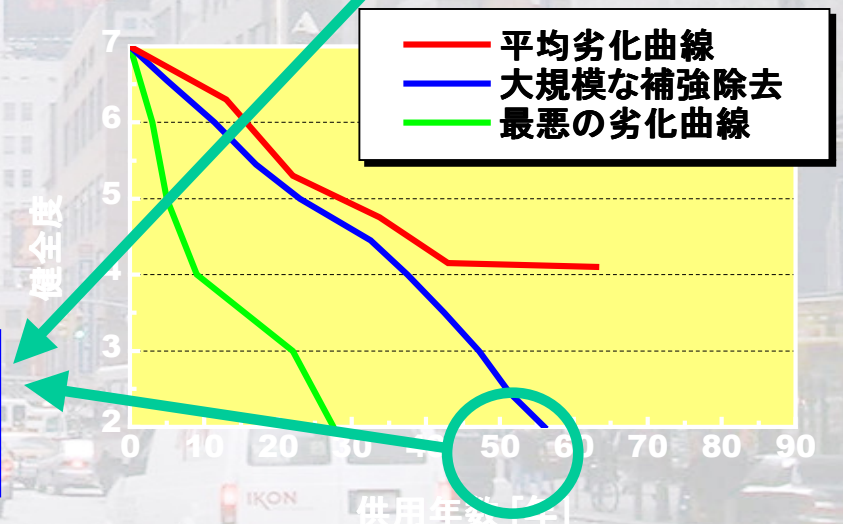
Results of Analysis

Expected Life Time: about 80 years

The Worst Case: 25 years

Almost Similar to the results of the existing method

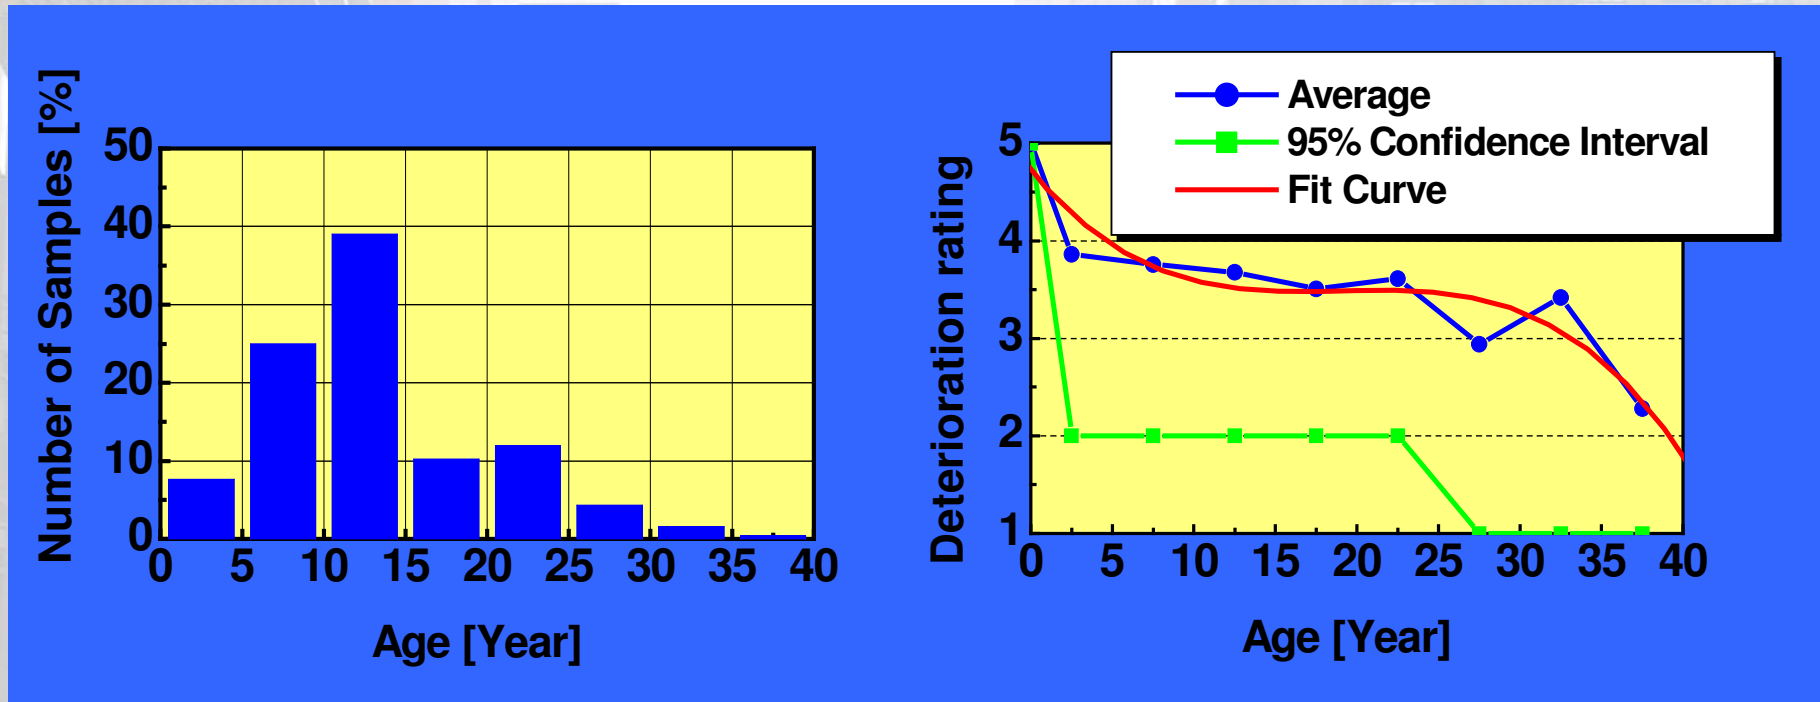
Results by the Existing Method

- Deterioration rating of painting goes down in more than 40 years on average.
- The painting period would be 25 years on 95% confidence interval.

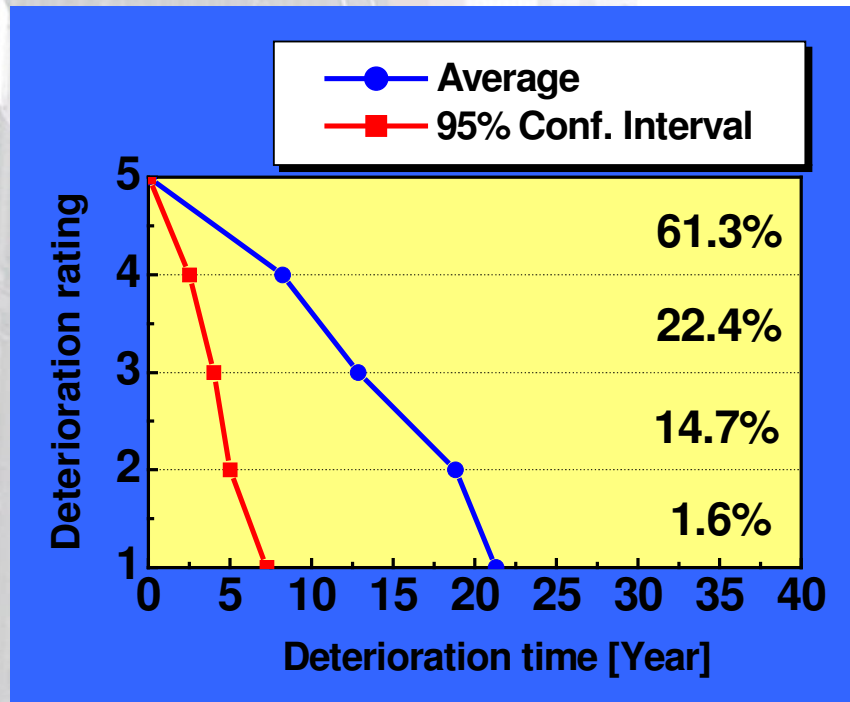
Result by the Proposed Method

- ▶ Painting is durable for 20 years on average.
- ▶ The current painting period 8-15 years is reasonable from 95% confidence interval.
- ▶ The lower classes do not have enough samples, reliability of quantity still remains.

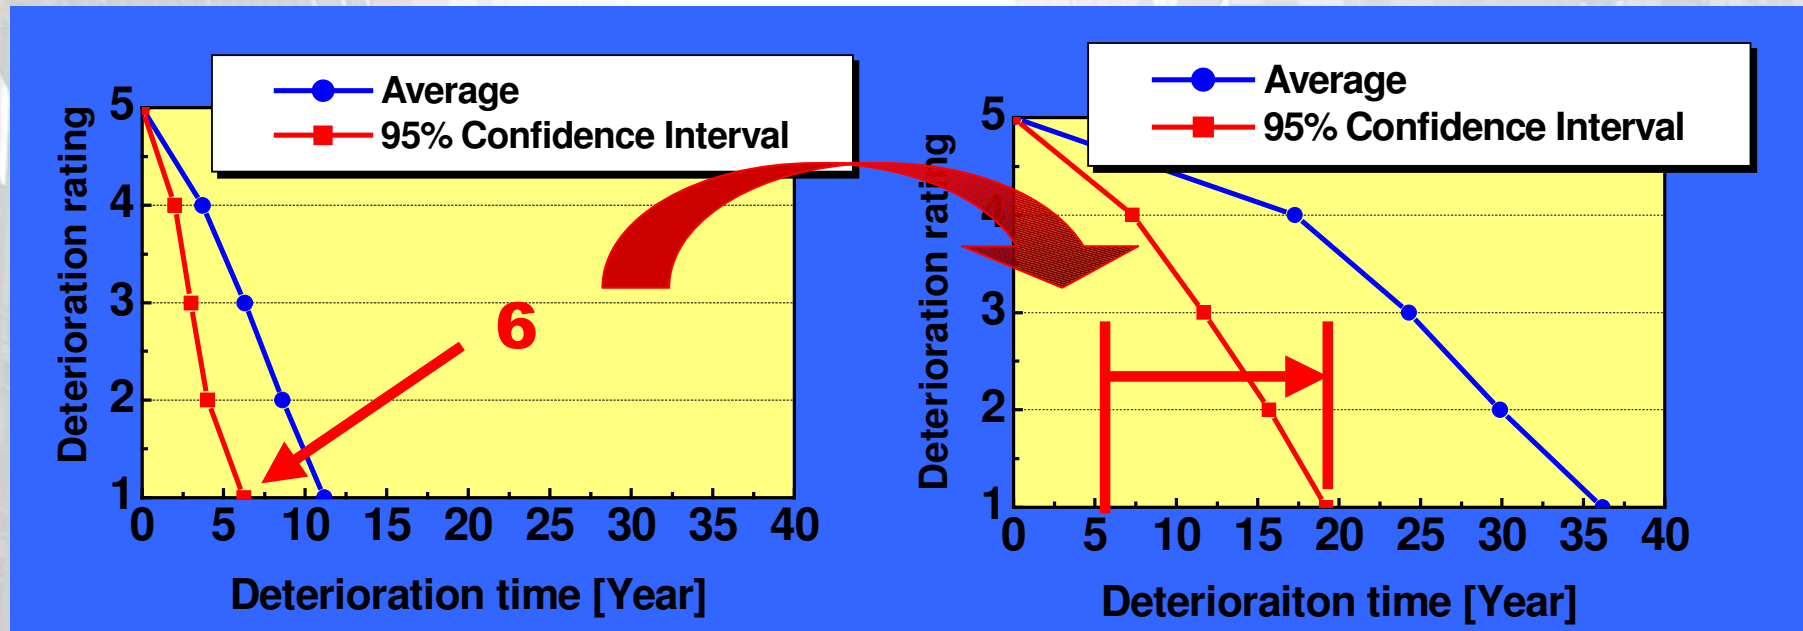
Painting Period

- ▶ Corrosion gives crucial damage to steel member in 10 years.
- ▶ Doing actively preventive maintenance for corroded member, painting period can be extended up to 20 years with 95% confidence interval.

→ LCC can be saved in some cases, and the accountability for necessity of painting is possible to be carried with this quantitative results
