UNIVERSITY OF TRANSPORTATION AND COMMUNICATIONS  
*SECTION OF URBAN TRANSPORT WORKS*

# THE BONDING STEEL PLATES AND CARBON FIBER REINFORCED POLYMER PLATES TECHNOLOGY FOR REPAIRING CONCRETE BRIDGES IN VIET NAM

Pro.Dr. Nguyen Viet Trung

## **EXISTING CONCRETE BRIDGES REPAIRED BY BONDING STEEL PLATES AND CARBON FIBER REINFORCED POLYMER PLATES IN VIET NAM AFTER 14 YEARS OF SERVICE**

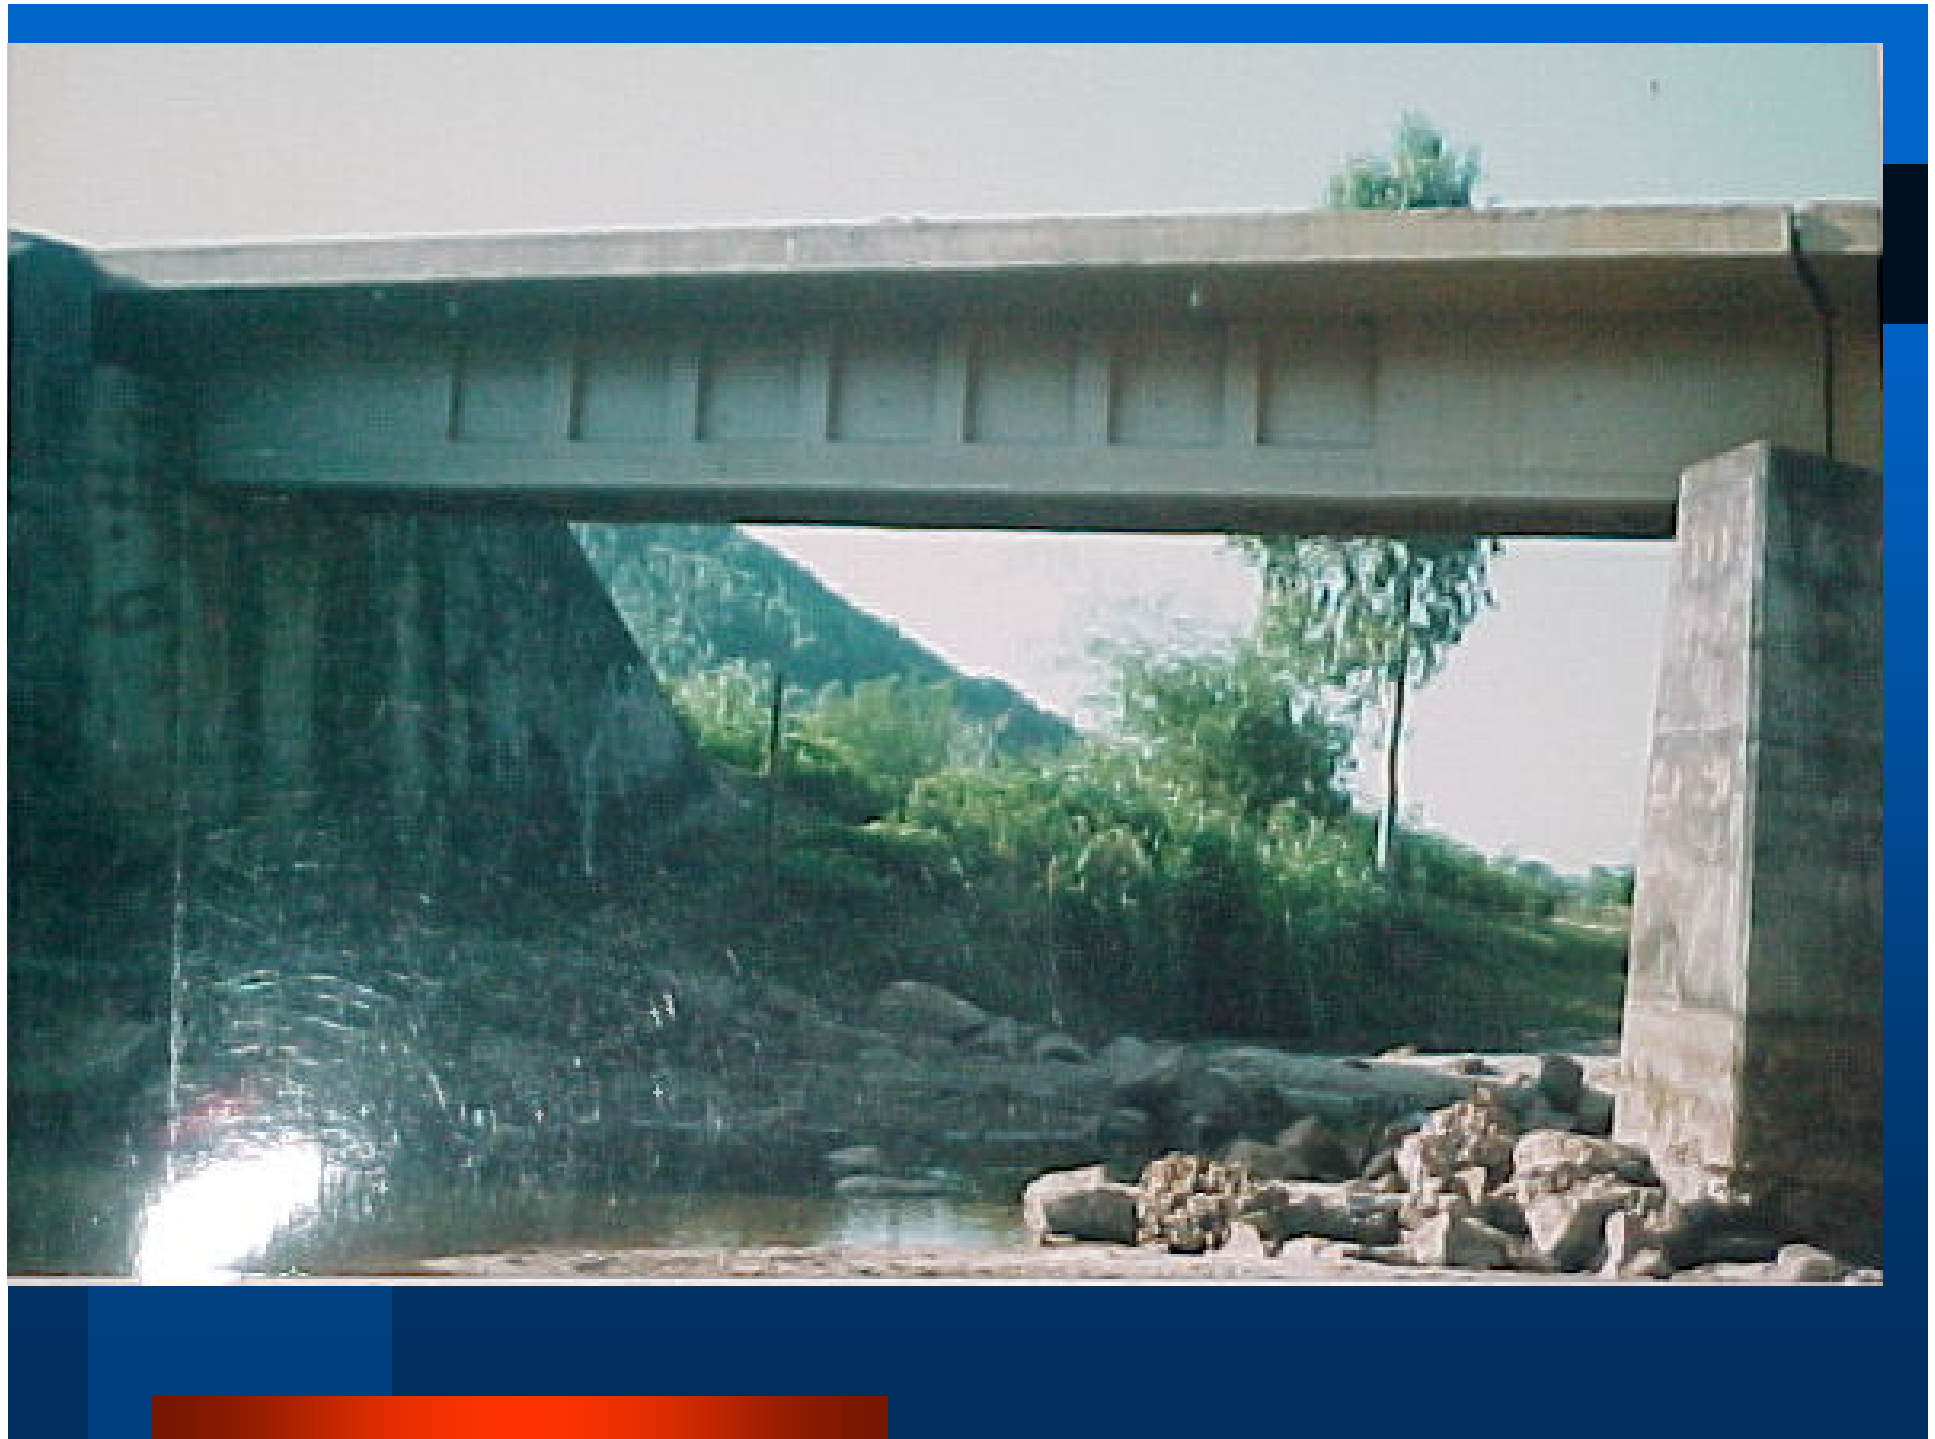
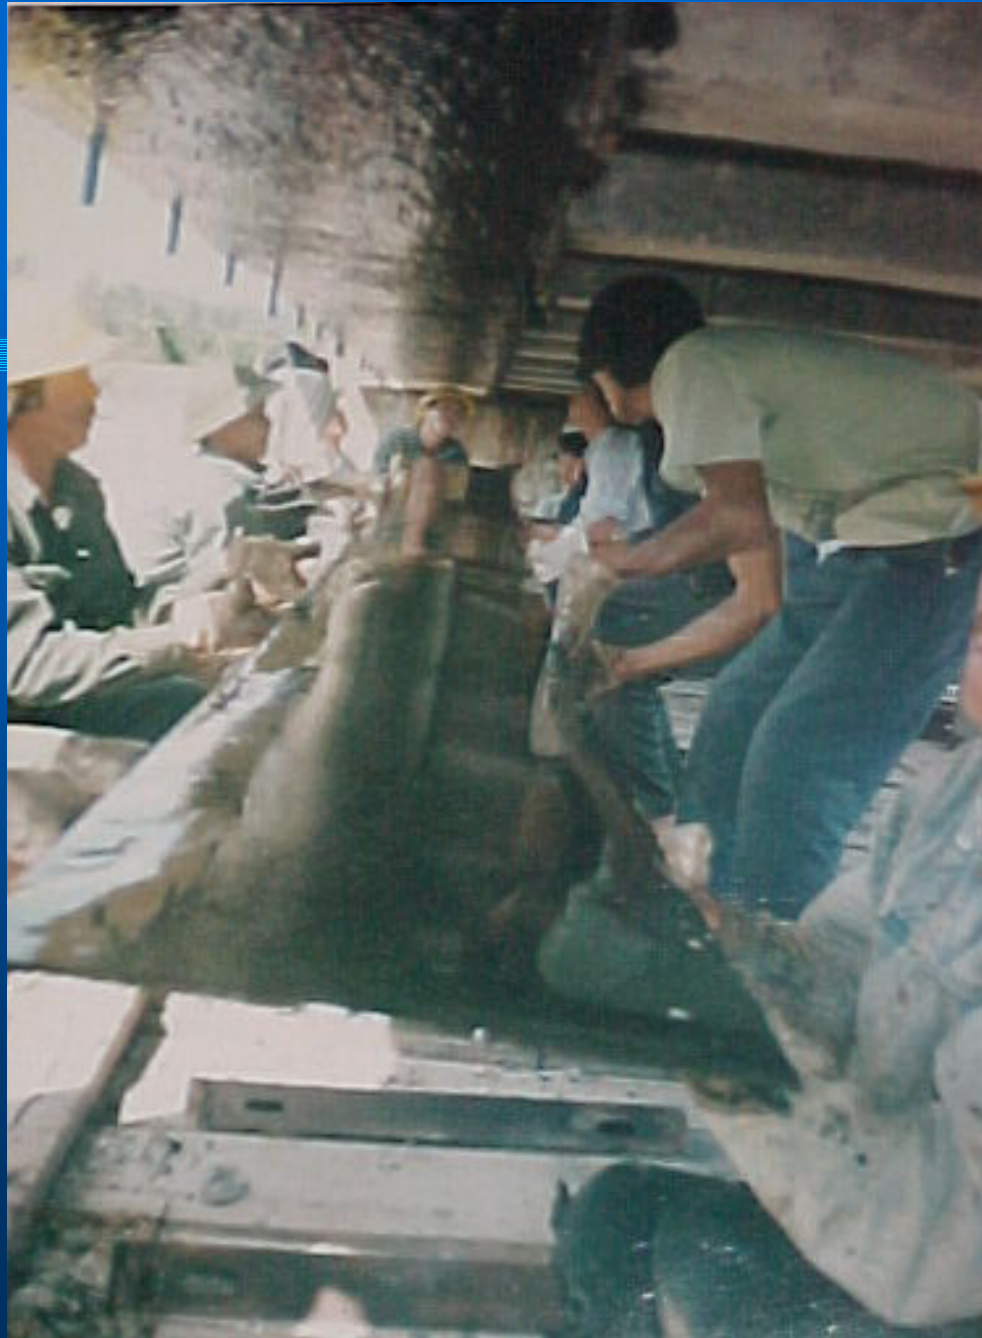
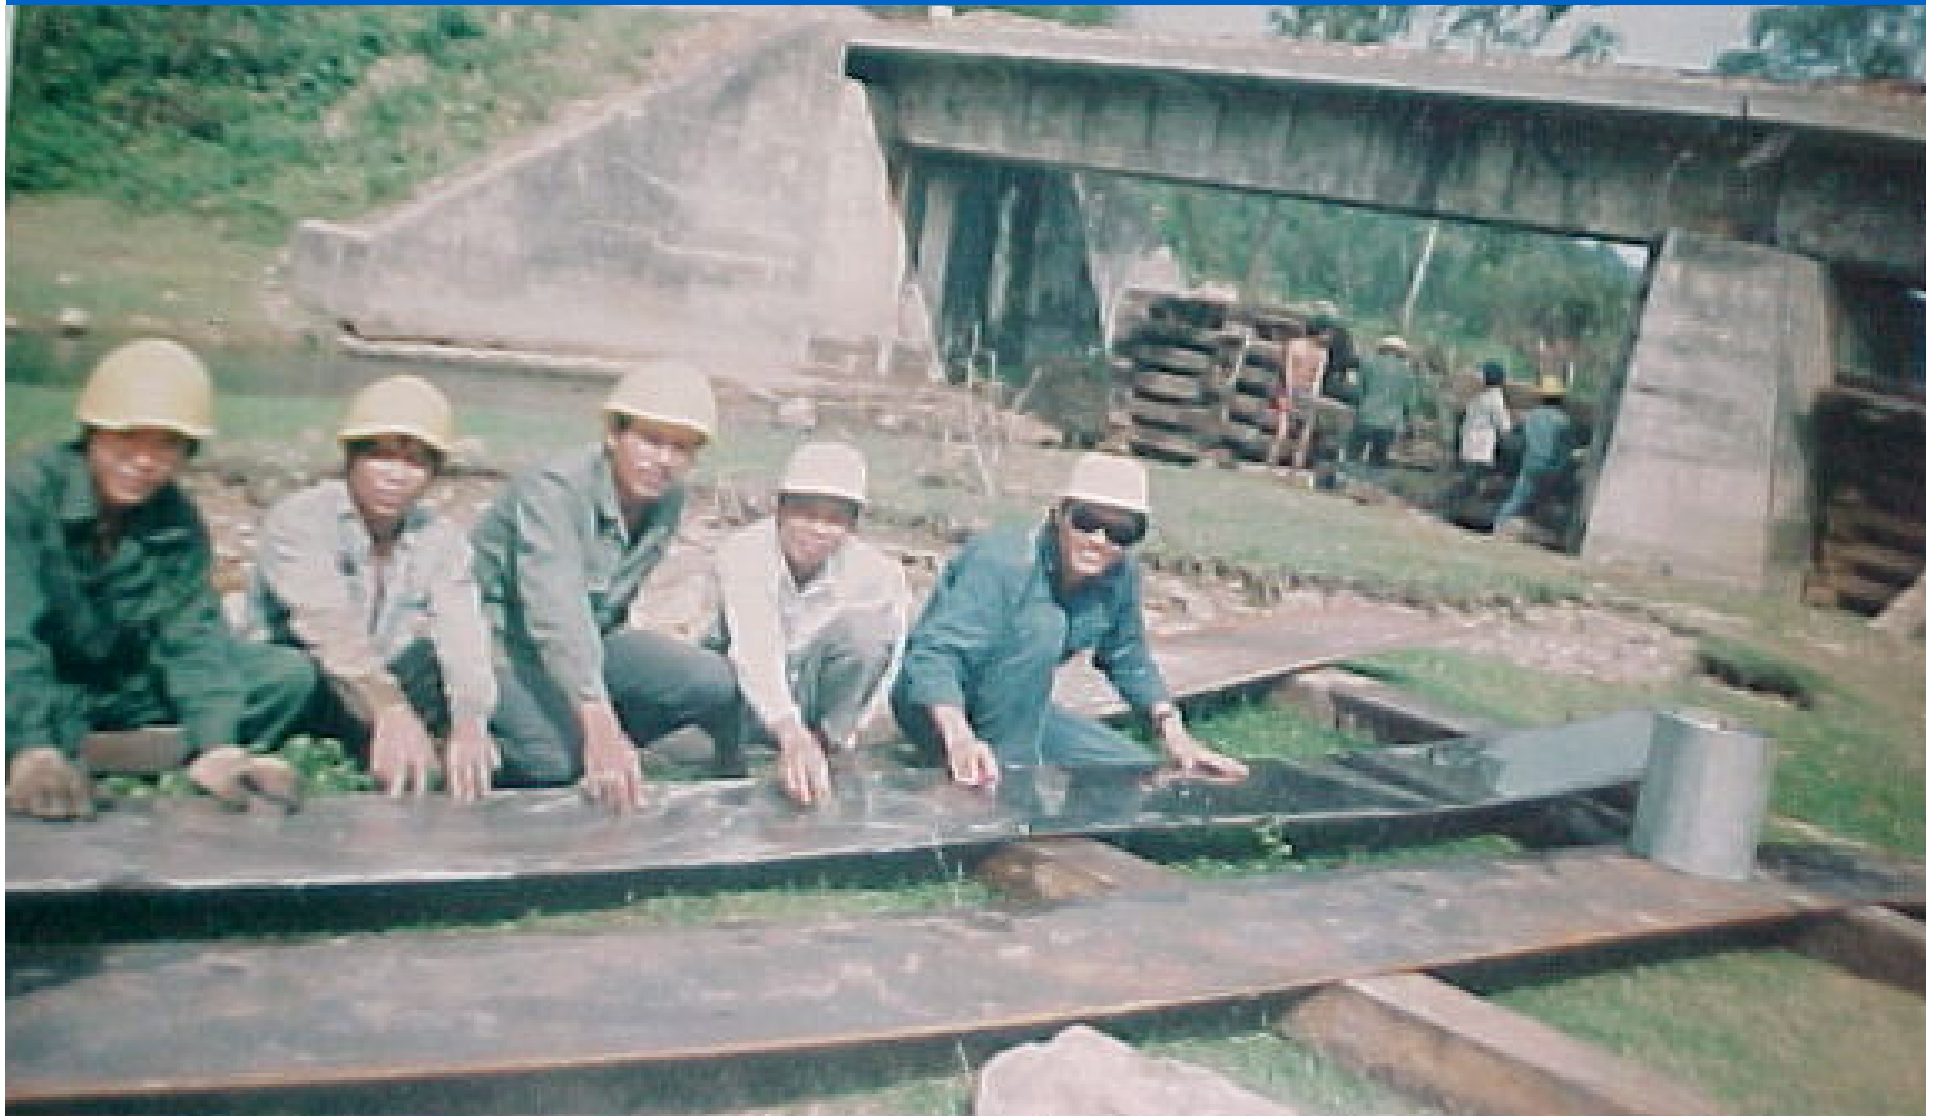
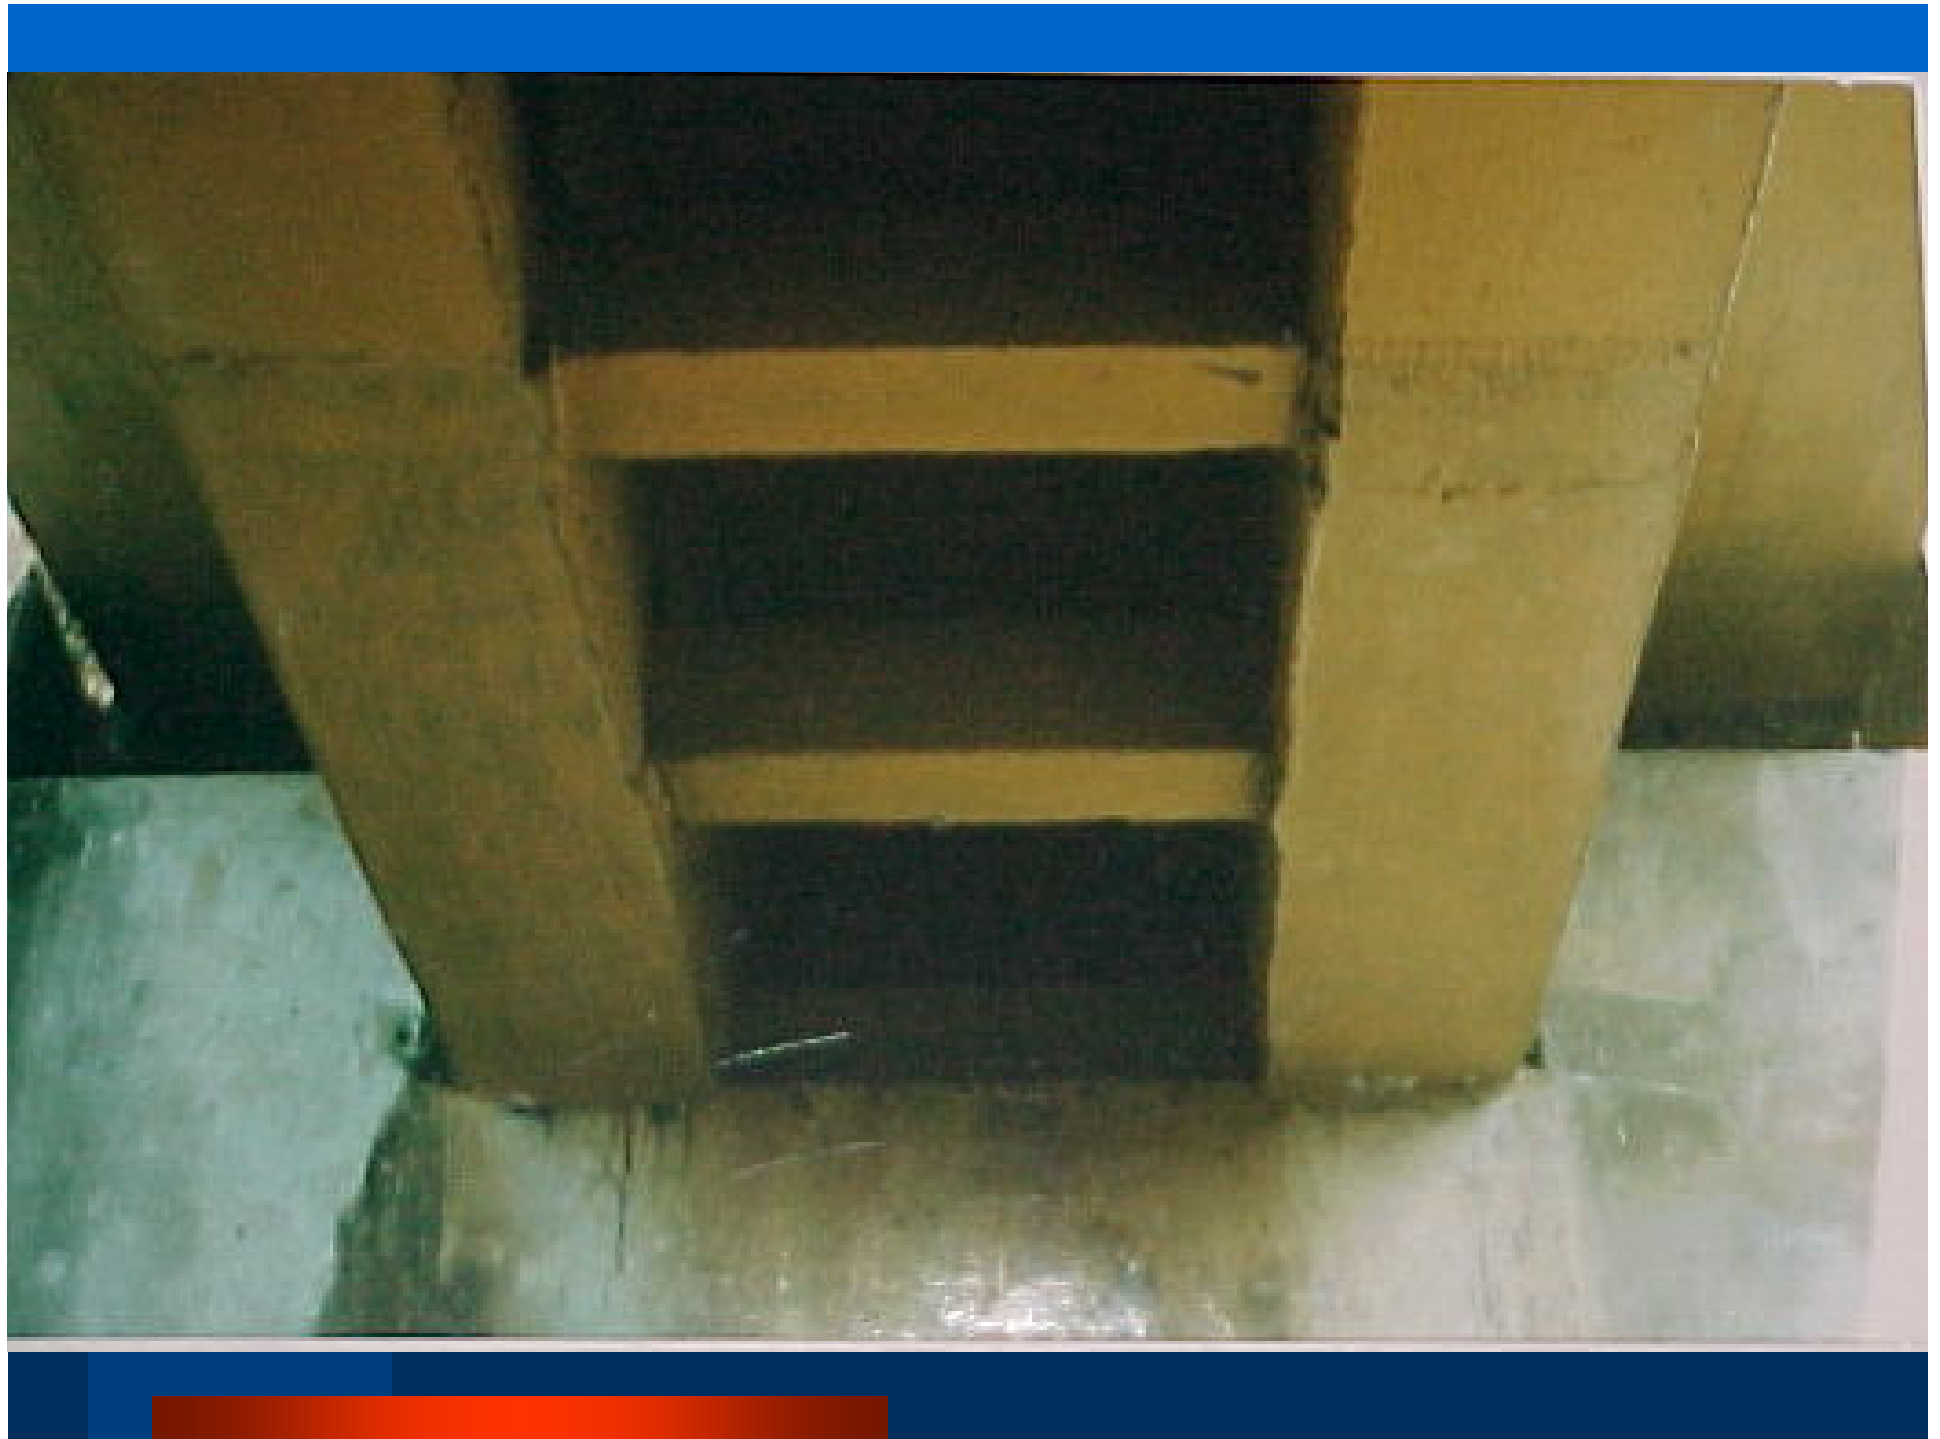
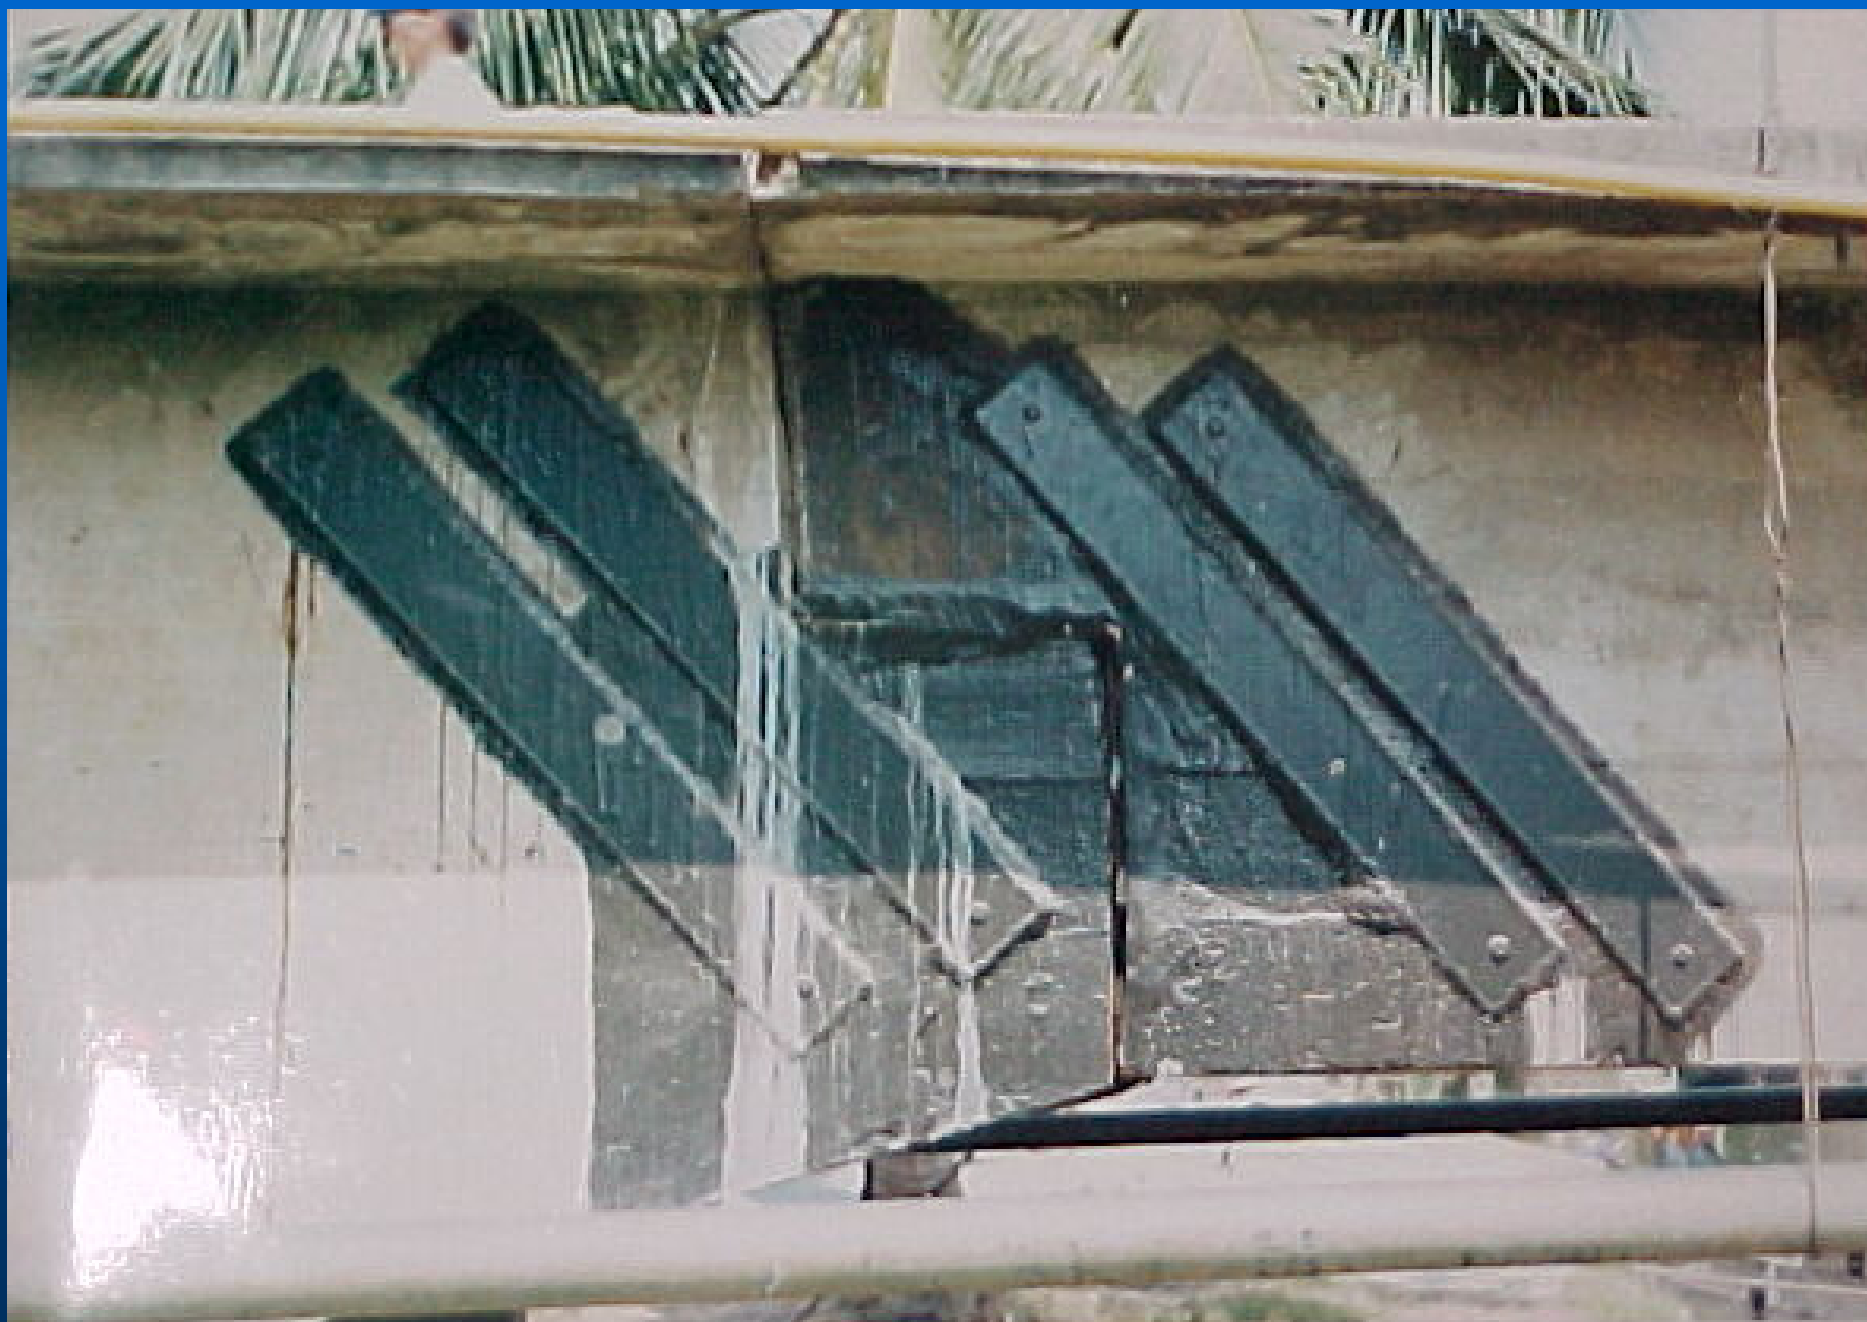
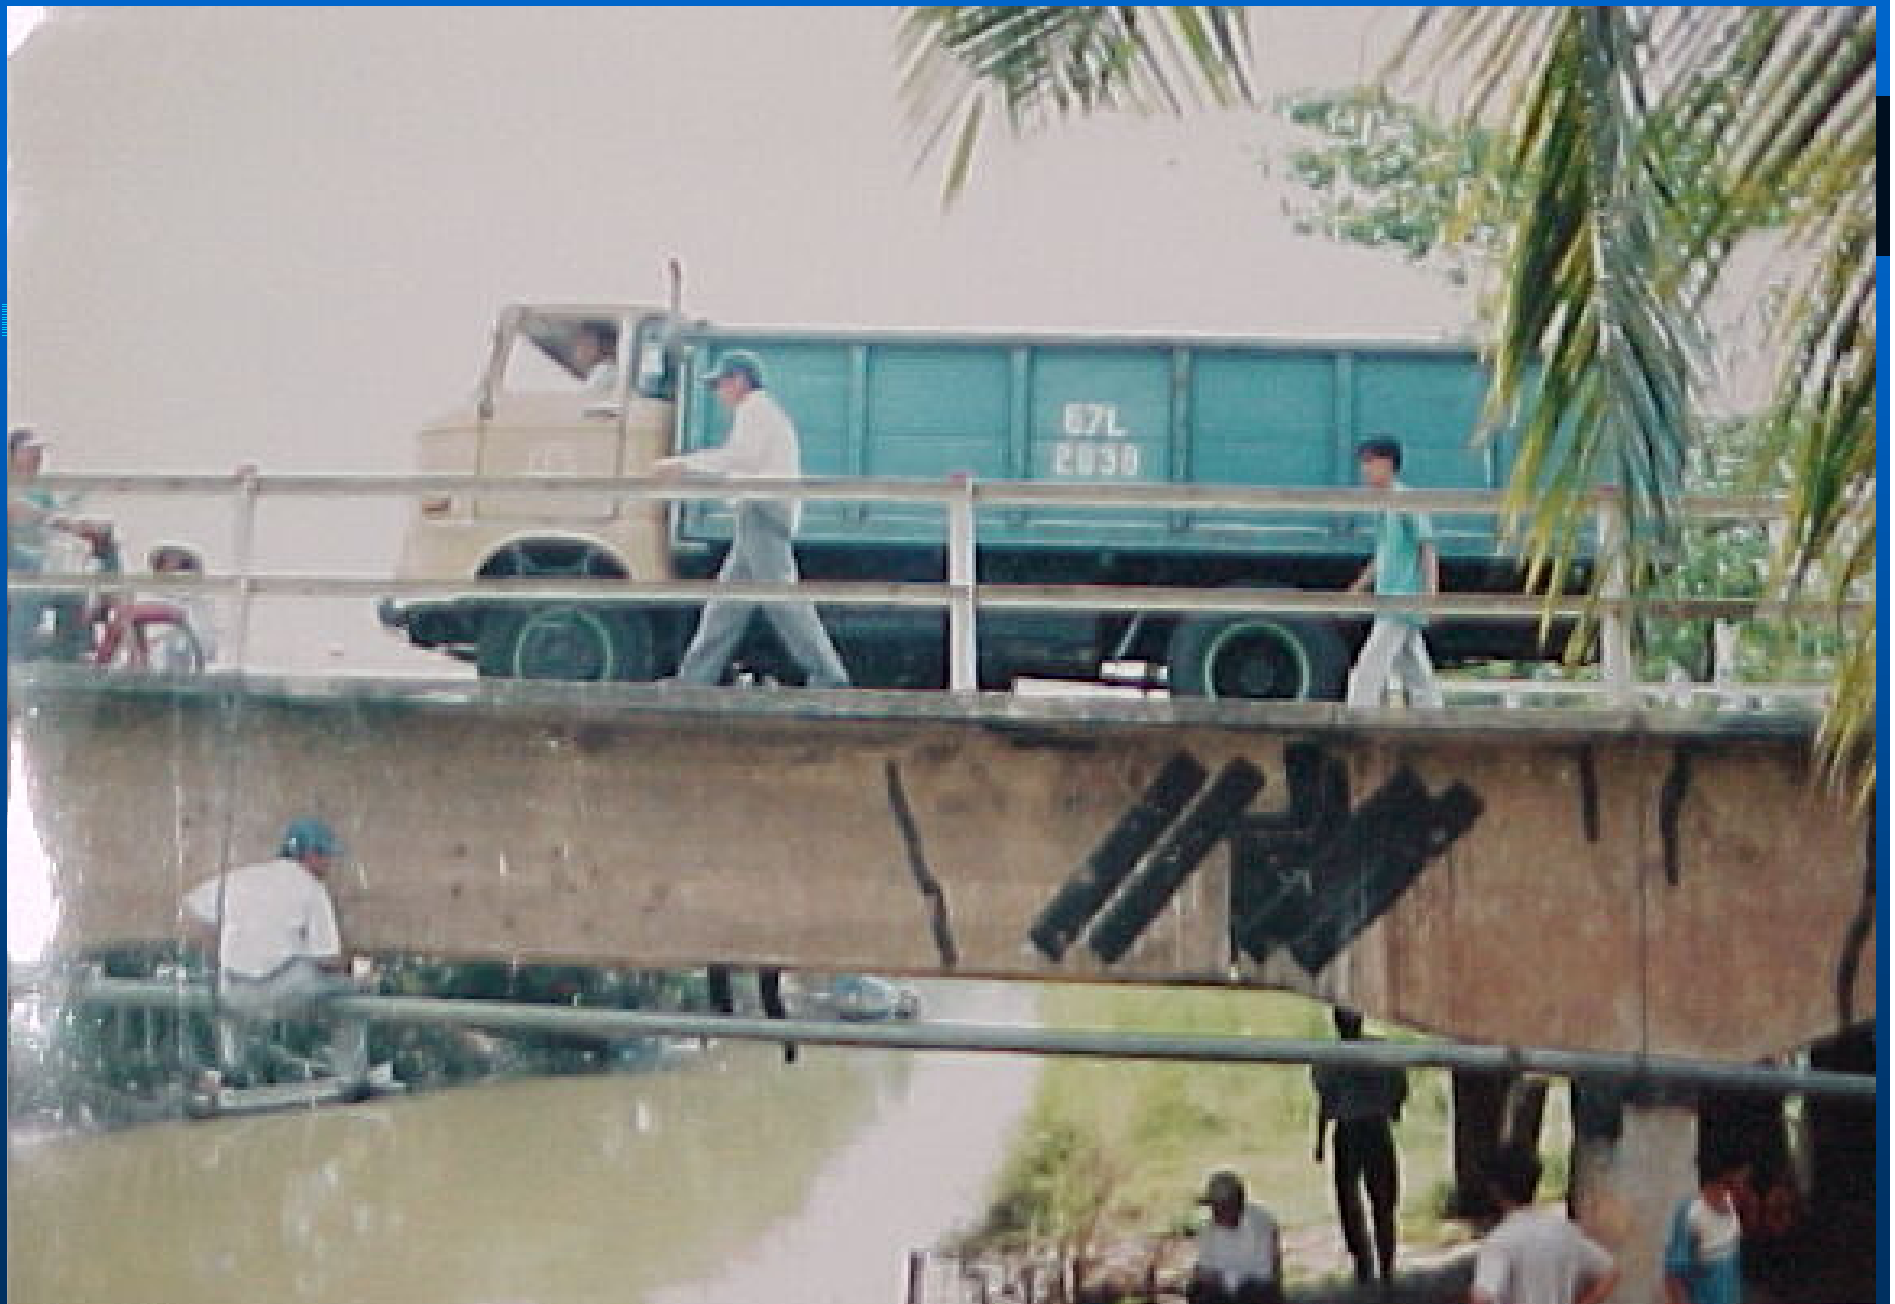
### SOME BRIDGES IN CUU LONG RIVER LOWLAND THAT HAVE BEEN STRENGTHENED BY BONDING STEEL PLATES.

- There are some bridge in Cuu Long River Lowland that have been strengthened by bonding steel plates. They are good for servicing.
- These are some picture about repairing process and existing of some bridge:
